Date of Report: 9/28/2020

BURNED-AREA REPORT

PART II - BURNED-AREA DESCRIPTION**A. Fire Name:** Ranch 2**B. Fire Number:** CA-ANF-003289**C. State:** CA**D. County:** LA County**E. Region:** Five**F. Forest:** Angeles**G. District:** San Gabriel
Mountains National Monument**H. Fire Incident Job Code:** P5NE4520 - 0501**I. Date Fire Started:** 8/13/2020**J. Date Fire Contained:** 96% as of 9/12/2020**K. Suppression Cost:** 5.8m**L. Fire Suppression Damages Repaired with Suppression Funds (estimates)**

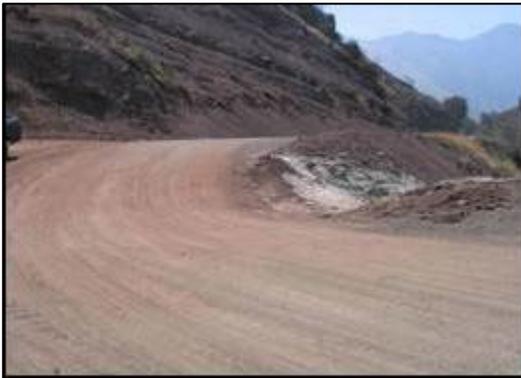
Big MAC concrete low water crossing

Road drainage structure improvements involves replacing existing deficient structures and installation of additional drainage structures to help ensure road drainage performs optimally. This work will be accomplished with contractor equipment and labor. *Locations:* Rincon Road
