Date of Report: 9/6/2016 **Initial Request**

Blue Cut Fire – San Bernardino National Forest, Front Country Ranger District

BURNED-AREA REPORT
(Reference FSH 2509.13)

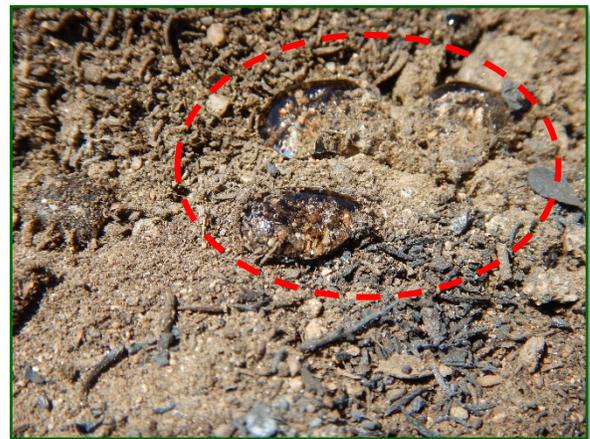
Figure 1: Strong soil water repellency

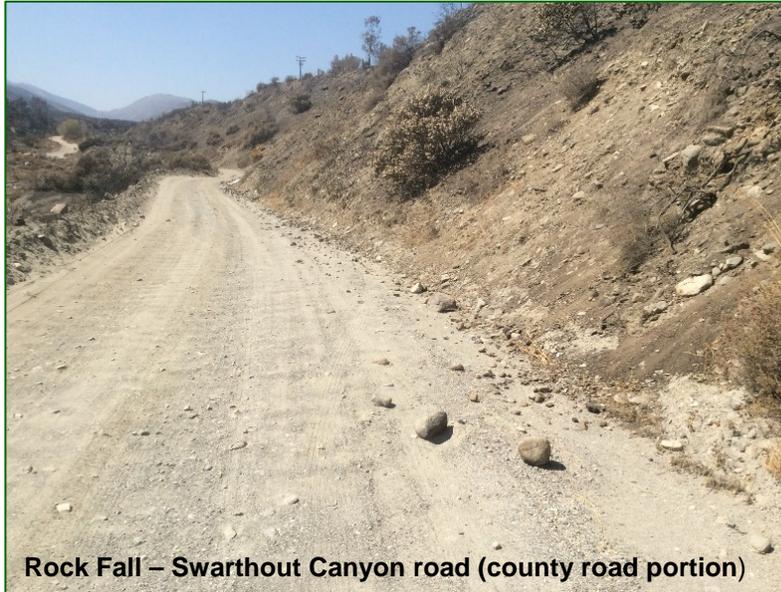
- Roads (Forest Service roads (3N06/3N49) Lytle Creek, Swarthout canyon and Lone Pine Canyon, Hwy. 66 (county), Hwy. 138 (State)): Rock fall occurred under pre-fire conditions below steep cuts and rock outcrop areas before the fire. County maintained Hwy. 66 is a 4 lane highway with the two lanes closest to the burned slopes closed. Rock fall is likely to occur in this area along the road. Rock fall will continue. The risk of rockfall and slope wash (dry ravel) along sections of these roads that burned is considered **High to Very High**.

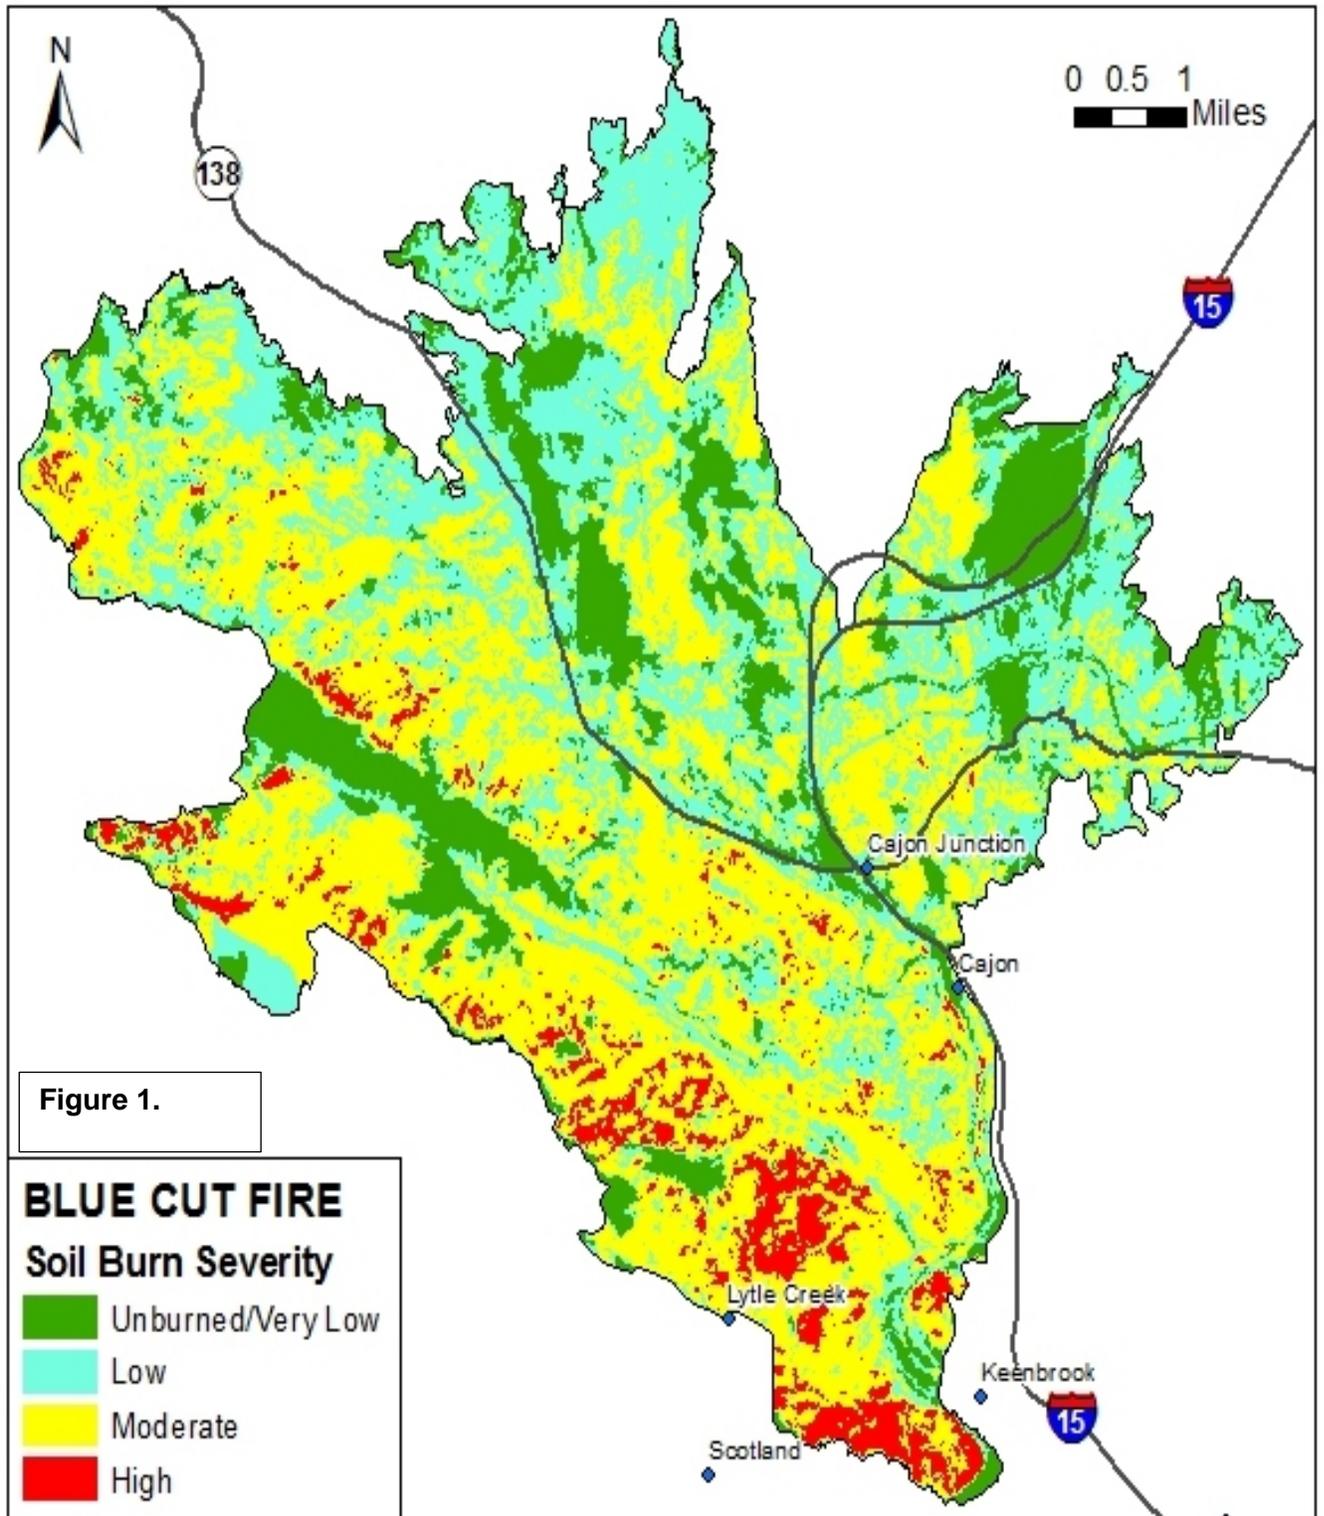
- Railroad tracks: The Union Pacific railroad track within the fire area is along the foot and toe of slopes that burned with high and moderate severity, especially in western portions of the fire, between milepost 64 and 68, and the narrow portion of the track in the Keenbrook area by milepost 67. The risk of rockfall and slope wash (dry ravel) in this section of the tracks as a result of the fire is considered **Very High**.
- PCT: various sections of the PCT through steep slopes, especially between Lone Pine Canyon and Lytle Canyon. PCT use through this section is generally highest in late spring, rocks and debris actually impacting hikers as they traverse by is possible, especially during storm events. Rock and debris are expected on the trail potentially impacting tread. This risk can be considered **High** as a result of the fire.

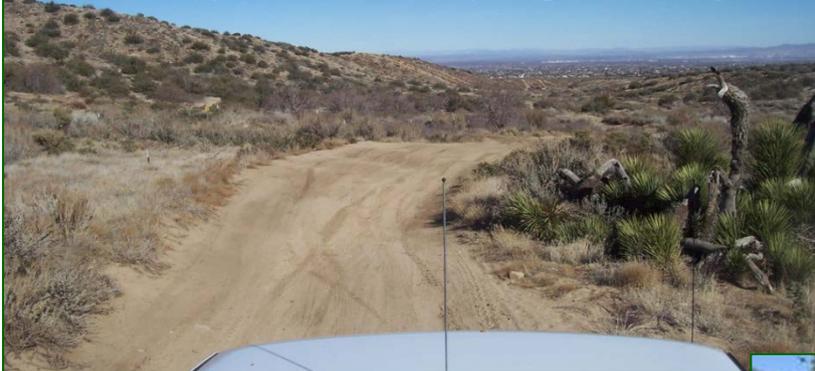
In 2013, three-strand wire fence that lined both sides of 3N24 in Baldy Mesa was stolen by scrap metal salvagers.

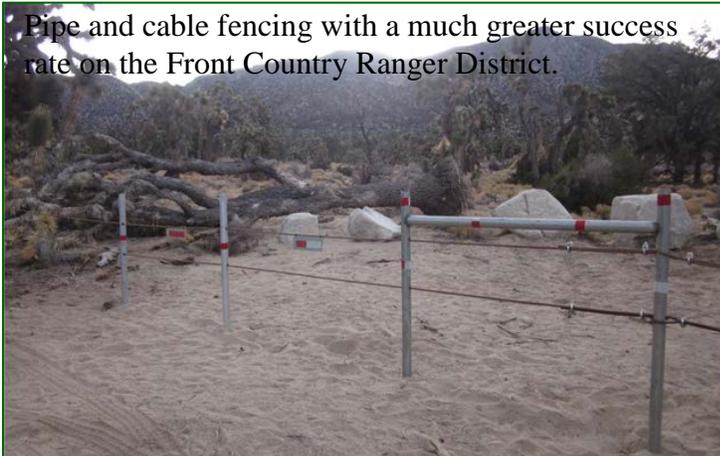
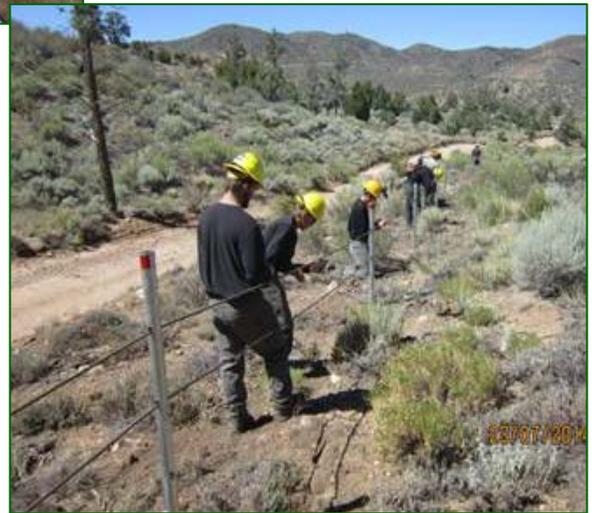
Pipe and cable fencing with a much greater success rate on the Front Country Ranger District.

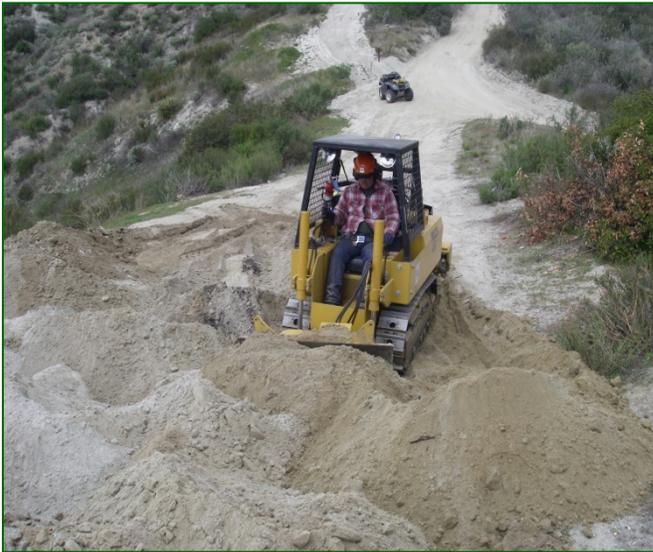
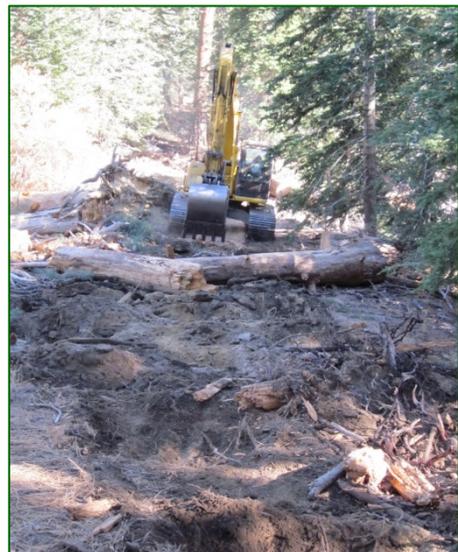
Above: Chunking with an excavator along a dozer line. After chunking, then the equipment spread topsoil and slash from the dozer piles over the treated area.

Chunking is described as using the bucket of an excavator or articulating blade on small trail dozer to de-compact unauthorized roads/trails by digging into the compacted area and creating divots (see below). These divots act as mini-catch basins (increasing infiltration), require minimal maintenance, and provide microsites for seed catchment and germination. In addition, container plants planted within the divots have high survival rates.
