**Trails Assessment - Rough Fire South Zone BAER
Sequoia National Forest
October, 2015**

By: Hannah Stone, BAER Recreation Specialist
Eldorado National Forest

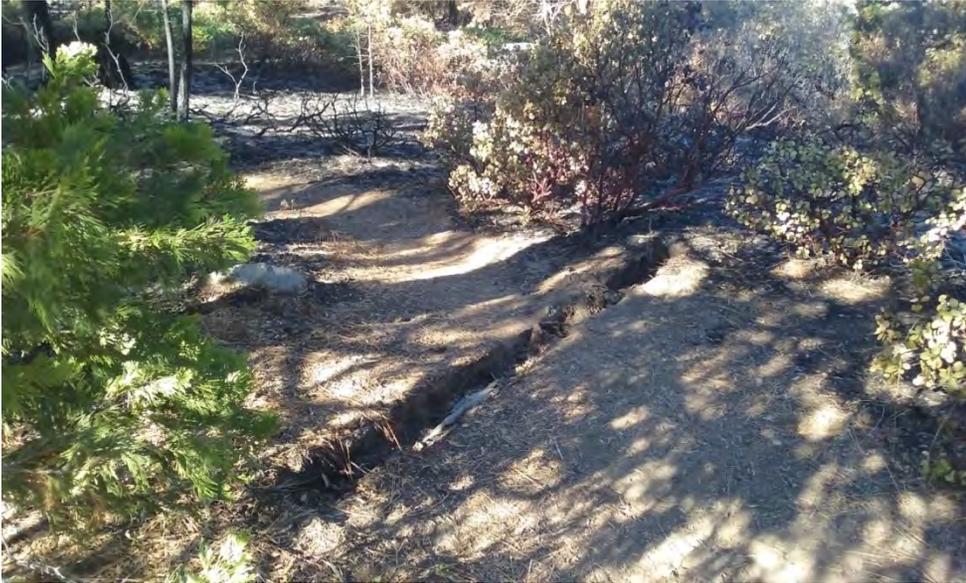
Boole Tree Trail (28E02): The Boole Tree Trail had 13% of its length within moderate burn severity, and is downslope of approximately 23 acres of land burned at moderate and high severity (Appendix B, Table 1). Numerous log waterbars used to divert water from the trail and a log retaining structure stabilizing approximately 40 feet of the tread were burned in the fire (Appendix A, Photo 1 and 2). The loss of waterbars will increase flow down the trail, and result in erosion of the tread. If uncorrected, rills or gullies may form which will further concentrate flow and exacerbate erosion. The loss of the log retainer has resulted in undercutting and destabilization of the outside edge of the tread. A large tree stump on the inside edge of a switchback burned out, resulting in destabilization of the tread which could lead to tread collapse and threaten the safety of administrative or public trail users (Photo 3). Off-trail resource damage could occur if trail users choose to shortcut the switchback in order to avoid the destabilized tread. This trail has the capacity to capture flow from a couple ephemeral drainages. Expected accelerated flow at these drainages from moderate and high burn severity above will result in increased erosion of the trail tread and sediment delivery to the drainages. It is recommended that the burned waterbars and log retainer be replaced, burned-out stump holes be filled with adjacent material, and that drainage function be maintained and restored along the length of the trail in order to reduce the risk to property, safety, and natural resources posed by the fire (Treatment 1). Observations not warranting treatments due to low risk to BAER critical values include potential hazardous waste from burned Forest Service electrical equipment adjacent the trail and reduced functionality of a grazing allotment fence due to numerous burned wooden posts. It is recommended that the burned electrical materials be removed and that the grazing allotment permittee be notified of the damage to the fence.

Photo 1: Burned Waterbar on Boole Tree Trail

Replacement and installation of log water bars: This treatment would occur on the Boole Tree Trail. Burned log water bars would be replaced and log waterbars would be installed where necessary to restore drainage function so that they match existing log water bars in order to keep the character of the trail and reestablish drainage function. Waterbars should be up to 12" diameter peeler core or treated lodgepoles, anchored 12" into the cutslope and extending at least 6" into the fillslope at a 45° angle (Exhibit X). Log water bars must be maintained regularly to function properly. If maintenance cannot be guaranteed, consider installing knicks instead (Exhibit 2).

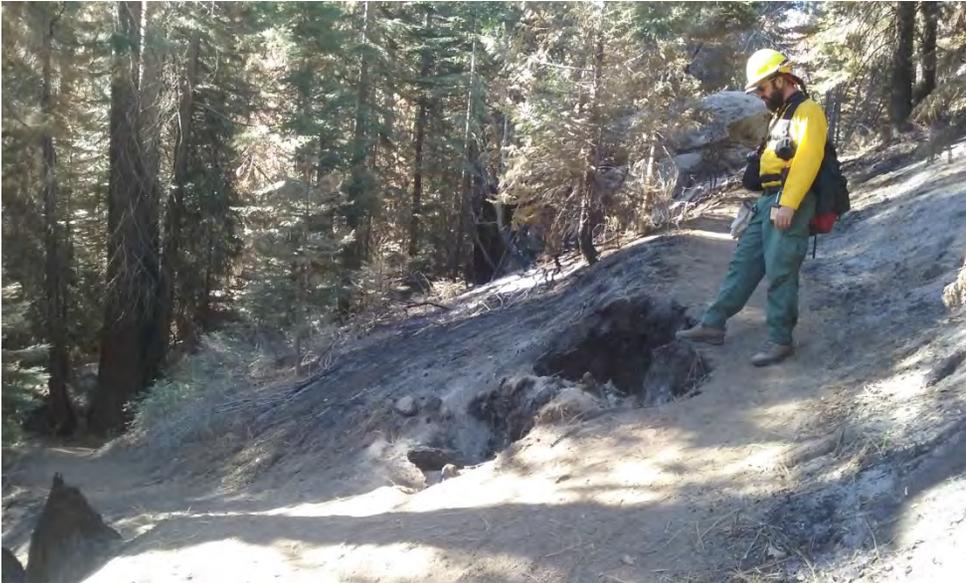
Photo 3: Burned-Out Stump Hole on Boole Tree Trail

Filling of Stump and Root Holes: This treatment would occur where identified on the Boole Tree Trail and anywhere stump and root holes may destabilize trail tread on the other trails that will receive storm proofing treatment. Fill material would be removed from adjacent the trail tread after receiving archeological clearance, and would be packed into the stump or root hole then compacted with the back of a McLeod or a tamping bar.

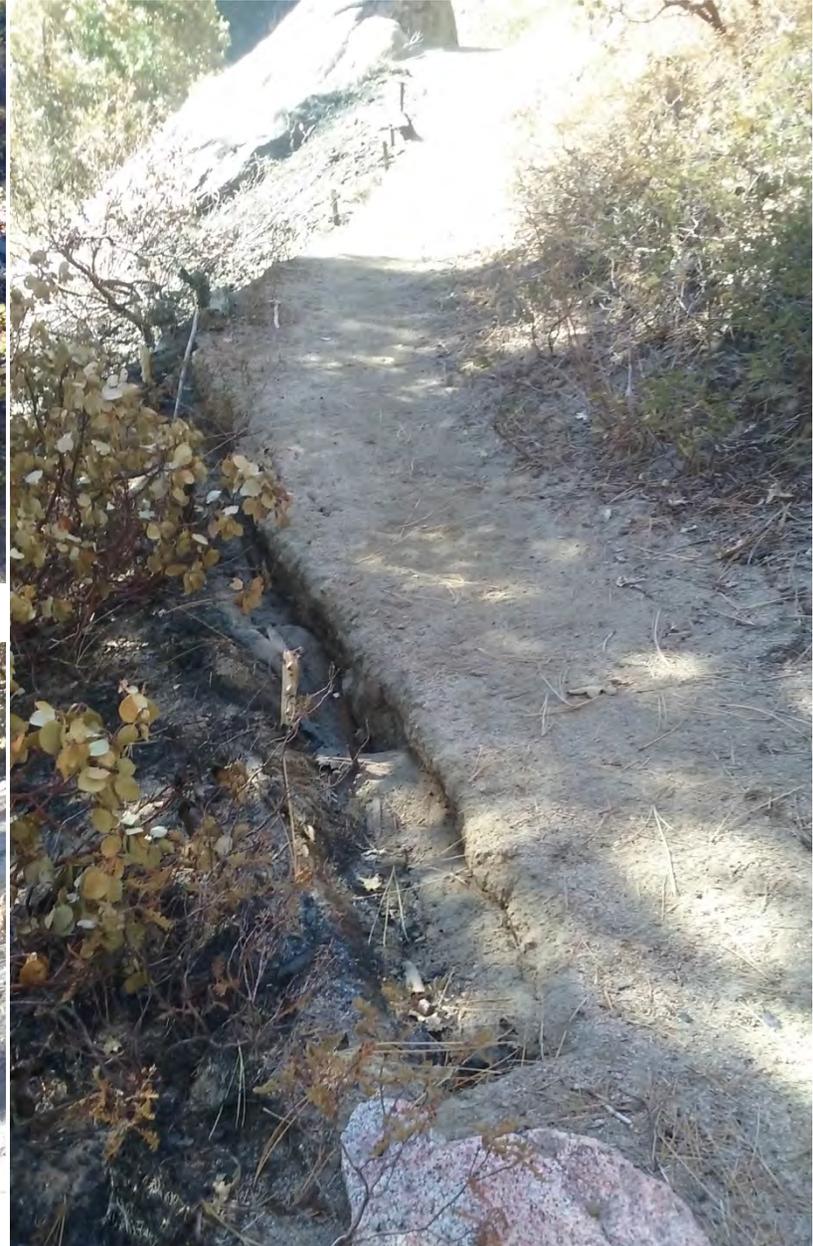
Photo 2: Burned Log Retainer on Boole Tree Trail

Burned Log Retainer Replacement: This treatment would occur on the Boole Tree Trail. Treated 6-8" lodgepole or peeler core would be placed where the logs burned out and would be anchored using lengths of rebar. Fill material would be used to fill the tread on the inside edge of the log retainer (Exhibit 6).

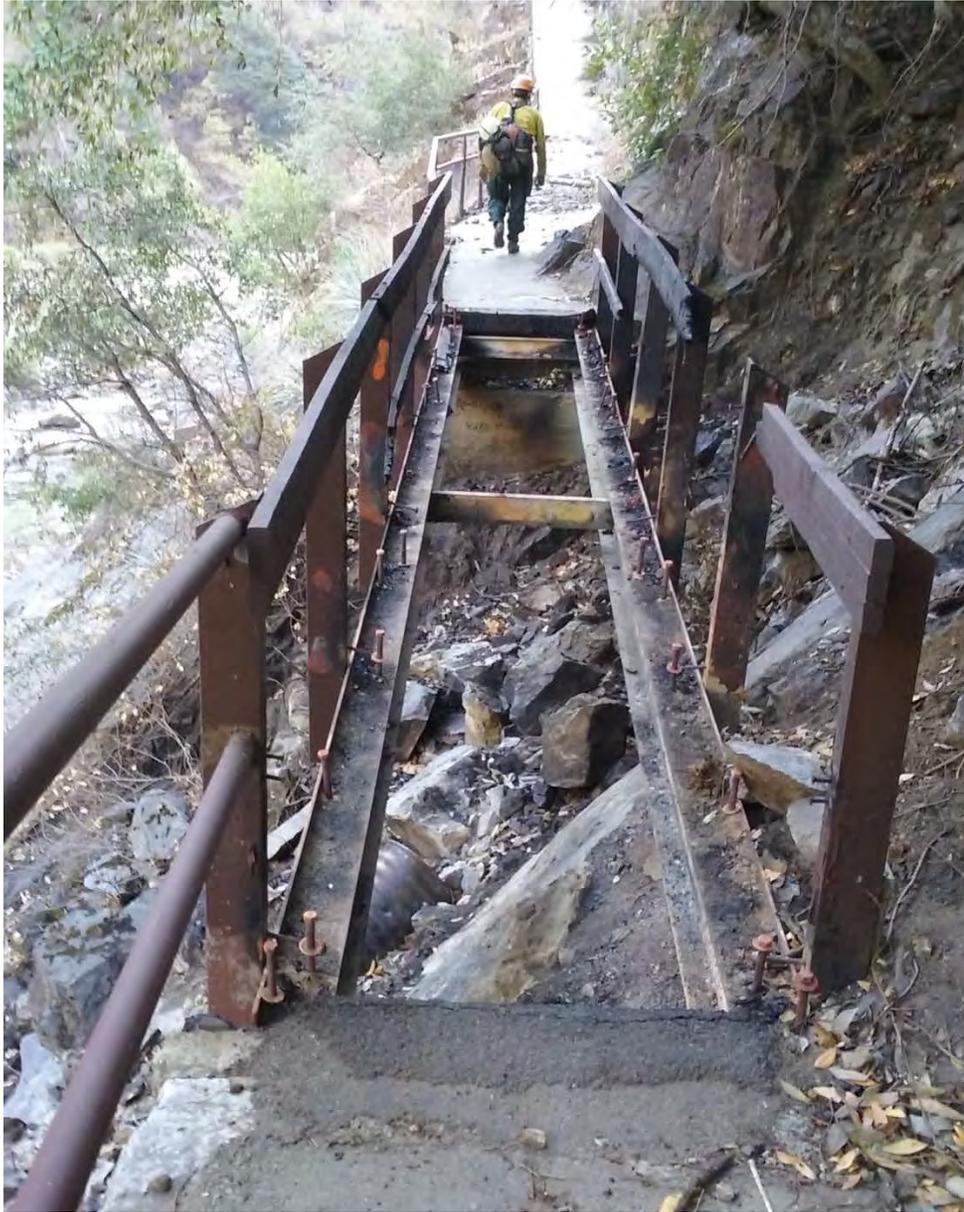
Boyden Cavern Pathway (11141-6): The Boyden Caverns pathway was subject to low severity burn (Table 1). Potential risks to natural resources and human life and safety exist along this path. Burned equipment alongside the pathway may leach hazardous materials. A burned tree damaged the paved pathway on the outside edge of the tread when it fell. The decking and railing of two walking bridges was burned, making the bridges unsafe for pathway users (Photo 4). There is also potential for small rocks and debris to fall from slopes above the trail. It is recommended that the permittee keep the pathway closed to public use until the bridges are repaired and the hazardous materials are removed.

Photo 4: Burned Bridge Decking and Railings on Boyden Cave Pathway

It is recommended that the Forest notify the grazing allotment permittee of the burned fence posts along the Boole Tree trail, and the Boyden Caverns permittee of the of risk to life and safety due to the

burned walking bridges on the Boyden Cave pathway. It is also recommended that the private landowners be notified where the Crabtree Trail meets the 12S01 road, and at the south end of the Camp 4 Trail before installation of a warning hazard signs at these locations.

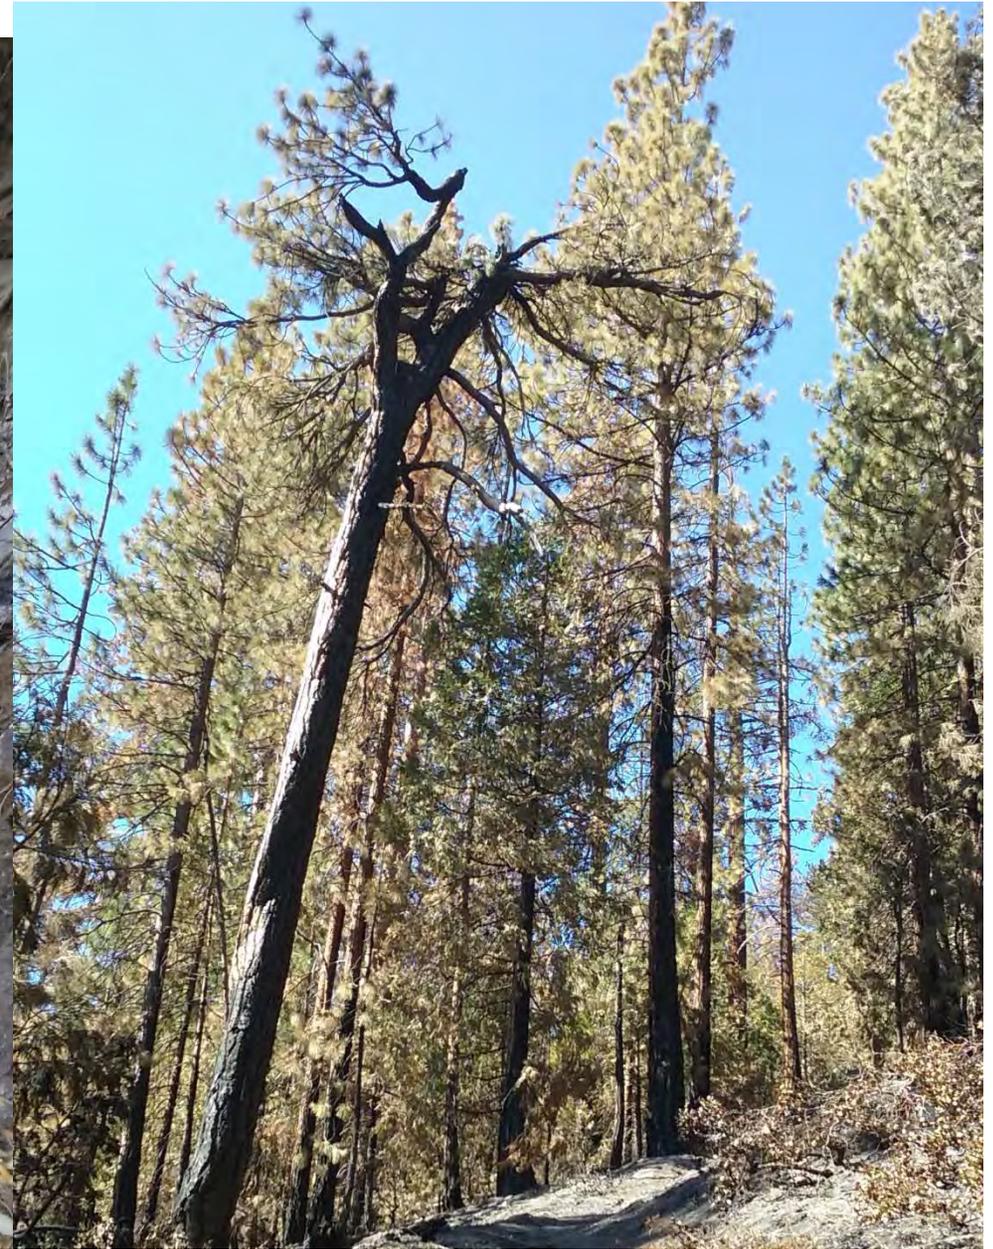
Kanawyer Trail (30E04): The Kanawyer Trail had 11% of its length subject to moderate burn severity, and 1% subject to high burn severity (Table 1). The segment of the trail between Boulder Creek and Monarch Grove has approximately 224 acres of mostly moderate burn severity land upslope (Map 3). The trail was assessed in the field from the Kennedy Grove Road trailhead to an overlook that allowed viewing of the burned trail segment east of Boulder Creek. Approximately 6 trees were observed and determined to be imminent hazards to trail users along the 2 miles of trail surveyed (Photo 5-7). It is very likely that more hazard trees exist that would pose a risk to life and safety of administrative or public trail users. Several burned stumps along the edge of the trail corridor have destabilized the tread, and pose a safety risk to trail users and natural resources. Off-trail resource damage could occur if trail users choose to

Photo 5: Hazard Tree on Kanawyer Trail

Hazard Tree Removal: Hazard trees along the trails receiving treatment would be identified by a C-faller and removed before implementation. Blazed trees would be retained, if possible.

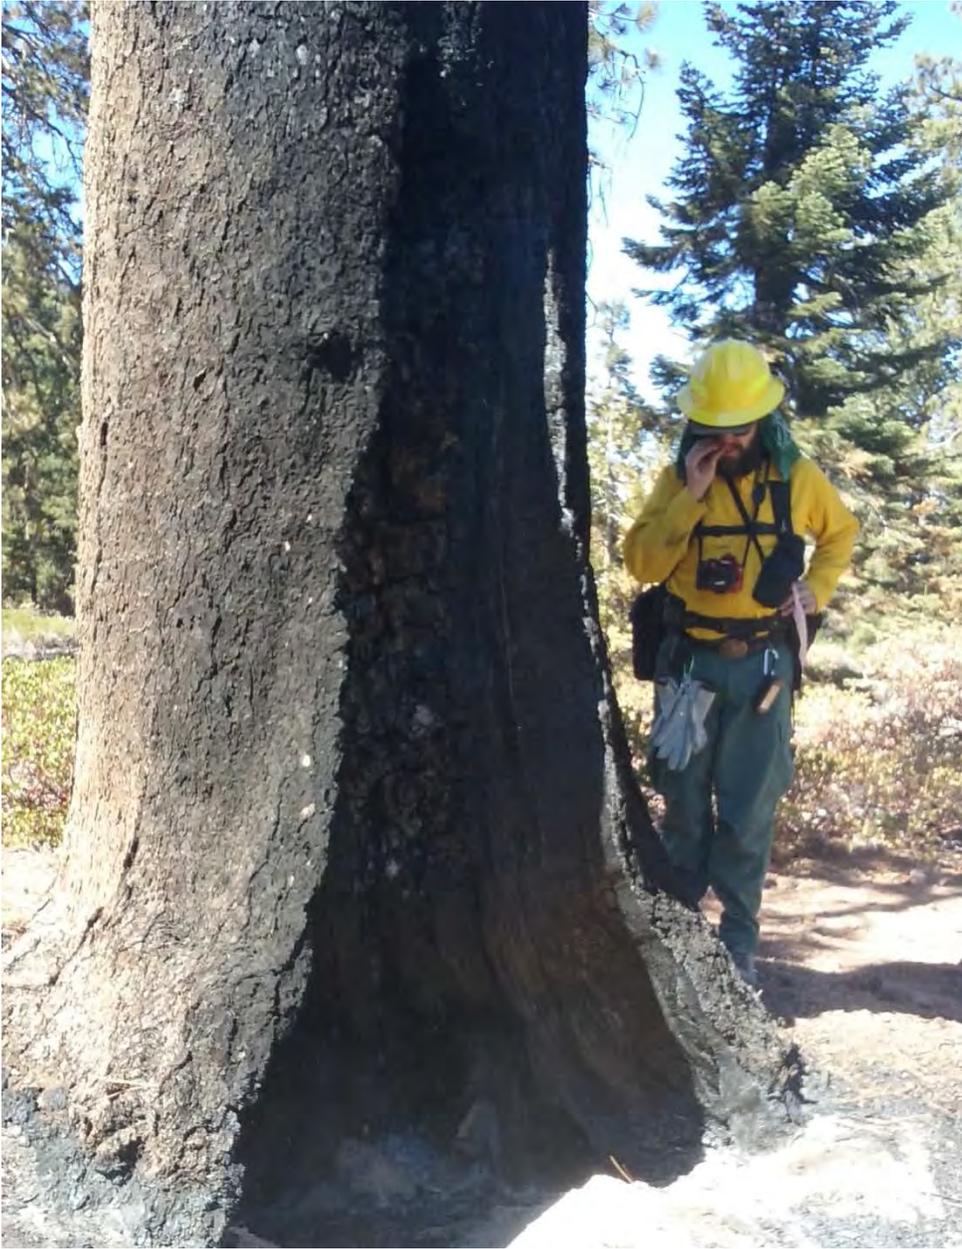
Photo 6: Hazard Tree on Kanawyer Trail

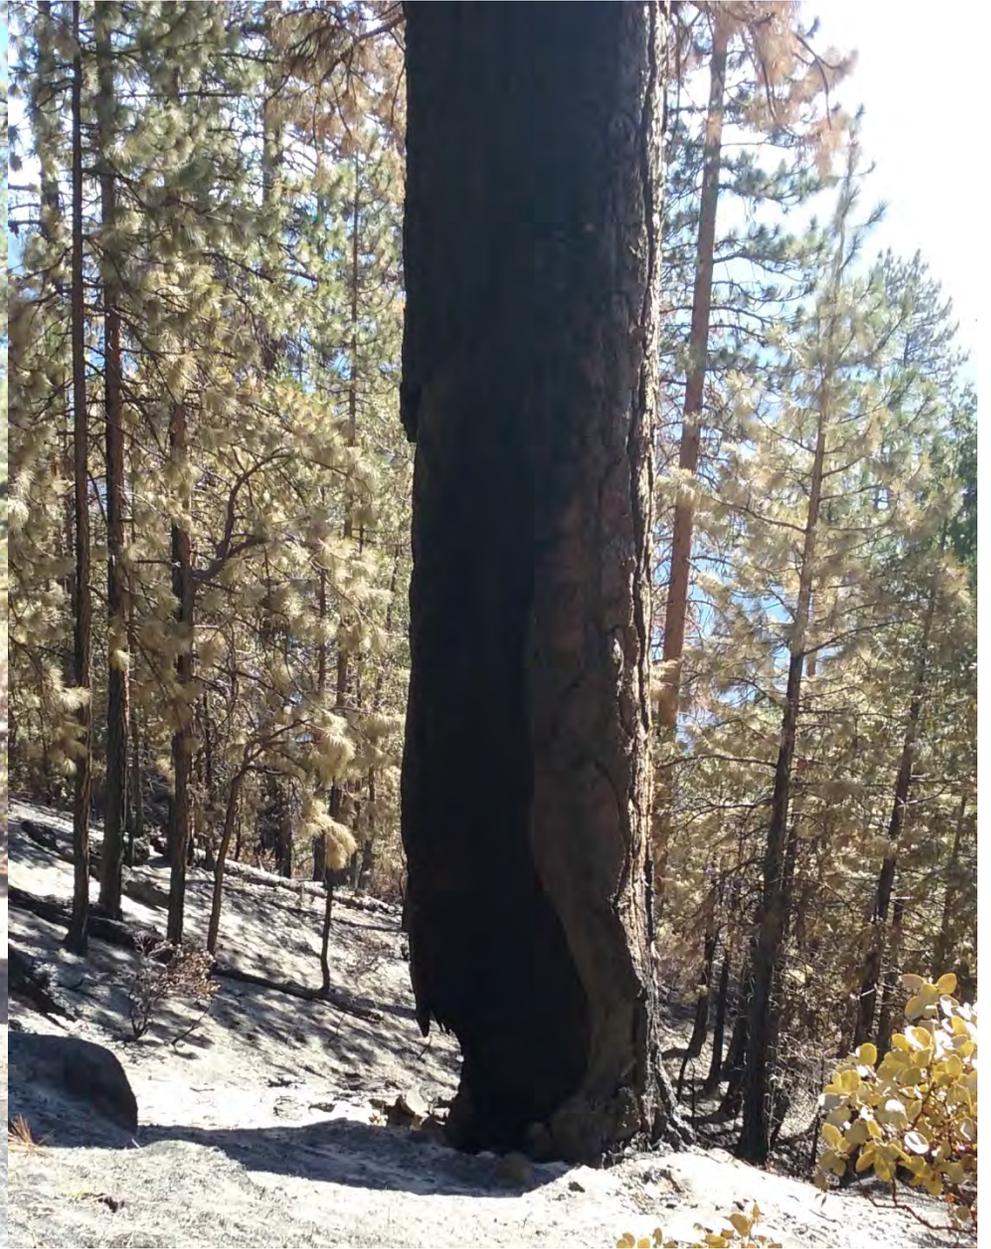
Photo 7: Hazard Tree on Kanawyer Trail

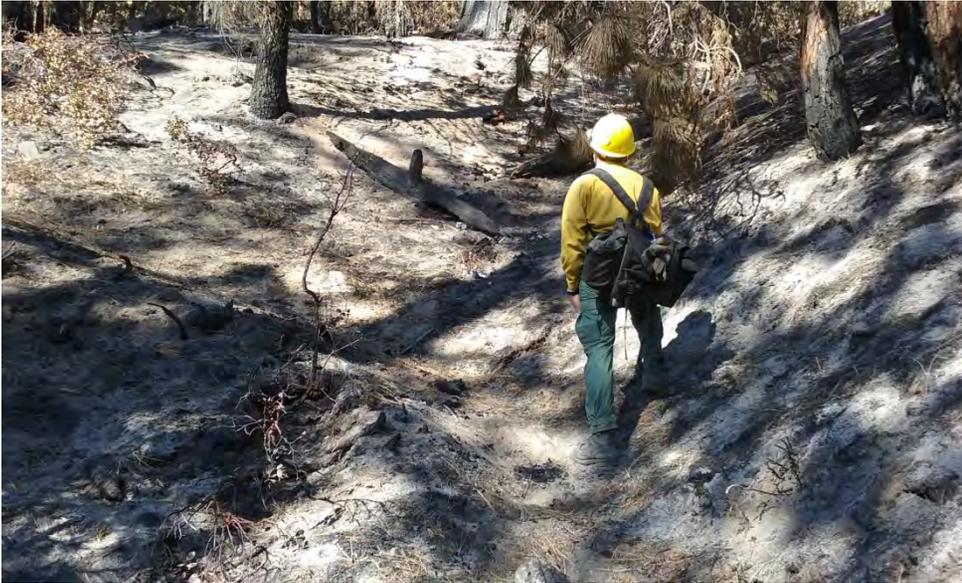
travel off-trail to avoid the destabilized tread. A burned directional sign at the western junction with Evan's Grove Loop may lead to user confusion. The trail has the capacity to capture flow due to the presence of berm and the lack of adequate water diversion structures, and will lead to increased erosion of the trail tread in areas of moderate burn severity if not addressed. The trail crosses multiple steep draws having the potential to carry accelerated flow from land subject to moderate burn severity upslope, and is at risk of washing out at these crossings in periods of high runoff (Photo 8). In some cases, flow from these draws would be captured by the trail tread for short distances, which can lead to complete loss of the tread. It is likely that there are similar risks at most of the drainage crossings along the burned sections of trail. Local knowledge and field observations indicate the area of moderate burn severity above the trail segment east of Boulder Creek appeared to have been mostly grasses pre-fire. This hillslope was left bare after the fire, and the trail below may be subject to increased flow from the bare hillslope and ephemeral drainages feeding into rattlesnake creek. The seldom maintained trail tread likely has the potential to capture flow which would increase erosion of the tread and the potential for sediment delivery from the tread to Rattlesnake Creek or Boulder Creek. In order to address the unacceptable risk to life and safety along the Kanawyer Trail, it is recommended that a forest order be obtained to close the trail from the Deer Meadow Trail junction to the 13S25 Road for up to a year or until the hazard trees are mitigated, and that hazard warning and closure signs be posted at trail access points adjacent the fire perimeter (Treatment 2). To protect property and natural resources it is recommended that stump holes are filled, berm is removed, the tread is outsloped, rock waterbars are maintained, additional rock waterbars and/or rolling dips are installed where necessary to deflect flow from the trail tread, and armored drainage dips are installed at the identified at-risk draws and where necessary to prevent wash-outs at drainage crossings (Treatment 1). Completion of this work would require hazard tree removal to protect the safety of workers. It is recommended that the implementation leader seek approval to operate chainsaws within the Monarch Wilderness in order to speed implementation and prevent damage to critical values that may be caused by the first damaging storm.

Photo 8: Kanawyer Trail Tread Captures Flow

Installation of rock waterbars: This treatment would occur on the Kanawyer trail. Rock waterbars would be installed to match the existing rock waterbars where necessary to restore drainage function. Rock would be gathered from adjacent the trail and should be installed so that there is an overlapping line of rock skewed 45° on the downhill side of the trail, 2/3 of each rock buried in the soil surface with at least 4" showing on the downhill side (Exhibit 3). Rock water bars must be maintained regularly to function properly. If maintenance cannot be guaranteed, consider installing rolling grade dips instead (Exhibit 4).

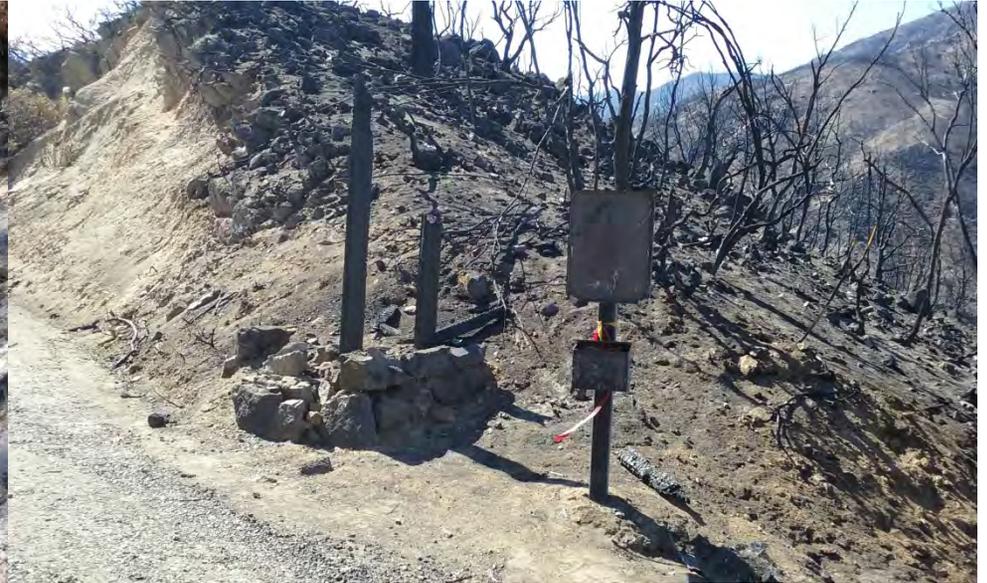
Yucca Point Trail (28E01): The Yucca Point Trail had 60% of its length subject to moderate burn severity and has a relatively small amount of contributing area with moderate burn severity (Table 1). Trailhead signage at the Highway 180 junction was burned which may lead to user confusion (Photo 9). The trail has the capacity to capture flow due to the presence of berm and the lack of adequate water diversion structures, especially where a culvert directs flow from a large roadside catchment into the trail tread (Photo 10). Accelerated flow from land burned at moderate severity adjacent the trail and land draining into the road culvert is likely to erode the trail tread. Removal of vegetative cover and burning of the soil structure has destabilized the slopes above the trail, and caused the slopes to be subject to dry ravel

Photo 9: Burned Signs at Yucca Point Trailhead

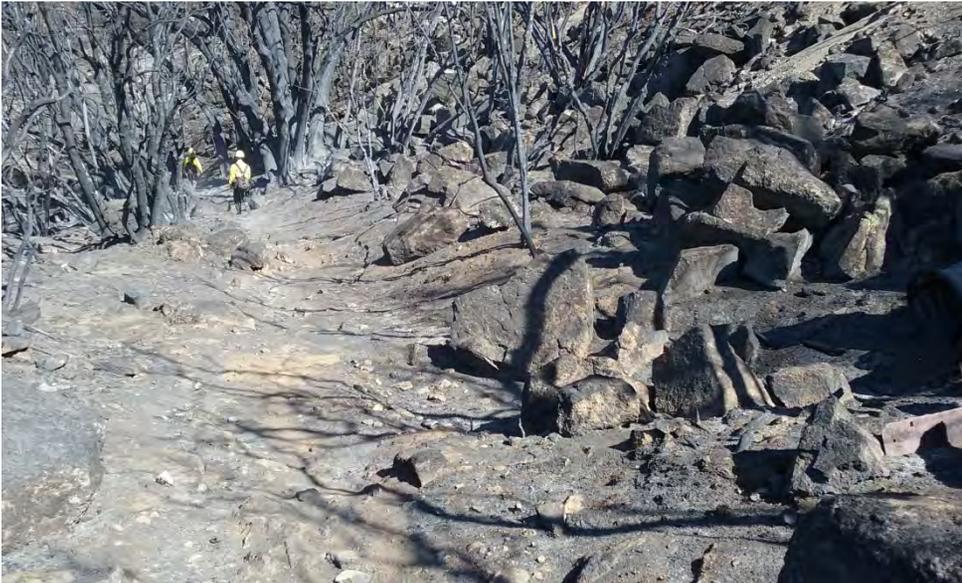
(Photo 11). Loose rock material has sloughed onto the trail tread and has likely loosened boulders on the steep slopes. The instability of the dry ravel-covered trail tread and the potential for rock fall poses a risk to life and safety of trail users. It is recommended that a forest order be obtained to close this trail to public use for up to a year or until there is no longer an unacceptable risk from rock fall, and that hazard warning and closure signs be posted at both ends of the trail (Treatment 2). To protect property and natural resources it is recommended that dry ravel is periodically removed from trail tread, berm is removed and the tread is outsloped, where feasible, rock waterbars are maintained, additional rock waterbars and/or rolling dips are installed where necessary to deflect flow from the trail tread, and an armored rolling grade dip is installed to deflect water entering the trail from the road culvert (Treatment 1).

Photo 10: Yucca Point Trail Captures Flow from Road Culvert

Installation of armored grade dips: This treatment would occur at a culvert outlet on the Yucca Point trail, and ephemeral drainage crossings and steep draws identified on the Kanawyer Trail, Boole Tree trail, Yucca Point Trail, and potentially existing on the Choke Creek and Happy Gap trails where tread erosion from accelerated post-fire flows is likely. Rock would be gathered from adjacent the trail after obtaining archeological clearance. Tread would be reshaped to create a gradual dip where water can exit the tread followed by a rise at an angle to the outslope to divert water off the trail. The drainage structure would include a riprap tray where the water exits the trail followed by a rock waterbar to divert flow, a section of fill and a retainer bar to retain the fill (Exhibit 5).

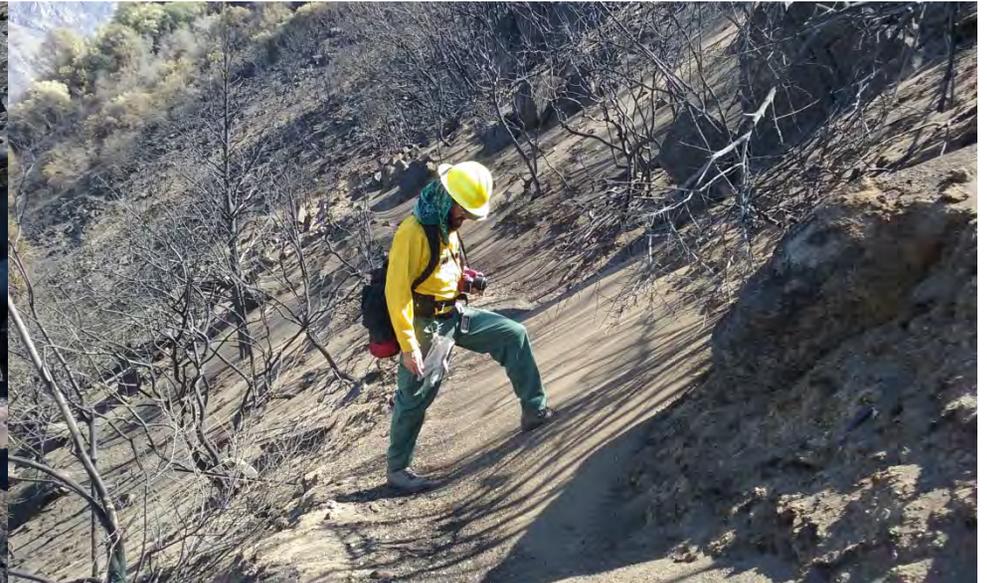
Photo 11. Dry Ravel Sloughing onto Yucca Point Trail

Dry Ravel Removal: Dry ravel would be removed from the Yucca Trail tread in order to provide for ease of passage and safety of trail workers. It is expected that the material will need to be removed a few times during the course of implementation or if the trail opens to the public before the slopes stabilize.
