Erskine Fire BAER - Recreation Assessment
Sequoia National Forest
July, 2016
 By: Hannah Stone, BAER Recreation Specialist
 Eldorado National Forest

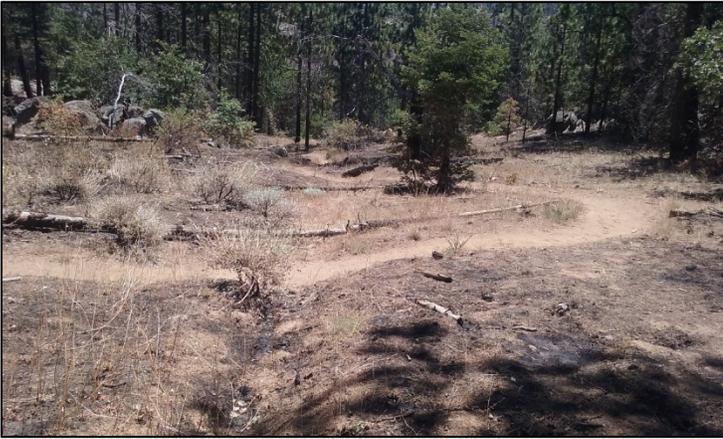
- Off-trail travel is common where the trail has a sinuous design and there are no obstructive barriers. This is a pre-existing issue caused by the trail design in these locations, and possibly more open conditions created by past fires. However, down woody material burned in the Erskine fire may have created off-trail access in some areas which may lead to an increase in unauthorized use. Many of the unauthorized routes are capturing flow and there is some delivery to the existing trail, although there is little potential for damaging accelerated flow due to the small amount of contributing area (Photo 1). It is recommended that barricades be installed or fire-damaged trees be strategically felled, where possible, to prevent off-trail travel and that unauthorized routes be restored more effectively to prevent future travel and flow capture.

Photo 1: Trail braids on South end of Dry Meadow capture flow and deliver to existing tread.

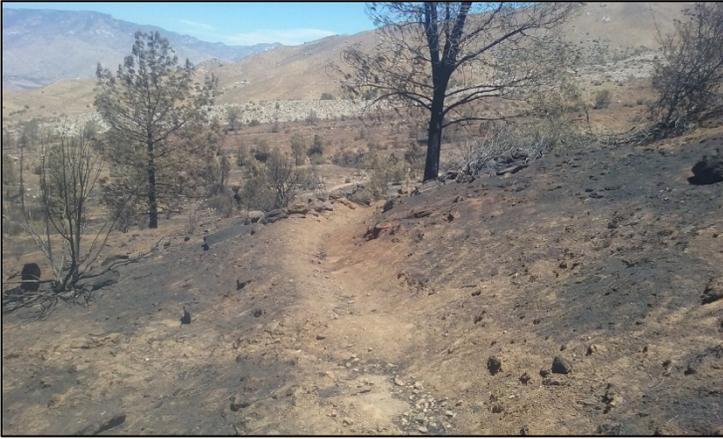
- Generally, the tread of the south end of the trail was in good condition and did not capture flow. The north end of the trail on the ridge above Long Canyon channels flow for most of its length in between water breaks due to tread incision up to 2.5' in depth. The trail in this section follows the ridgeline closely and it is unlikely that accelerated flow from burned areas would significantly increase the amount of flow and subsequent tread erosion. However, the concentrated flow from the tread is released at water outlets onto adjacent burned land. Some of the water outlets are on steep slopes and have existing rills (Photo 2-3). It is likely that accelerated flow from the fire will create additional erosion leading to gully formation. It is recommended that water outlets be armored to reduce flow velocity and prevent excessive off-site erosion.

Photo 2: Rilling at water outlets on North end of Dry Meadow Trail.

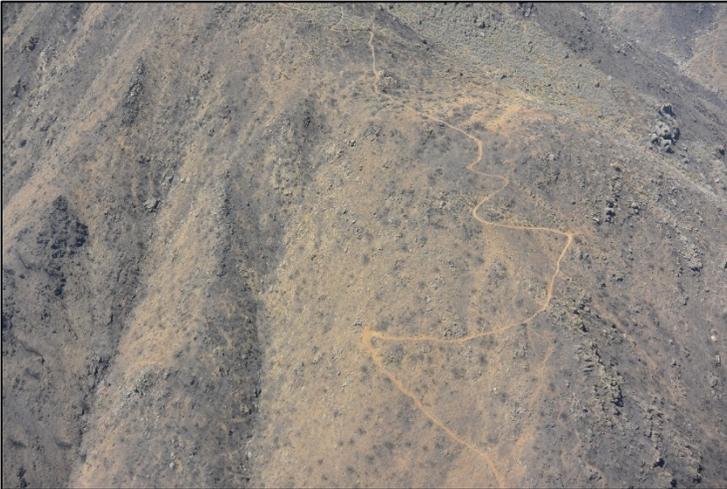
Photo 3: Erosion at water outlets on North end of Dry Meadow.

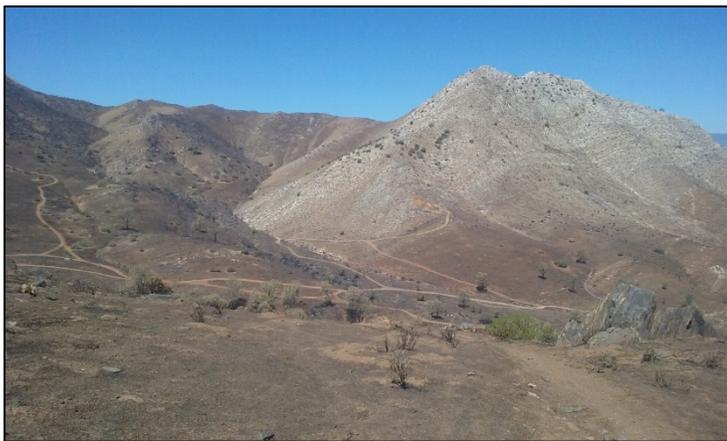
- Regular unauthorized off-highway vehicle (OHV) use occurs on NFS lands, most of which originates from primitive and administratively closed roads on adjacent BLM land to the North (Photo 4). The issue existed prior to the fire, although post-fire conditions may increase the unauthorized use. A post and barbed wire grazing allotment fence runs along the BLM and FS boundary and was damaged in the fire. It is likely that the fence was already in disrepair in some sections, but is now mostly non-functional and opens up many other potential access points for OHVs. Herbaceous vegetation was present before the fire, so loss of this vegetation is unlikely to contribute to creation of OHV access.

Photo 4: Unauthorized OHV use is common near North end of Little Dry Meadow.

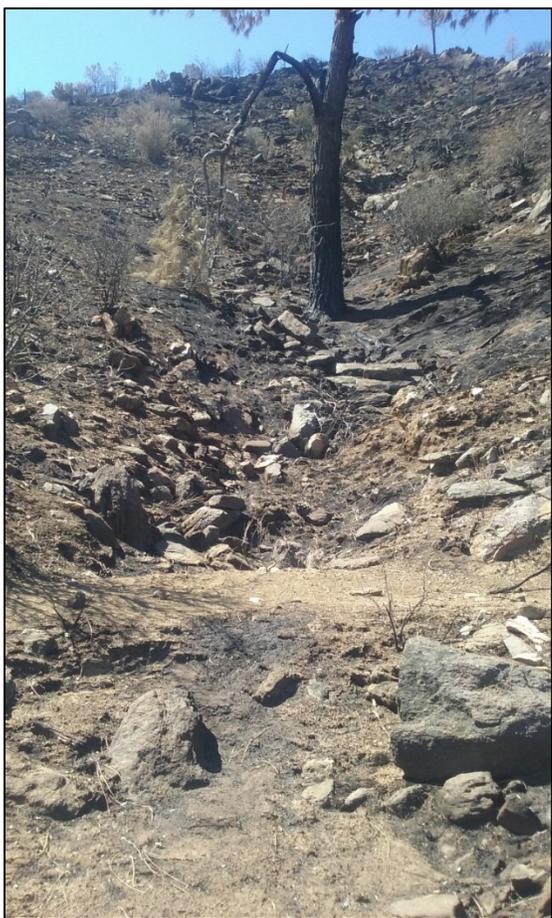
- There is a risk to tread from accelerated flow at drainage crossings. In most cases, damage would be localized and minor due to adequate water diversion features. One observed drainage crossing was not graded to allow for easy passage of flow, and it is recommended that a drainage dip be constructed in this location (Photo 5). It is also recommended that dips be maintained at all crossings to ensure effective water removal.
- The potential for debris flow exists along this trail. A USGS debris flow model predicted from 20-60% probability of this occurring using a design storm of a peak 15-minute rainfall intensity with a rate of 28

Photo 5: Long Canyon trail needs drainage dip constructed at crossing

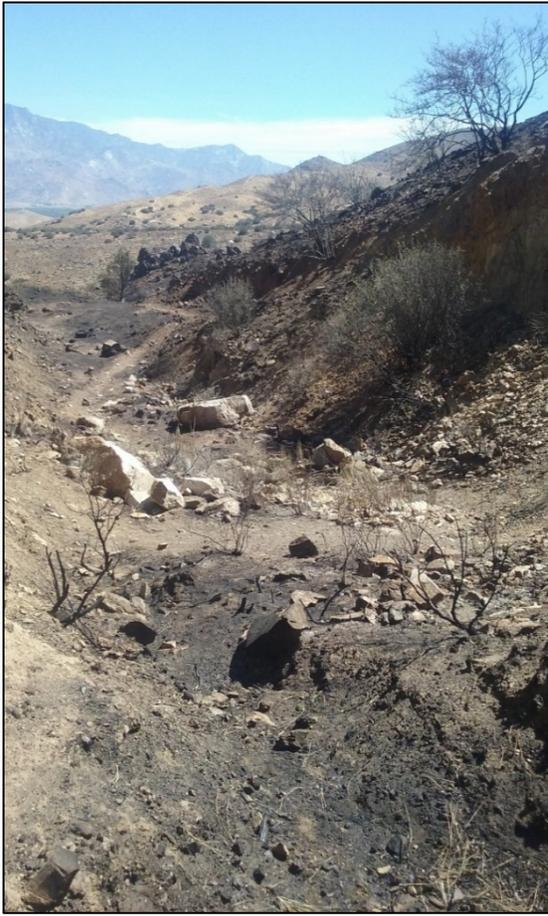
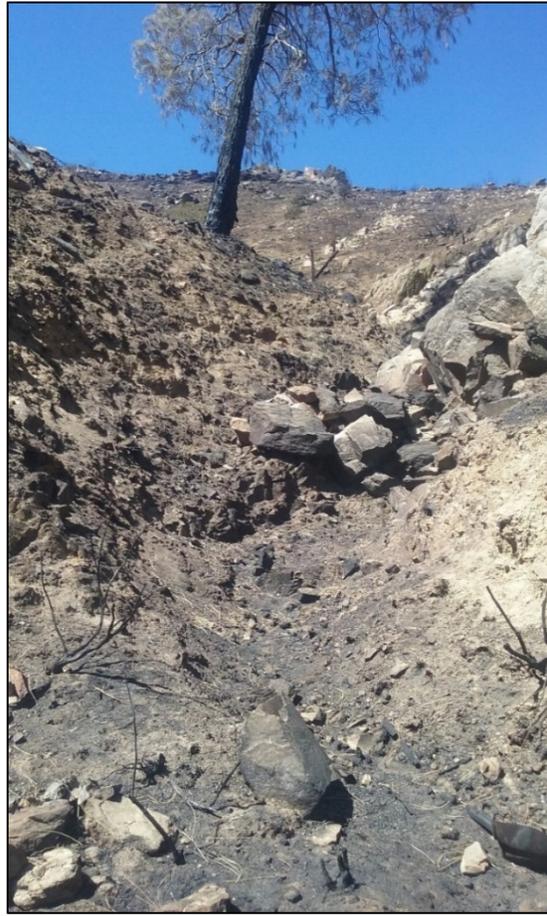
- Some sections of the trail with steeper, rocky side slopes may receive rock fall due to soil destabilization from lack of vegetation and increased flow caused by the fire (Photo 6-7). Although, the slopes observed were not very steep and had a relatively small amount of fire-affected contributing area. It is recommended that hazard warning signs be posted at trailheads and junctions.
- A fire-damaged grazing allotment fence was observed on the Forest/BLM boundary near the East endpoint, although has little effect on critical values associated with recreation at this location.

Photo 6 and 7: Long Canyon trail at risk from rock fall and wash out of tread at drainage crossing (L), although the slope is not very steep and there is a relatively small amount of contributing area burned by the fire (R).
