**Hazardous Materials Assessment**  
**Rim Fire Burned Area Emergency Response – Stanislaus National Forest**  
**September, 2013**

*By: Casey C. Shannon, Hydrologic Technician/Burned Area Emergency Specialist*  
*Inyo National Forest*

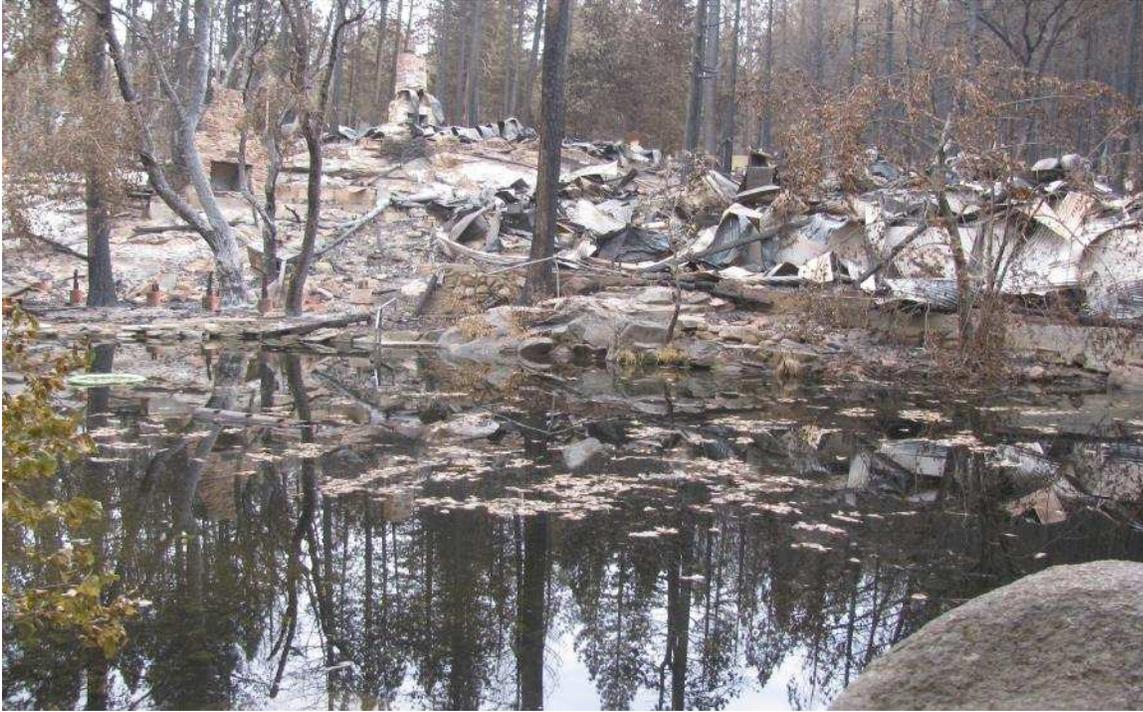
The camp is located near the South Fork Tuolumne River. All but a few outbuildings of the camp were burned by the fire. Copious amounts of burned residential refuse remains at the site over a 4-5 acre area. Residential structures consumed by wildfires may contain concentrated amounts of heavy metals, such as arsenic, barium, beryllium, copper, chromium, cadmium, lead and zinc (CIWMB, 2007). Most of the largest structures are located within 25 to 50 feet of the river, situated on steep slopes of bedrock. Burned refuse can easily transport into the river during a heavy storm event, impacting water quality and aquatic habitat. The slopes above the camp burned moderate to high severity and increased runoff into the camp is likely. The burned structures contained large amounts of furniture, appliances, hazardous materials and assorted mechanical equipment and tools. Some of the burned buildings contained large amounts of hazmat such as oils, chlorine, paints, sprays etc. and the ash residue is readily available for transport to the river. There is an imminent threat to water quality from the site to the river when a large storm occurs if containment or cleanup actions are not taken in the short term. It is recommended the Forest initiates full clean up and removal of solid and hazardous waste at this site with the responsible party (City of Berkeley) as soon as possible to reduce the potential for severe impacts to water quality when large storms occur the first few years after the fire.

**Photo 1:** Berkeley-Tuolumne Camp burned refuse by river. Imminent water quality impact threat.

At Berkeley-Tuolumne Camp, it is strongly recommended the Forest moves forward with complete site cleanup of hazmat and solid waste in a rapid fashion to reduce potential water quality impacts in the near term.

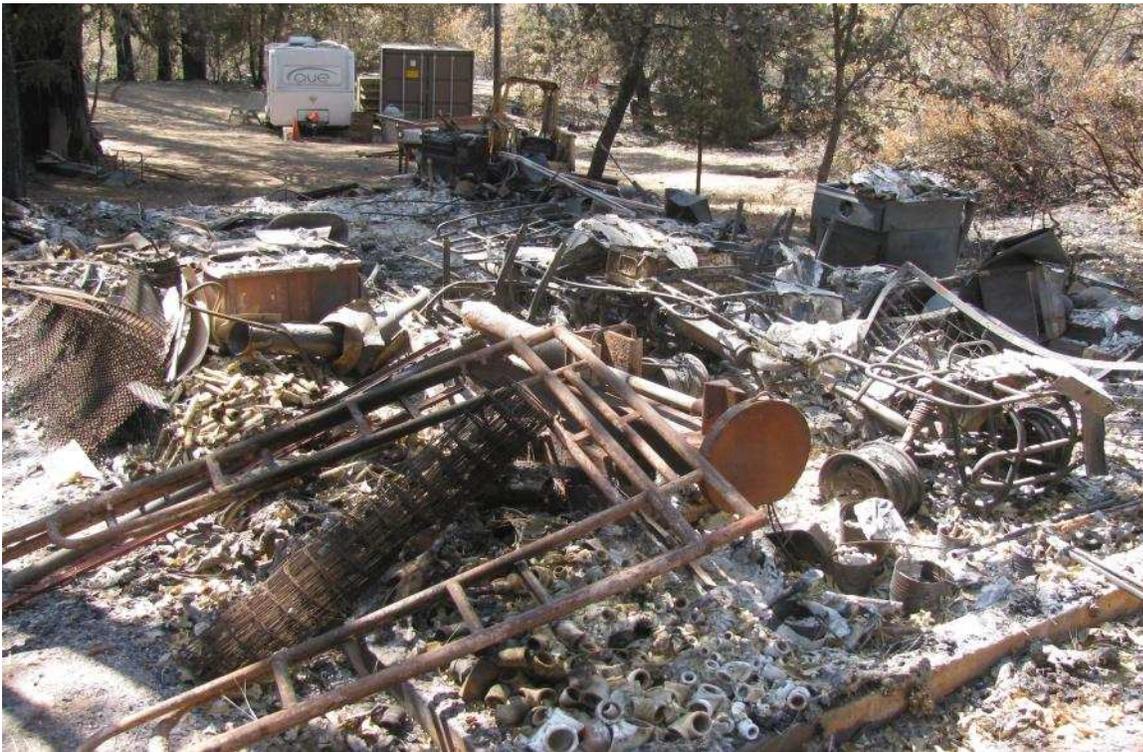
that has the potential to transport waste. A storage building was burned located close to the river that contained hazardous materials (paints, oils, solvents, etc.). A drainage swale adjacent to the building drains to the river that has the ability to transport hazardous waste to the river. A mobile home trailer burned in the same area as the storage shed. The burned refuse from the trailer is on slopes directly above the river and transport of waste to the river is likely. No other concerns with this site.

**Photo 2:** San Jose Camp burned storage shed with hazmat, install silt fencing at base to contain refuse.

There is a potential for burned materials transport to river 100 yards below.

Treatment Description: Install silt fencing around downslope perimeter of burned structure refuse until cleanup and disposal action can be conducted at identified sites (See Table 1, item 1). Monitoring and maintenance of fencing should be conducted after large storm events and corrective measures taken. Probability of treatment success: Likely. Treatment cost: \$20,000. Funding request has been approved previously.

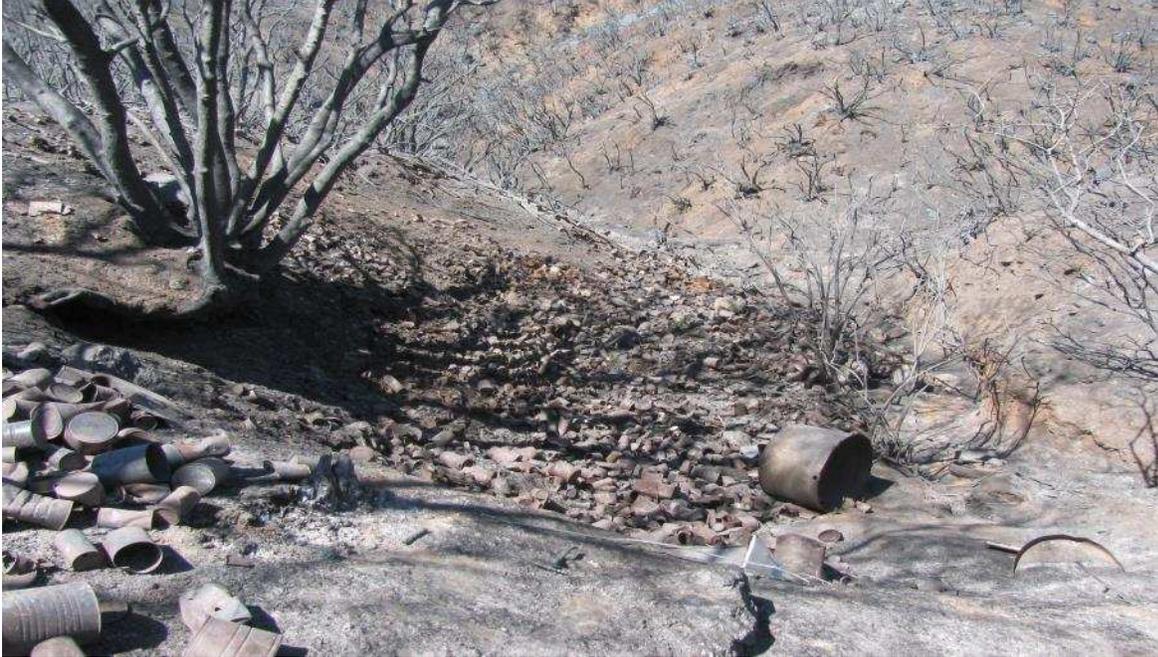
An ephemeral drainage to the Middle Fork Tuolumne River REDACTED and two abandoned automobiles located within and adjacent to the channel. The site is located within 300 yards of the river. Steep slopes upstream of the site burned moderately and will likely generate runoff that could cut into the dump site. The deposit is located on an outward bend of the stream. A threat of contaminants (possibly metals) from the deposit rinsed by high runoff from the dump site to the river is likely and water quality could be impacted. Heritage values of the site could also be impacted if the deposit is eroded. The automobiles may still have hazmat present and if so a minor amount, they should be removed from the stream channel and properly disposed.

Hazardous materials are likely to transport off site downstream into the Middle Fork Tuolumne River in the event of increased runoff from burned slopes upstream erodes into the dump deposits. Water quality impacts to the river are likely.

**Photo 3:** Dump site near REDACTED area with threat of hazmat release from increased flows caused by the fire during a large storm event. Hazmat could transport downstream to Middle Fork Tuolumne River. Rock Rip wall along channel edge will deflect flows away from dump materials.

Treatment Description: Install geotextile filter cloth underlayment over dump deposits along stream channel and apply class 3 rock rip rap deflector wall over cloth. Wall to be built will be approximately 2-3 feet tall by 30 feet in length. No soil disturbance to cultural deposit shall occur. Cloth and rock to be placed on deposits without soil/dump deposits movement. It is recommended an experienced watershed specialist provide design instruction during implementation and a trails specialist experienced with rock wall construction. Probability of success: Likely. Treatment cost:
