# Waldo Canyon Fire

Pike & San Isabel National Forests,  
Cimarron & Comanche National Grasslands

Burned Area Emergency Response

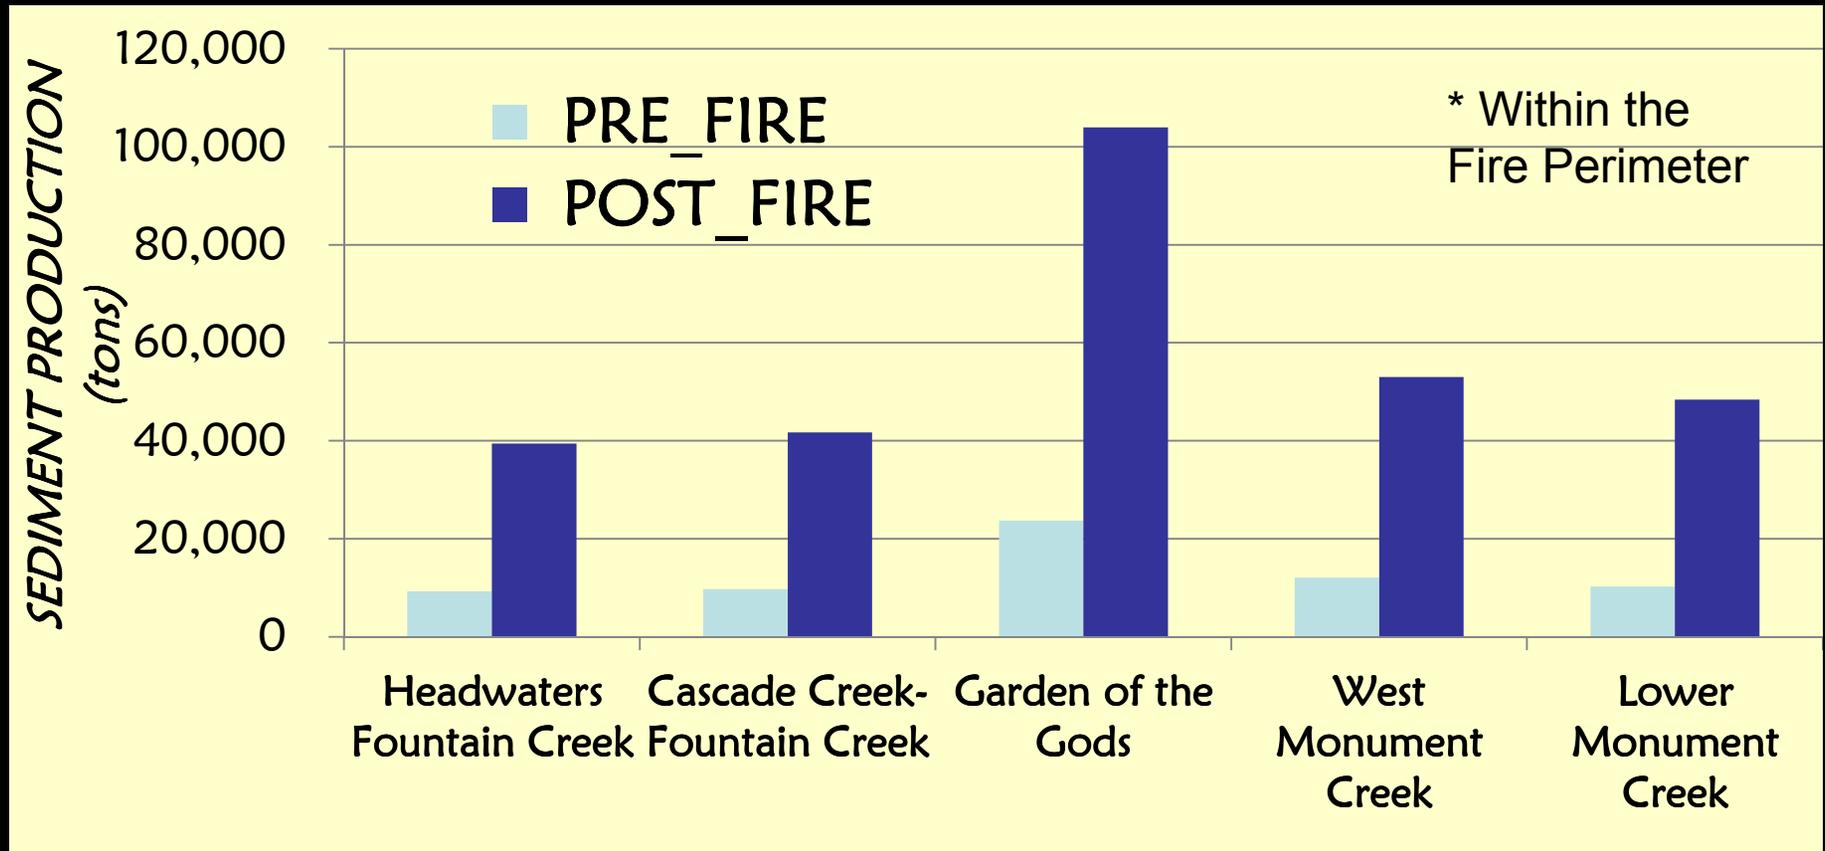
Big Picture: Erosion Potential modeled with WEPP-ERMiT  
(10 year event)

**Fire Effect: + 326-374% or > 4-fold  
increase in sediment**

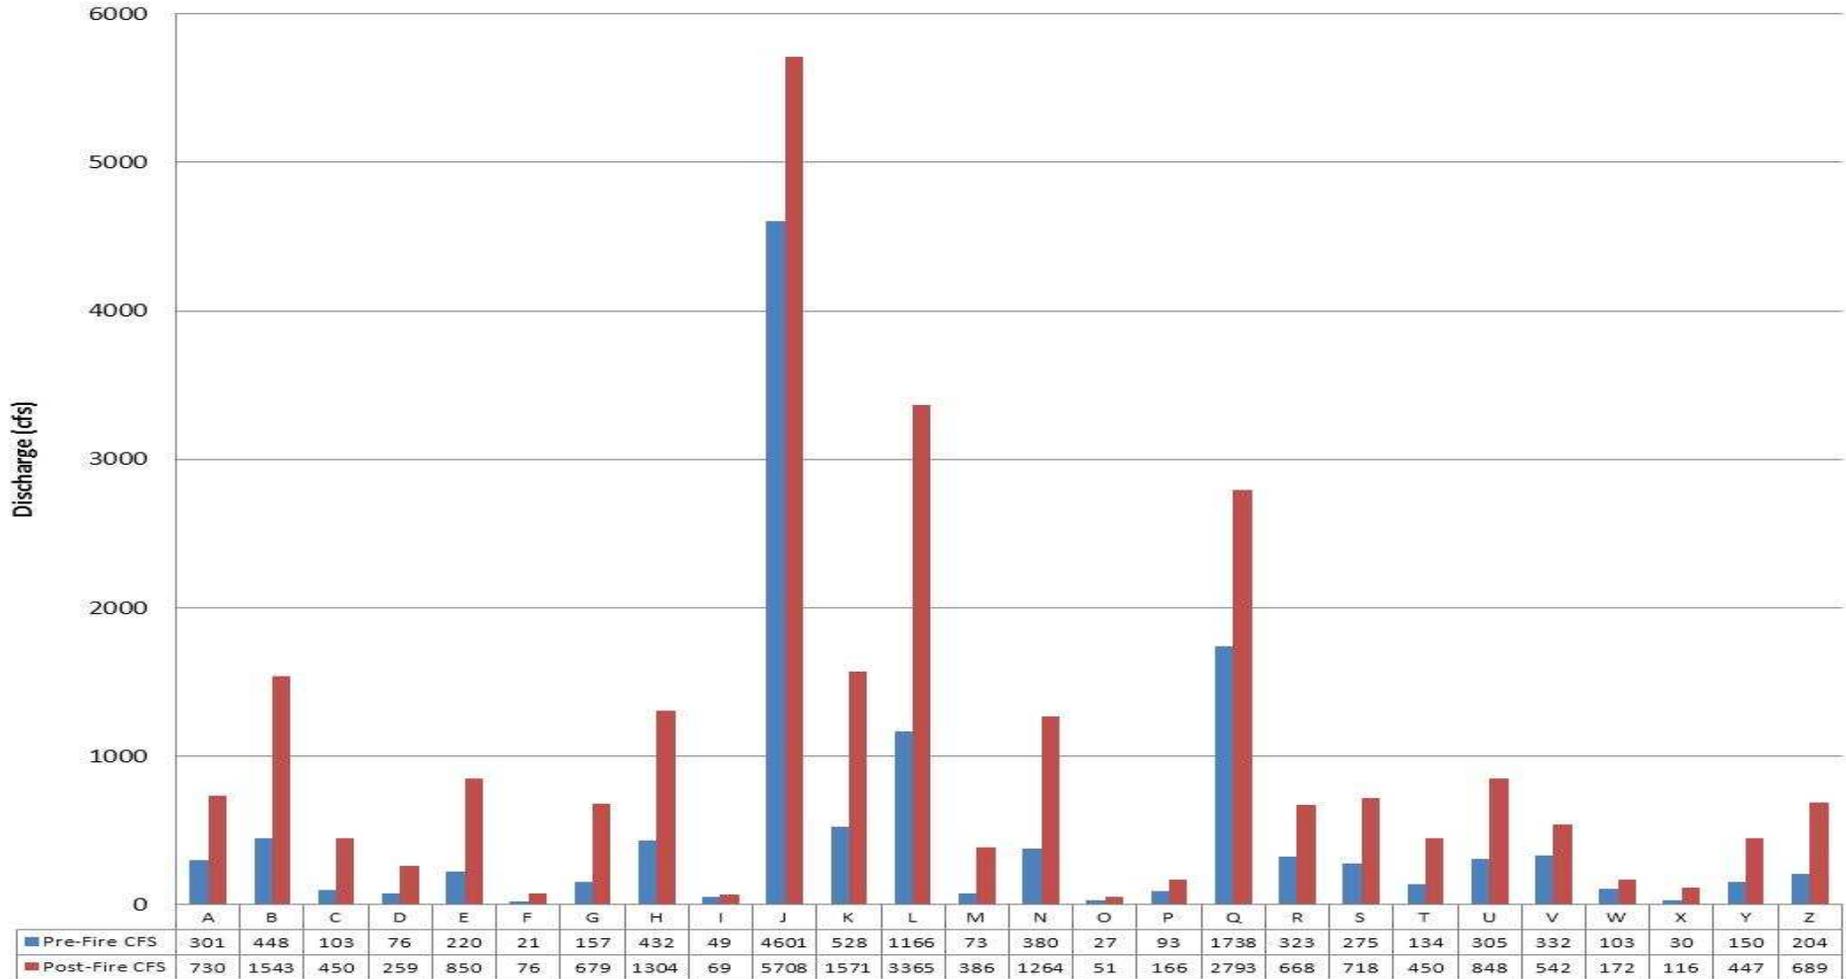
Pre and Post Fire Discharges for Pour Points and Sub-basins  
(10 yr 1hr Storm)

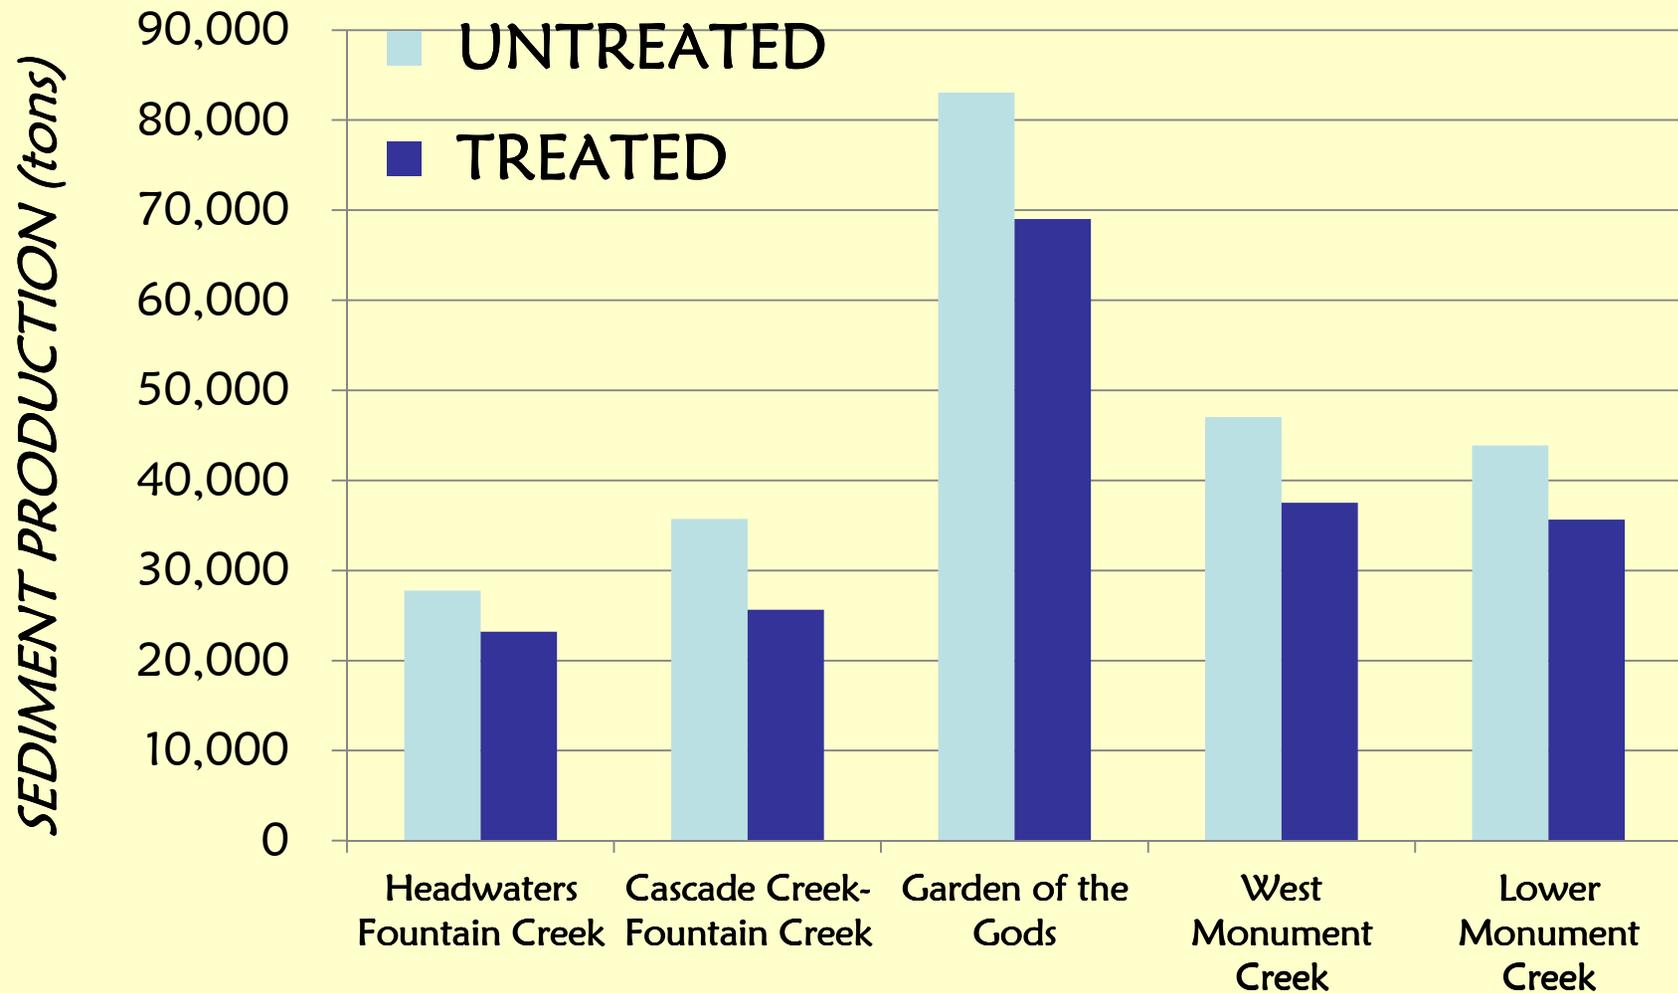
Within the  
Fire Perimeter

- Erosion Potential – Treatment Effect modeled with WEPP-ERMiT (10 year event)
- Treatment Effect: 16-28% reduction in sediment production

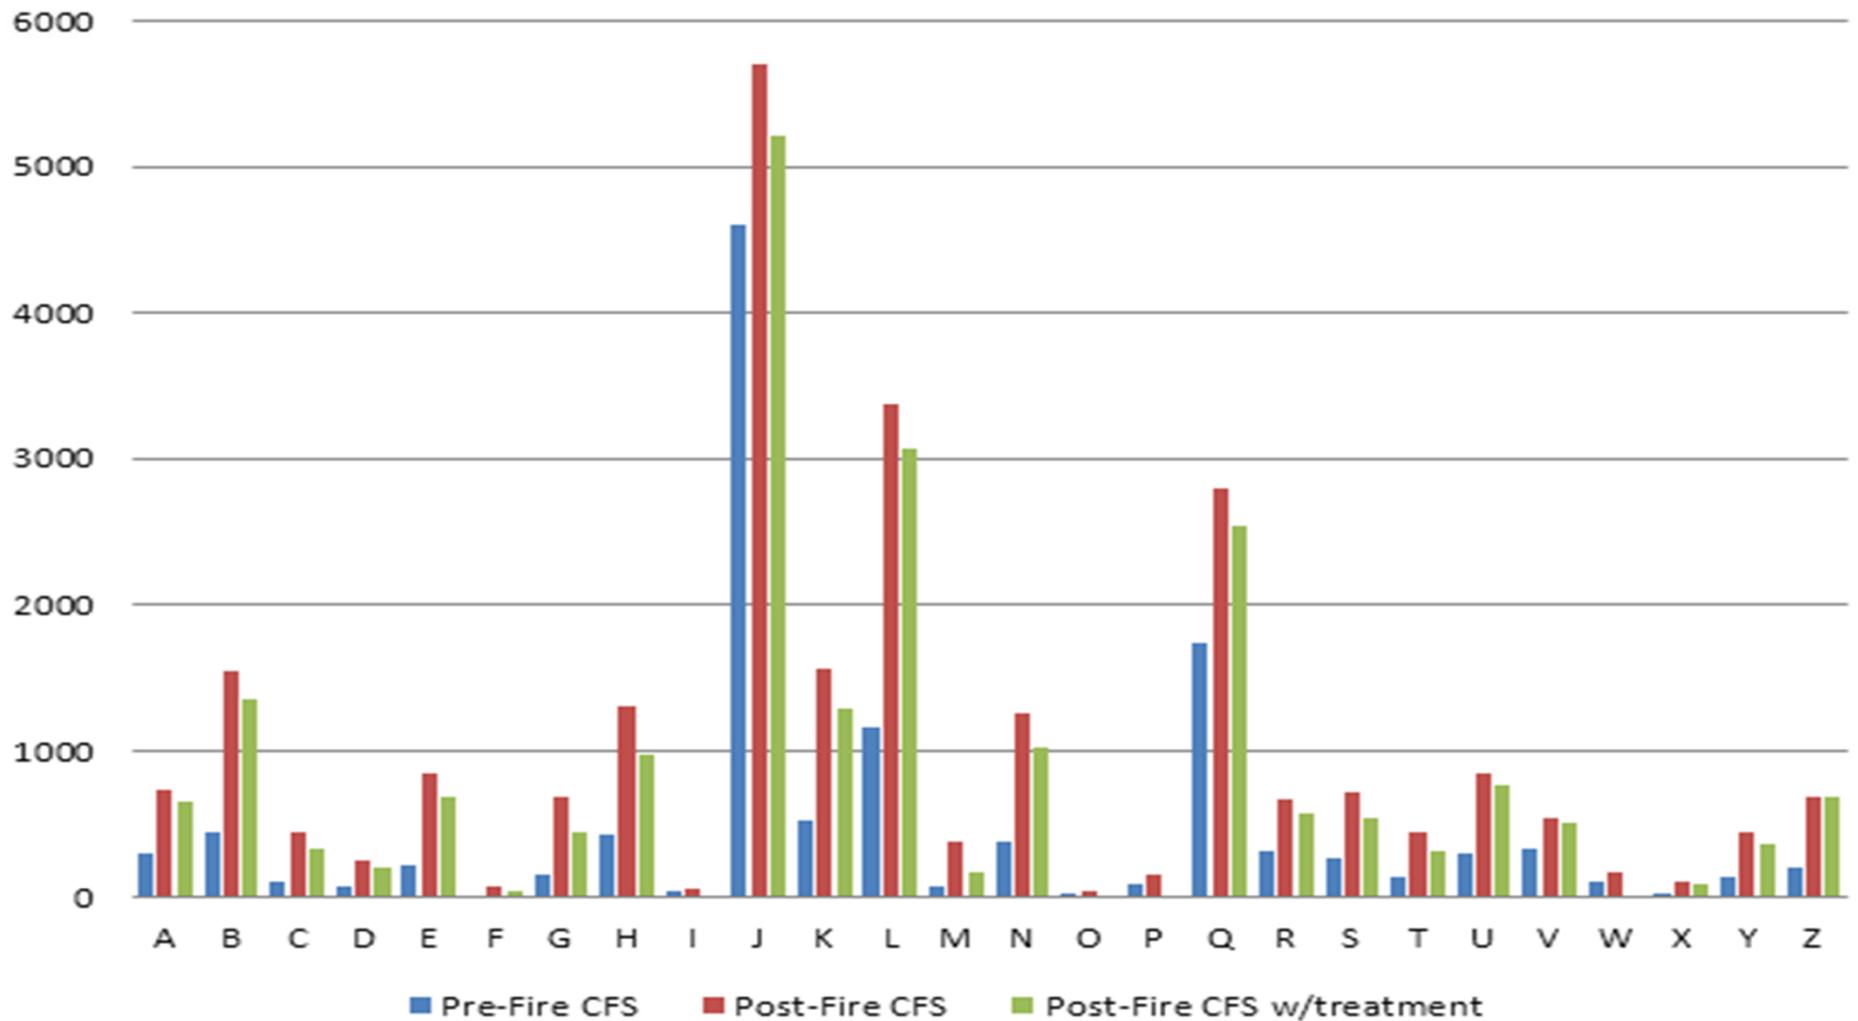
# Pre-, Post, and Post with Treatment Discharges for Pour Points and Sub-basins (10 yr 1hr Storm)
