# TECHNICAL SPECIALIST'S REPORT – BURNED AREA EMERGENCY RESPONSE

**Resource:** Roads

**Fire Name:** Waldo Canyon **Month/Year:** 7/2012

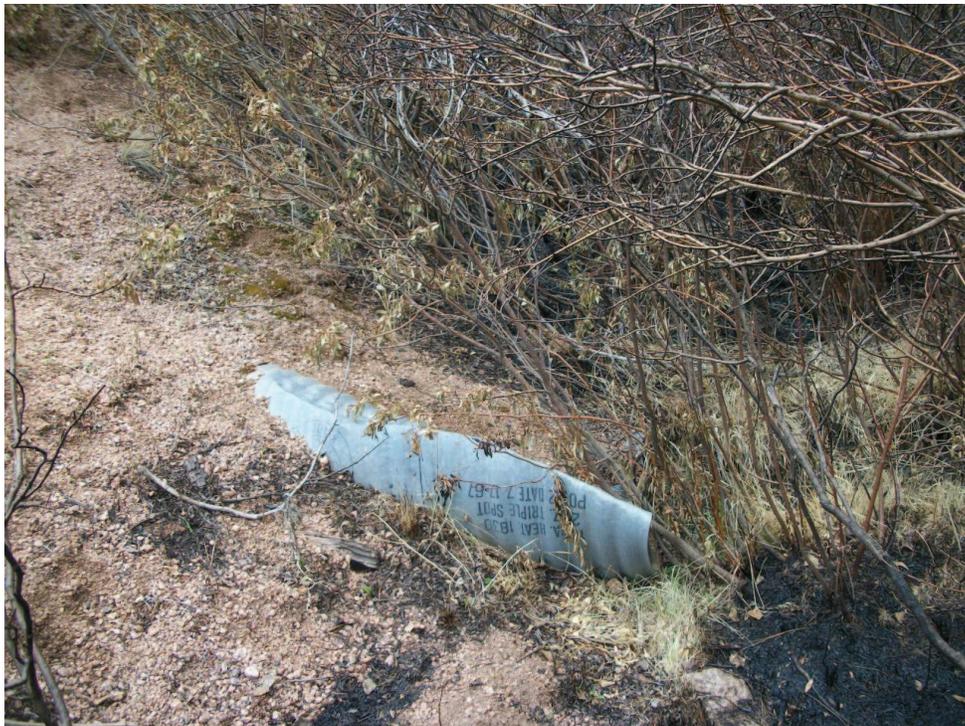
- g. FSR 306 and 306.A, 306.B, 306.C: These are paved roads providing access to developed recreational sites and to the dam at Rampart Reservoir. The areas immediately adjacent to the roads do not have significant burned area; however the drainages up-gradient from the roads have significant burned area and there is a potential to impact drainage crossings at the roads. There are 4 miles of ML 5 roadway which have been impacted by burned area.

**FSR 306 – Improve existing 48" CMP (Profile View)**

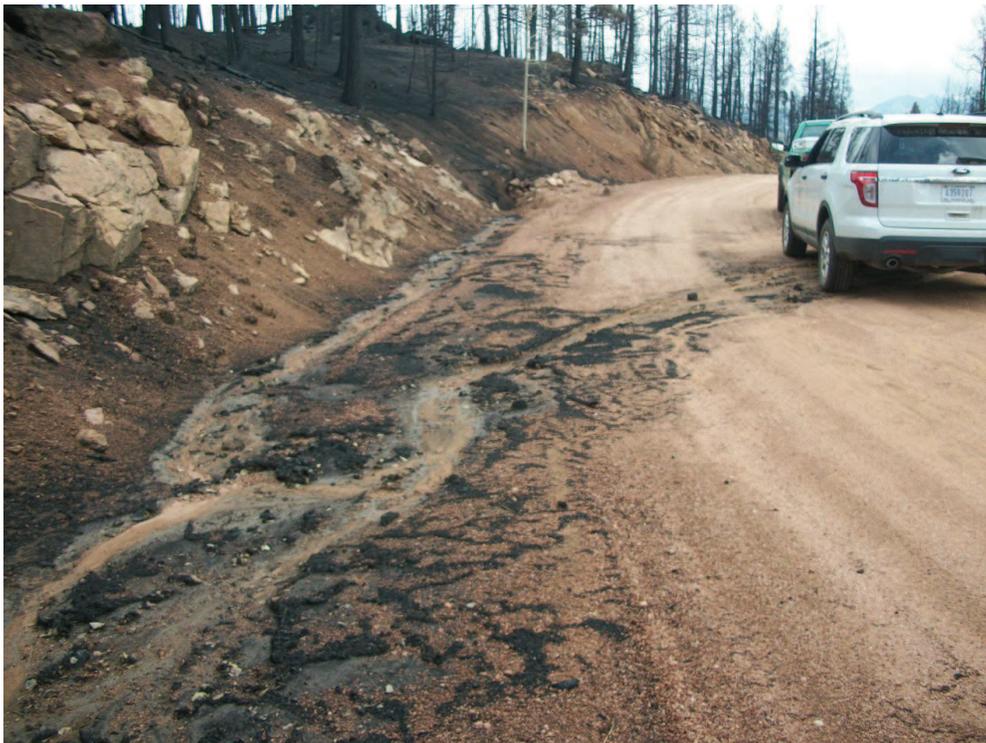
- d. FSR 302: This road provides recreational access from FSR 303. There are 2.5 miles of ML 2 roadway which have been impacted by burned area.
- e. FSR 303: This road provides recreational access from FSR 300 and also utility access to Northfield Reservoir. Approximately the upper 2.6 miles is open to public access, the lower road is gated and access is limited to Colorado Springs Utility. There are 2.5 miles of ML 3 roadway which have been impacted by burned area, ending just above the gate closure.

FSR 303 – Recondition Road
