TECHNICAL SPECIALIST'S REPORT – BURNED AREA EMERGENCY RESPONSE

Resource: Trails and Recreation Facilities
Fire Name: Waldo Canyon **Month/Year:** 7/2012
Authors Names: Judith Kittson: Civil Engineer ARP
Frank Landis: Recreation Specialist PSICC

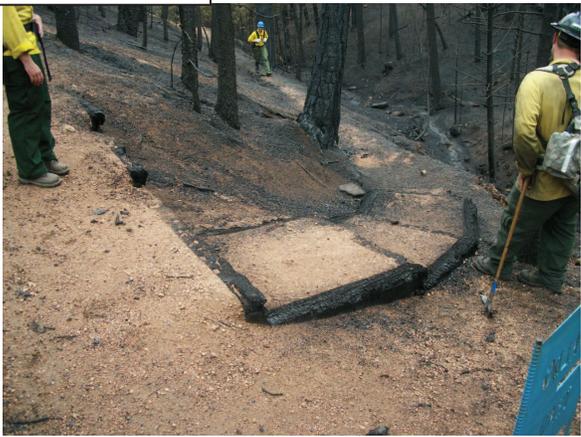
WALDO CANYON TRAIL- ACROSS BURNED SLOPES

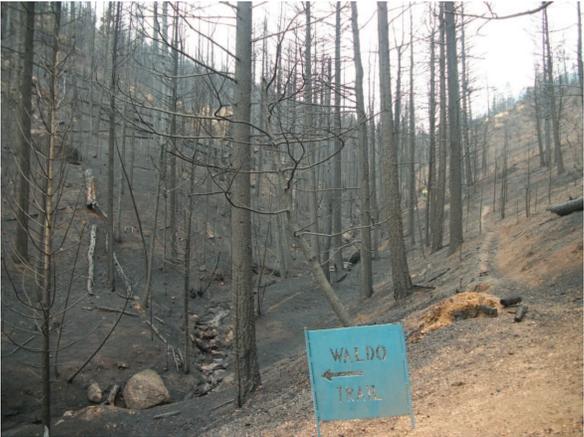
DAMAGED INFRASTRUCTURE REPLACE TO PROTECT TRAIL

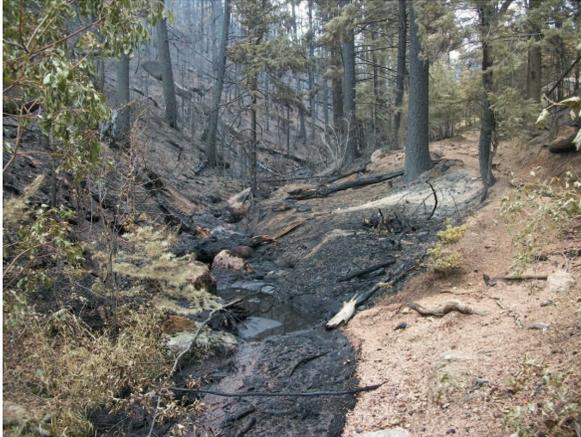
IMPACTED DRAINAGE WHICH CROSSES WALDOTRAIL

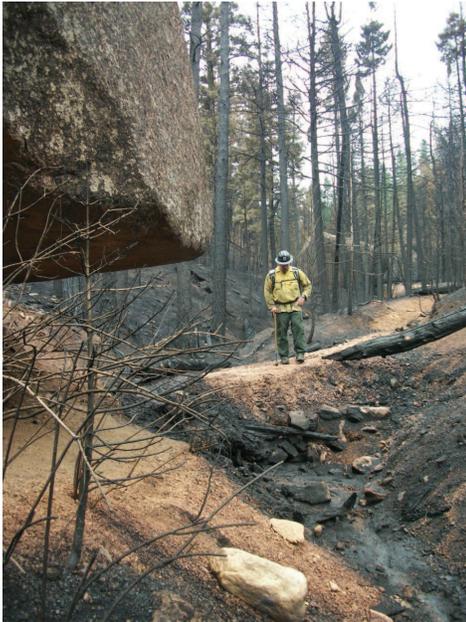
RECENT SEDIMENT FLOW ACROSS TRAIL

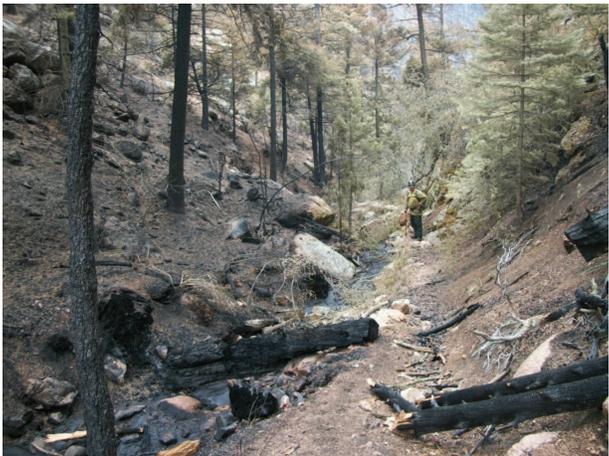
RECENT SEDIMENT FLOW ACROSS TRAIL

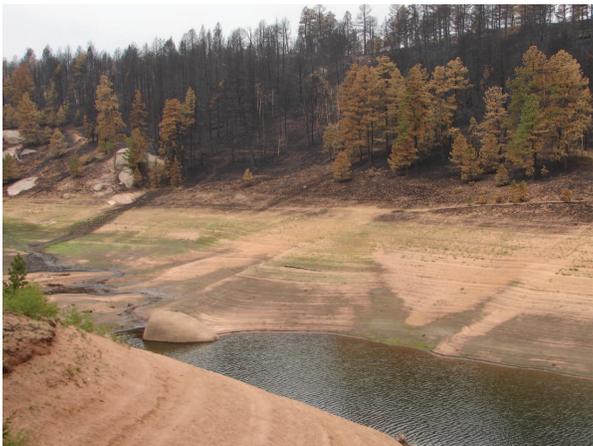
SEDIMENT FLOWS ACROSS TRAIL

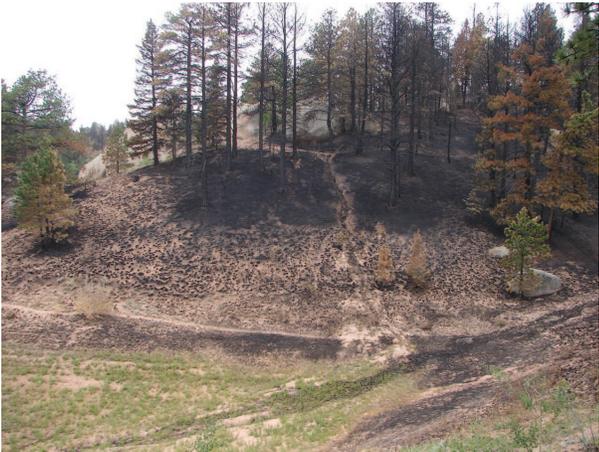
BURNED AREA IMPACT TO TRAIL

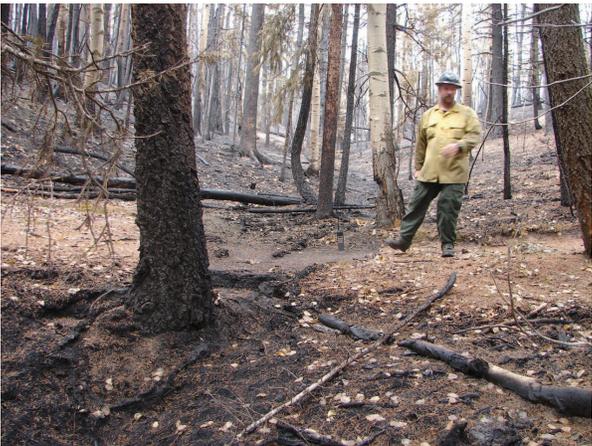
SEDIMENT FLOW ACROSS TRAIL

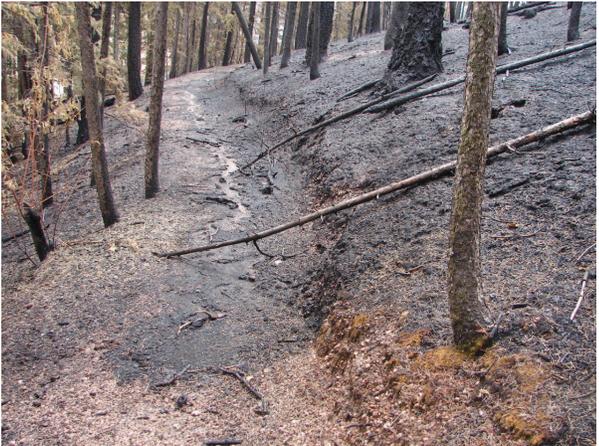
SEDIMENT FLOW DOWN TRAIL

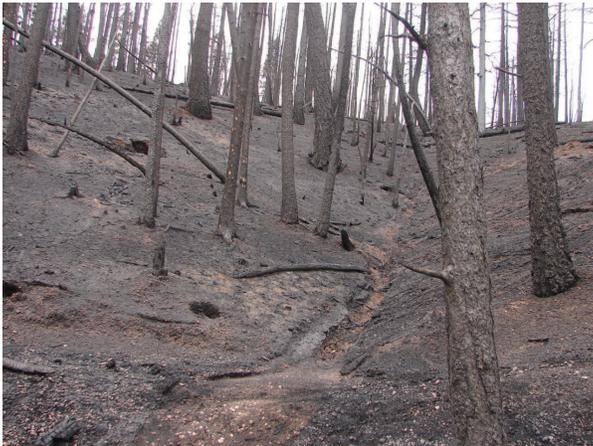
BURNED AREA IMPACT TO TRAIL

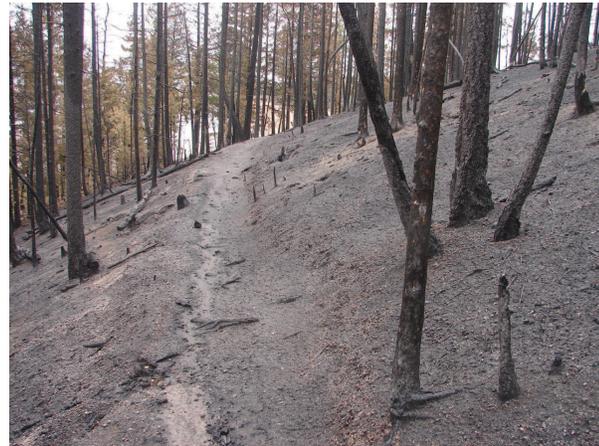
BURNED SLOPES ABOVE TRAIL
