Hayden Pass Fire July 2016

Date of Report: August 1, 2016

BURNED-AREA REPORT
(Reference FSH 2509.13)

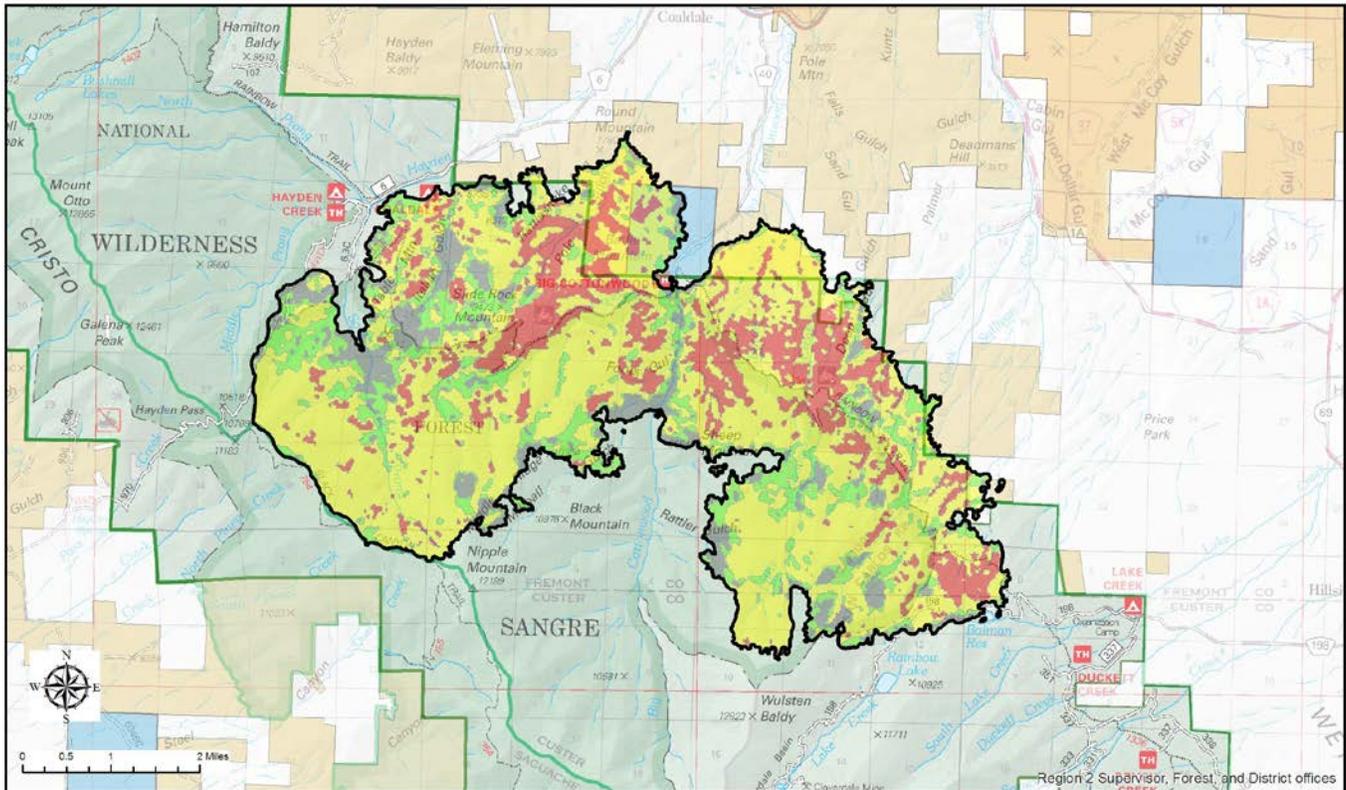
Figure 1: Soil Burn Severity Map.

2016 HAYDEN PASS FIRE
 SOIL BURN SEVERITY
 BURNED AREA EMERGENCY RESPONSE (BAER)

Acres vs Soil Burn Severity				
SOIL BURN SEVERITY				
BURNED EMERGENCY RESPONSE (BAER)				
High	Moderate	Low	Unburned	Grand Total
2,974	9,240	2,613	1,693	16,520

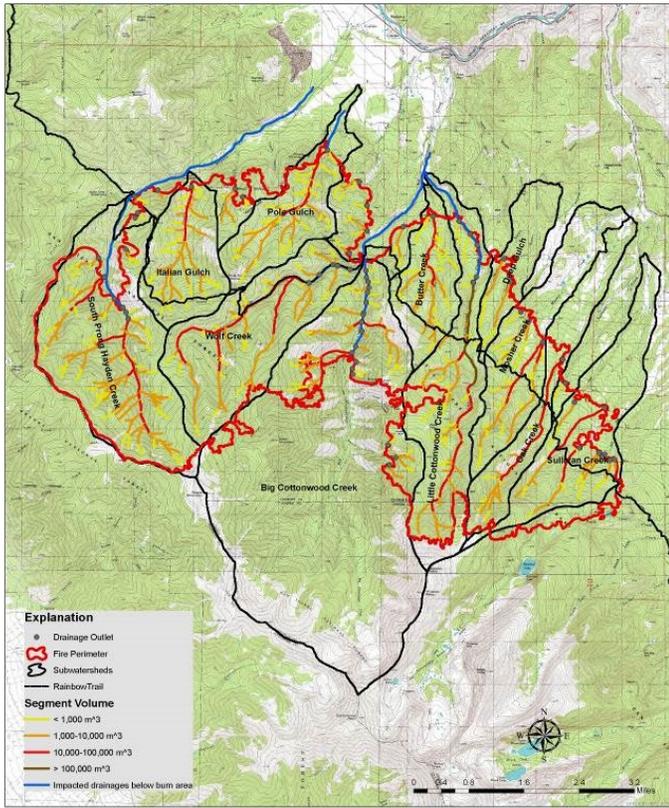
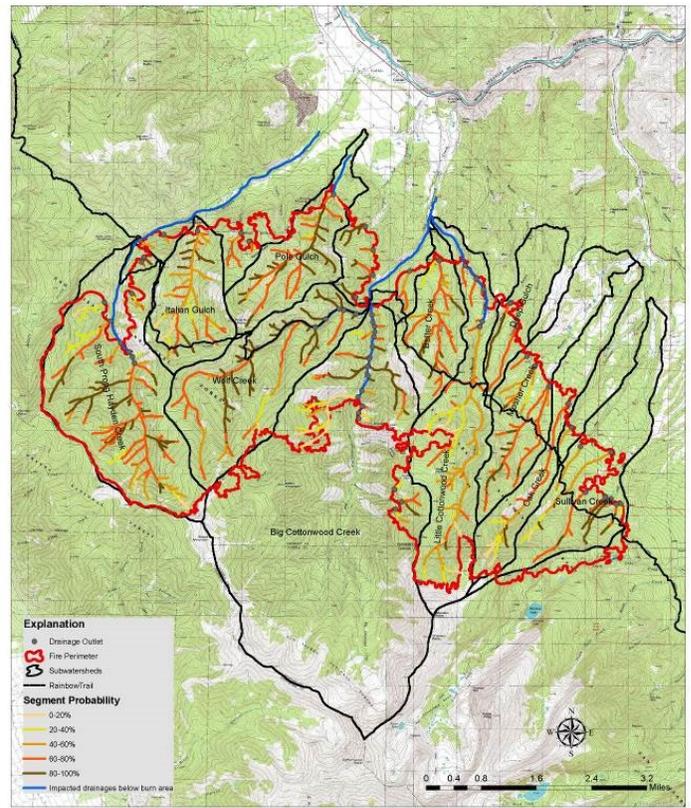
**Preliminary Hazard Assessment (USGS)
BURNED AREA EMERGENCY RESPONSE (BAER)
San Isabel National Forest**
Volume of debris flow by stream channel (m^3), Likelihood of debris flow by stream channel (%). Preliminary debris flow hazard for a design storm with a 15 minute rainfall intensity of 24 millimeters per hour (mm/h).
