# Hayden Pass Fire July 2016

**BURNED-AREA REPORT**  
(Reference FSH 2509.13)

**A. Fire Name:** Hayden Pass

**B. Fire Number:** CO-PSF-001022

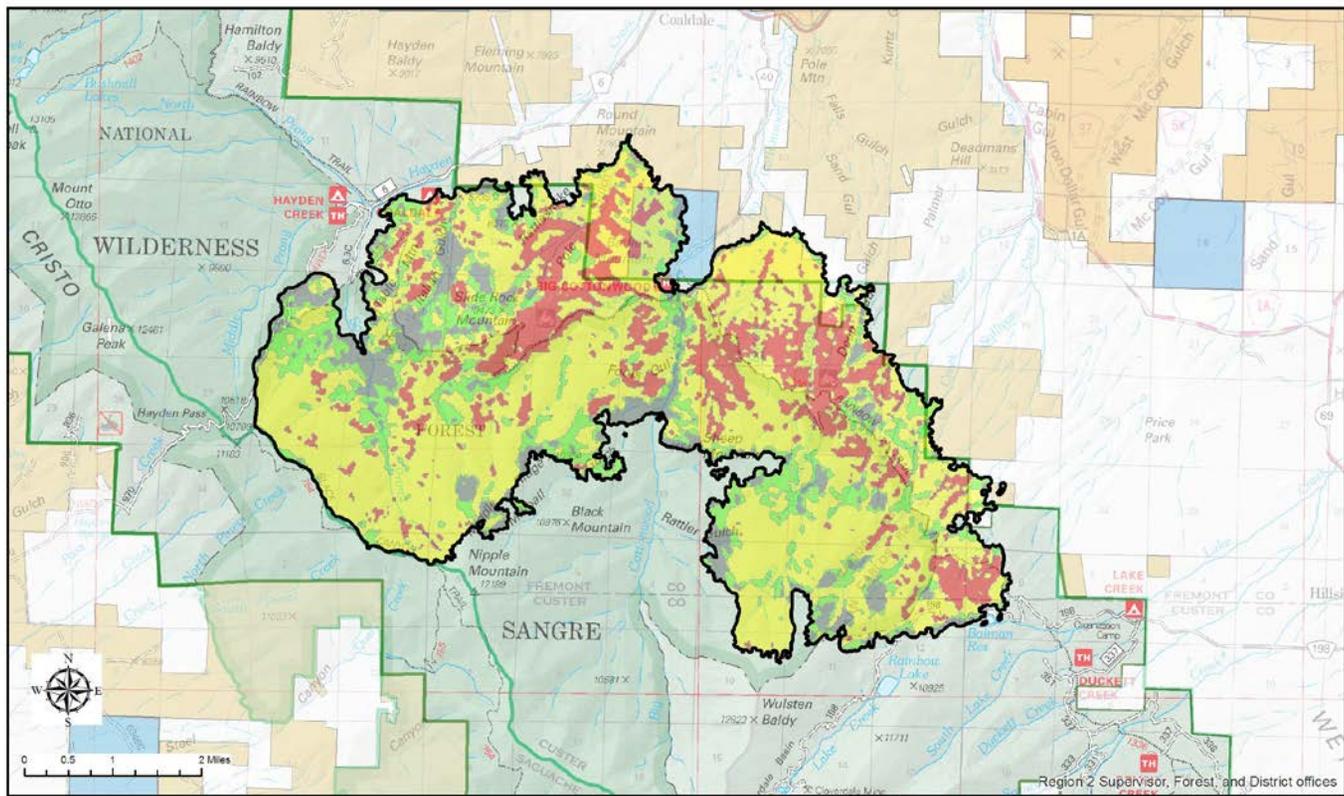
Figure 1: Soil Burn Severity Map.

2016 HAYDEN PASS FIRE  
 SOIL BURN SEVERITY  
 BURNED AREA EMERGENCY RESPONSE (BAER)

Acres vs Soil Burn Severity				
SOIL BURN SEVERITY				
BURNED EMERGENCY RESPONSE (BAER)				
High	Moderate	Low	Unburned	Grand Total
2,974	9,240	2,613	1,693	16,520

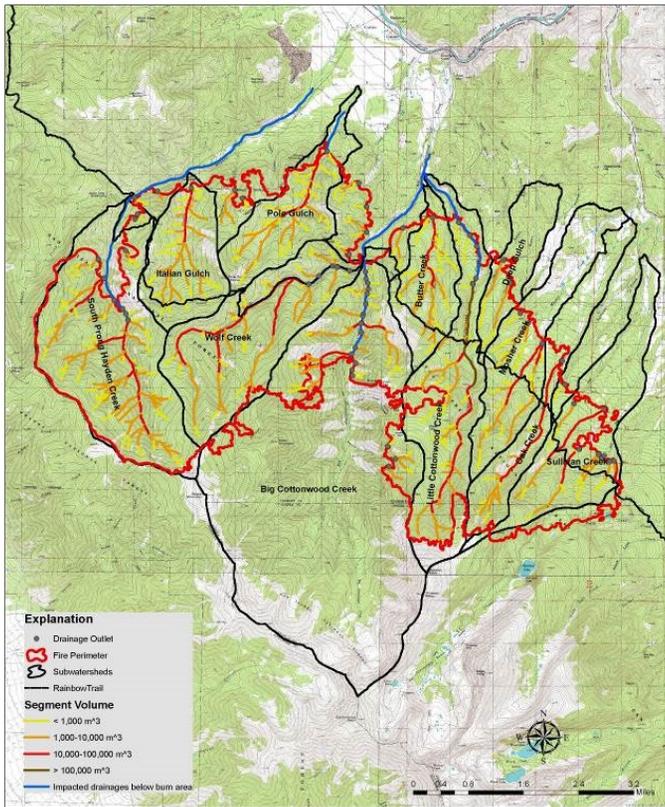
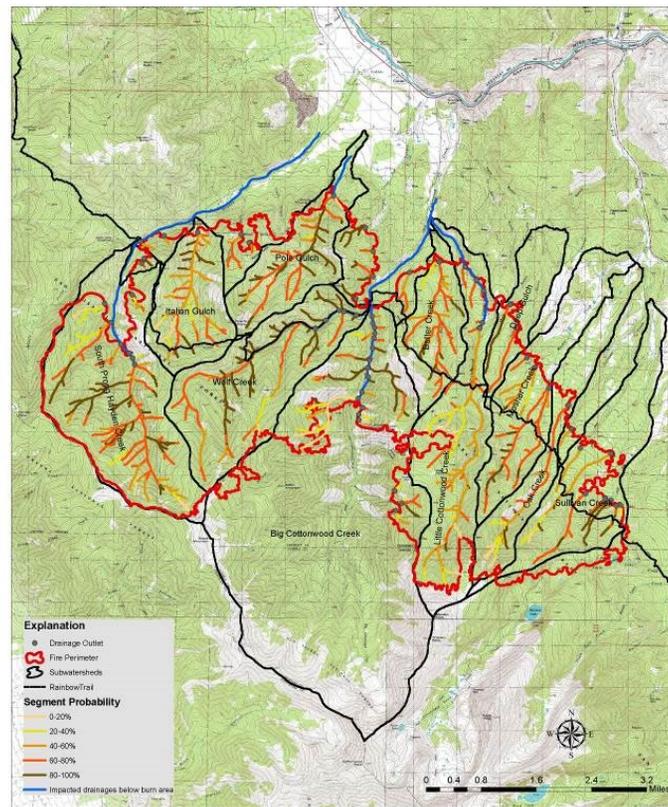
**Preliminary Hazard Assessment (USGS)  
BURNED AREA EMERGENCY RESPONSE (BAER)**

Throughout the burned area, the combined hazard ratings for debris-flow in first order tributaries to the main stem stream channels are moderate to high. At the fire perimeter exiting the burned area, the hazard ratings are high for all main stem channels, except the Italian Gulch and Deep Gulch channels which have moderate hazard ratings. At the burned area perimeter, volumes are predicted to be >100,000m<sup>3</sup> for Little Cottonwood Creek. Volumes in the range of 10,000 to 100,000m<sup>3</sup> are predicted for Oak Creek, Mosher Creek, Sullivan Creek, Butter Creek, Big Cottonwood Creek, Wolf Creek, Pole Gulch, Italian Gulch and South Prong Hayden Creek.

Volume of debris flow by stream channel (m<sup>3</sup>), Likelihood of debris flow by stream channel (%). Preliminary debris flow hazard for a design storm with a 15 minute rainfall intensity of 24 millimeters per hour (mm/h).
