Little Bear Fire

**Burned Area Emergency Response (BAER) Team
White Paper**

**Smokey Bear Ranger District
Lincoln National Forest
Ruidoso, New Mexico
July 3, 2012**

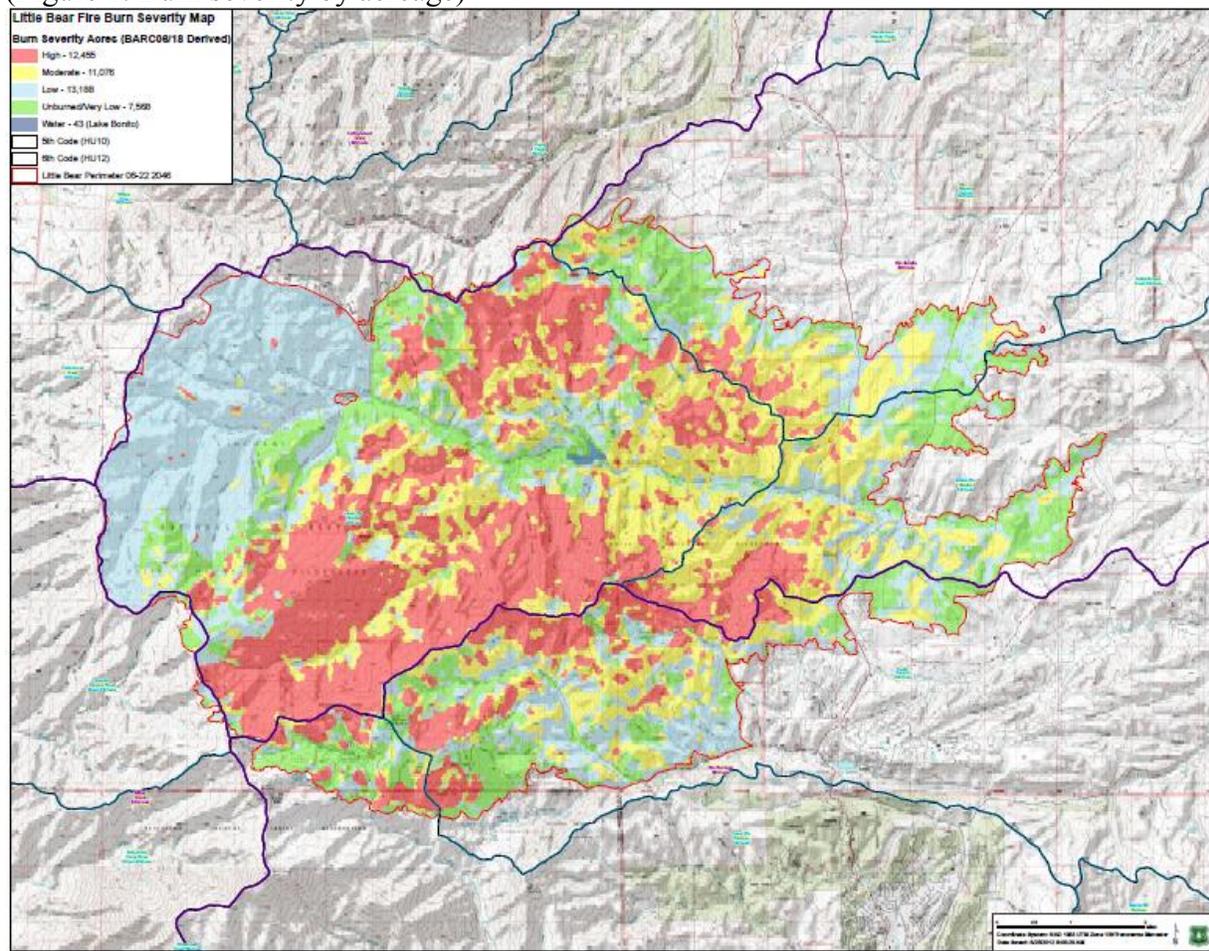
(Figure 1. Burn severity by acreage)

<u>Burn severity class</u>	<u>Acres burned in each class</u>	<u>Percentage of NFS area</u>
High	12,069 acres	34
Moderate	8,687 acres	25
Low	9,976 acres	28
Unburned	4,559 acres	13
<u>Total Acres</u>	<u>35,291 acres</u>

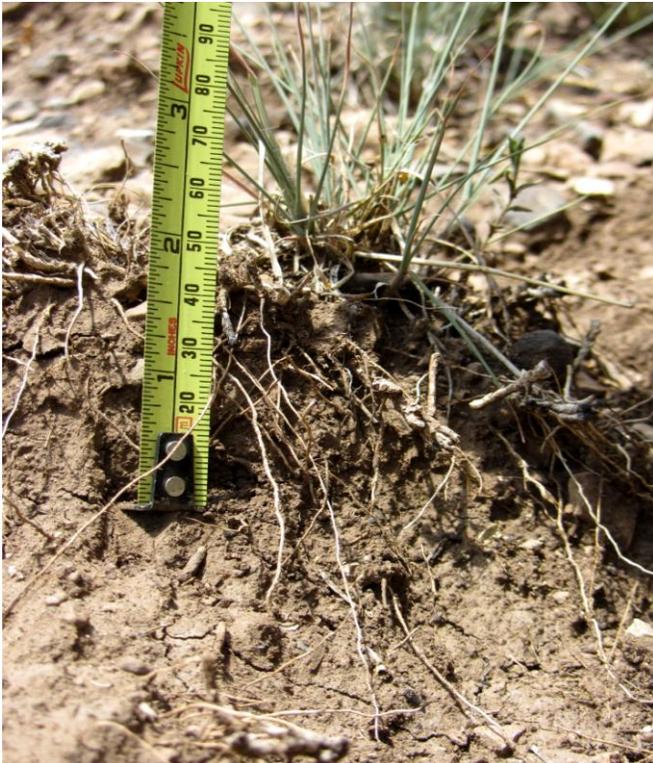
In order to validate the loss of soil erosion, the soil team returned to the White Fire that burned in April 2011. Sites of treated and untreated areas were assessed. Field information revealed that pinyon-juniper treated sites showed an average soil loss of 30 tons/acre and untreated sites showed a range of 60 to 80 tons/acre. In addition, the soil team also field verified soil loss on the Little Bear fire after the 1st rain event, which occurred on June 22, 2012. Soil loss in mixed conifer was estimated at 30 tons/acre.

Photo 1 displays pedestalling which equates to soil loss, from an untreated site on the White Fire, 2011

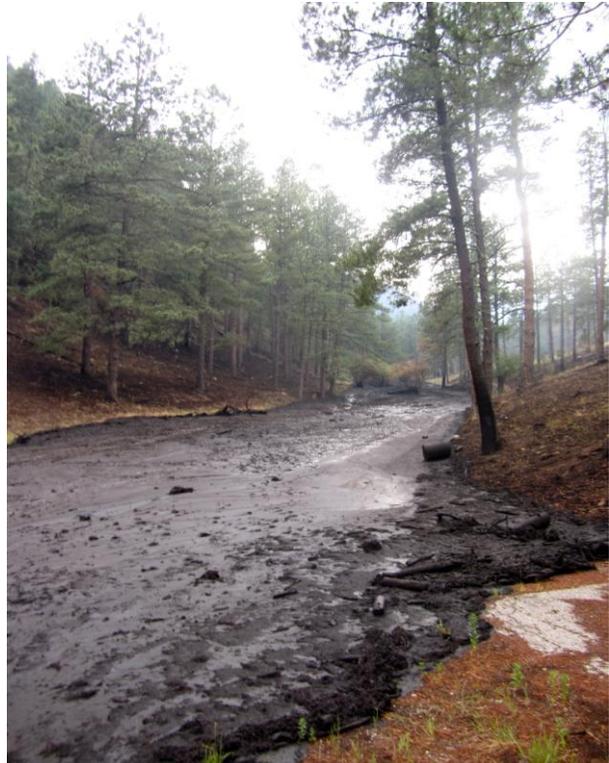
Photo 2 displays sediment movement that occurred from the 1st rain event on June 22, 2012
