**COLVILLE AND OKANOGAN-WENATCHEE NATIONAL FORESTS
BURNED AREA EMERGENCY STABILIZATION PLAN**

NORTH STAR FIRE

ENGINEERING RESOURCE ASSESSMENT – ROADS

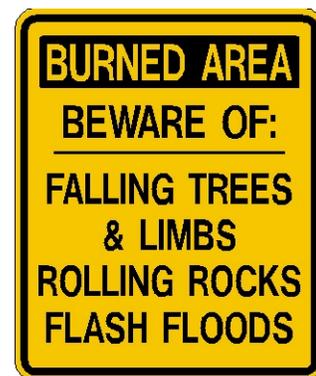
30"X36"

Situation: The severity of burn in some watersheds, combined with road location, high possibility of flash flooding and debris flows has increased the risk to road users.

Recommendation: Install warning signs for flash flooding and potential debris flows. Install “Burn Area Warning” (see example to the right) signs where necessary to properly alert the travelers of the dangers ahead. Install “Road Closed” signs where necessary to temporarily close roads that have received extensive damage. “Road Closed” signs should also be used in conjunction with gated closures.
