# Kaniksu Fire Recreation BAER Report

Resource Specialty: Recreation & Trails

Fire Name: Kaniksu Complex Fire

Month and Year: October, 2015

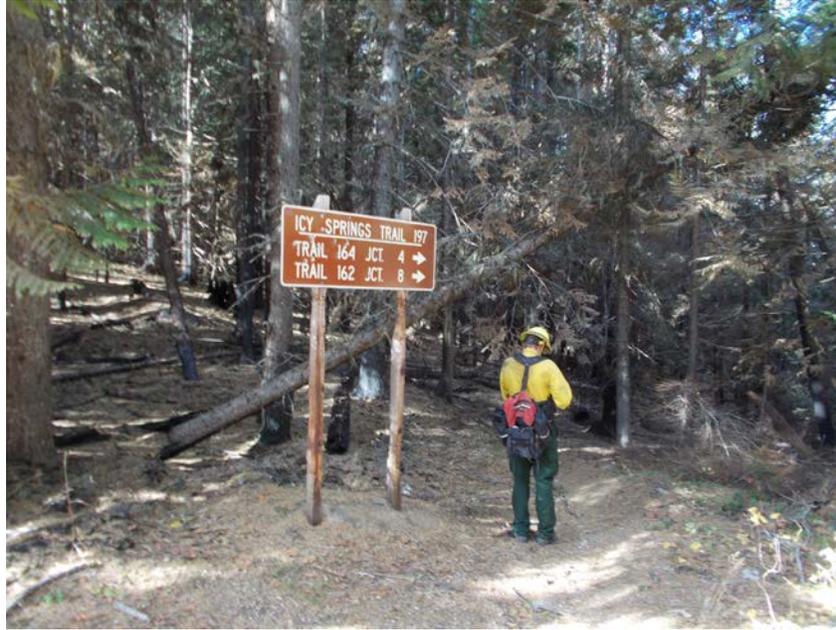
The existing trailheads contained very little infrastructure other than signage. That being said they are well used parking areas and often have vehicles staged at them for extended periods of time. Numerous hazard trees were observed at the trailheads located within burned areas. They would present a threat to life and property of both administrative and public visitors. The fire-weakened trees in the area will need to be reevaluated periodically and felled by qualified sawyers using regional guidelines for hazard tree classification.

**Figure 1 - >6" dbh tree failures at the Icy Springs Trailhead**

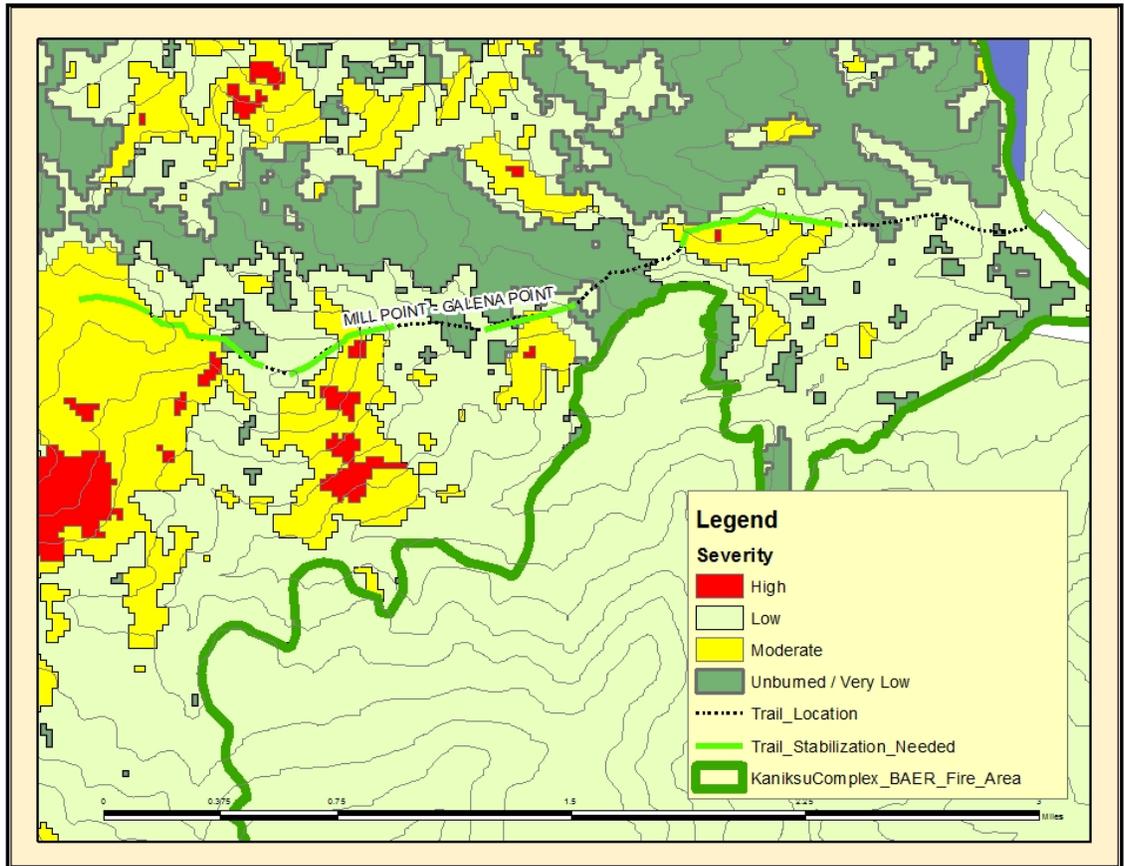
**Map 1 – Mill Point – Galena Trail (IPNF)**

**Mill Point – Galena Point Trail (#199)** – This trail is located on the IPNF. It is often faint and difficult to follow. High to moderate burn severity occurred on or above approximately 60% of the trail or around 2 miles. Given the low development level and lack of maintenance this trail should be considered low priority for stabilization efforts.

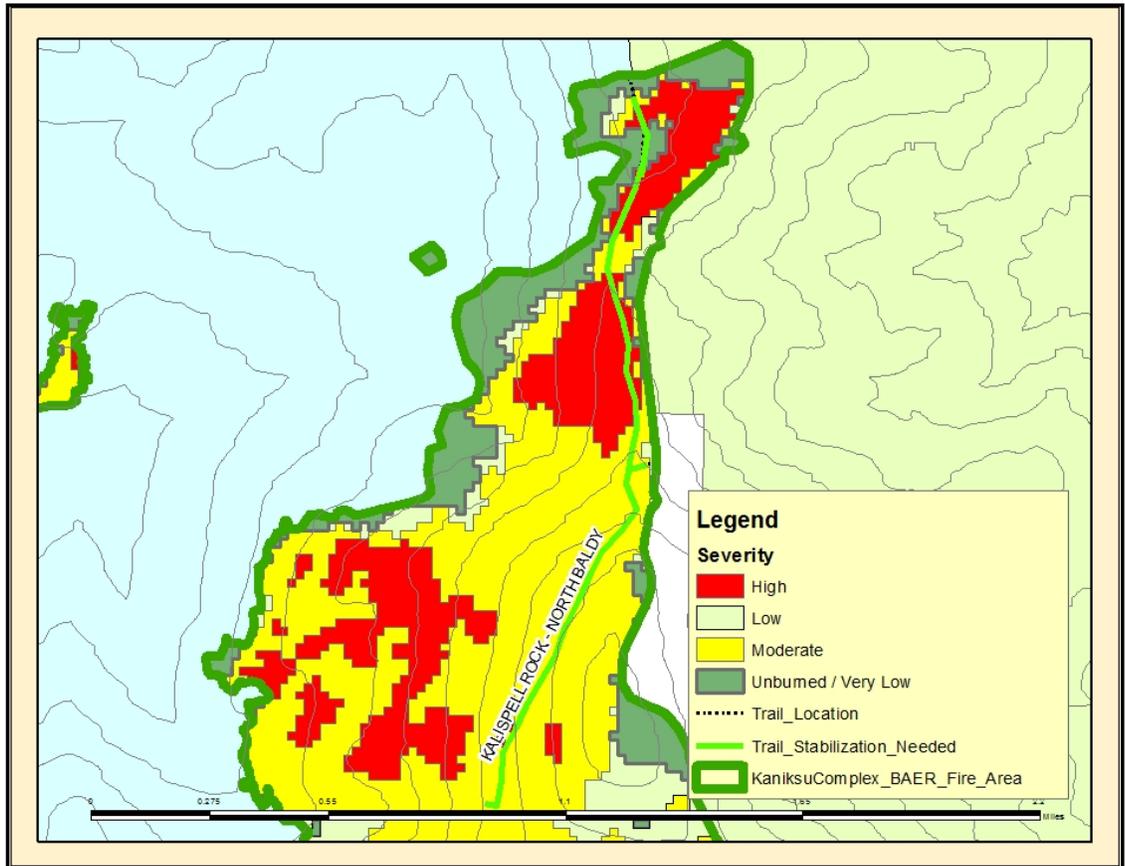
**Map 2 – Kalispell Rock – North Baldy Trail (IPNF)**

**Kalispell Rock North Baldy (#103)** – This route is partially a road bed that is easily followed. High to moderate burn severity is present on the entire length of this trail. Trail stabilization will be required for the entire length of this trail. Stabilization efforts will include rolling grade dips and earth bound water bars. Hazard trees will need to be mitigated within two tree lengths of feature requiring extended periods of time for the trail crew to complete.

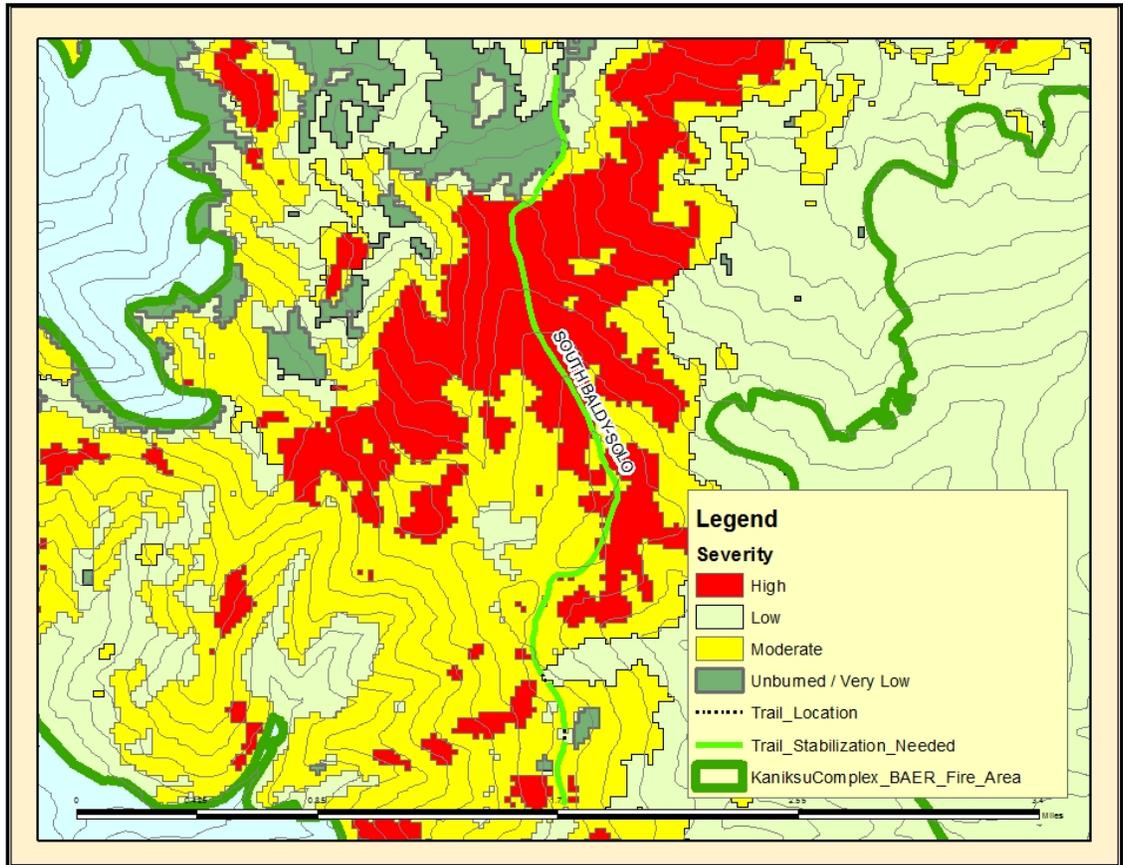
**Map 3 – South Baldy – Solo Trails (IPNF)**

**South Baldy – Solo Trail (#104)** – This trail receives moderate level of use. The tread is present and has received frequent levels of maintenance. That being said this trail is listed as a TC-1 trail class and should be managed for minimal development levels. Stabilization efforts are still recommended for a 90% of the length.

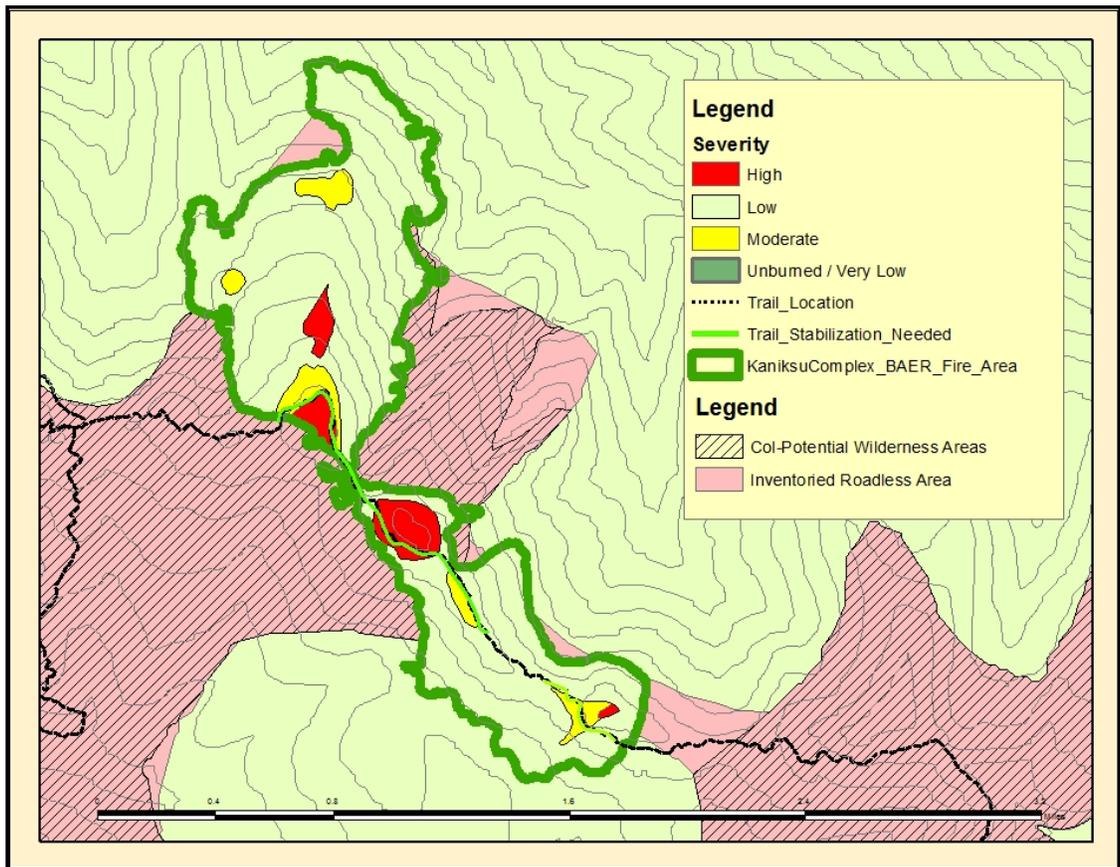
**Map 4 – Hall Mtn – Grassy Top Trail (CNF)**

**Hall Mtn – Grassy Top Trail** –This trail is on the CNF, it is feeder trail for the National Designated Pacific Northwest Trail (PNT). Approximately 75% of this trail goes through high to moderate burn severity. The recommendation for trail stabilization is constructing rolling grade dips and earthbound water bars to help with watershed and sedimentation. Hazard tree removal is necessary to mitigate risk for crews working on trail stabilization efforts. According the Washington Office BAER Guidance Paper for Roads and Trails (April,2013), “There may be rare situations where the trail is part of a nationally significant network (e.g. Pacific Forest Trail) where closures are outside of FS administrative control. In that case, BAER may be used for limited hazard tree felling for the purpose of risk reduction, not user convenience.”

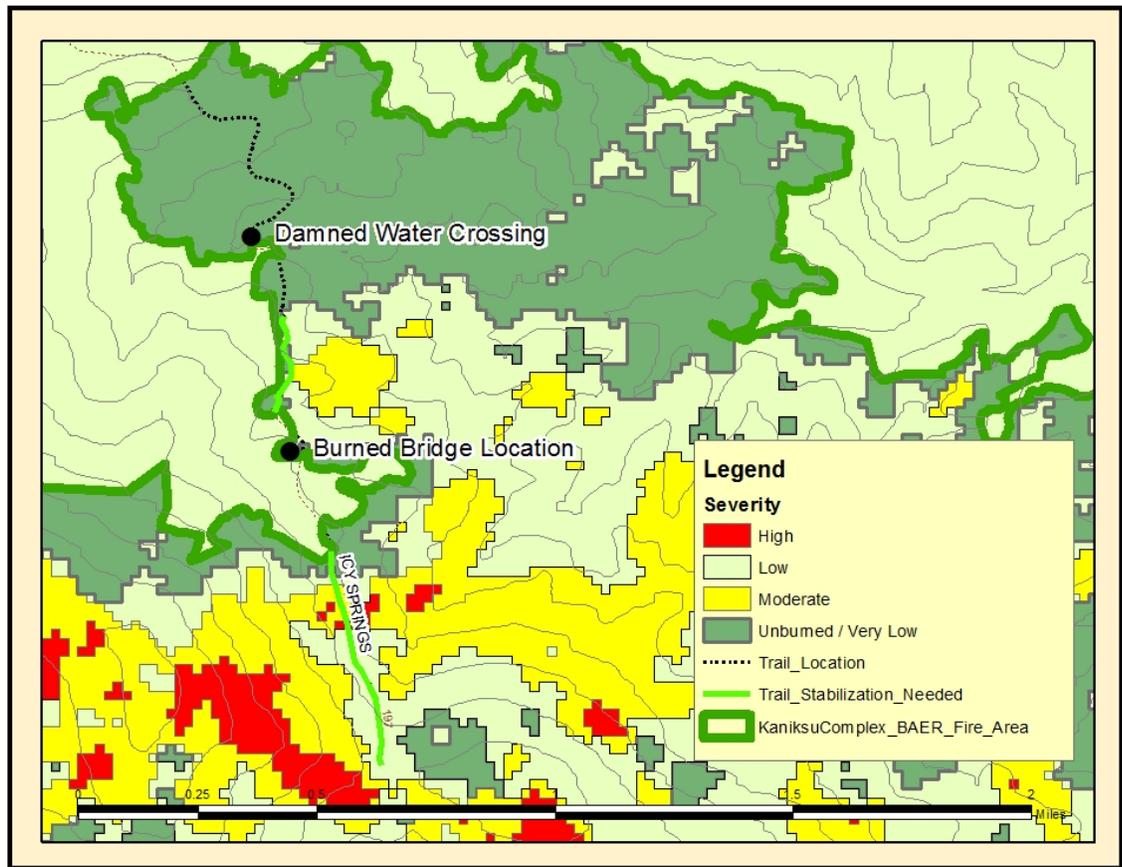
**Map 5 – Icy Springs Trail (IPNF)**

**Icy Springs Trail (#197)** – Icy Springs trail is located on the IPNF. It is the most used, developed and maintained trail located within the burned area of the Tower Fire. Although the GIS mapping exercise indicates that fire severity on the trail tread itself was for the most part less intense, on the ground surveys indicated that the fire followed the trail corridor and burned existing erosion control features more intensely.

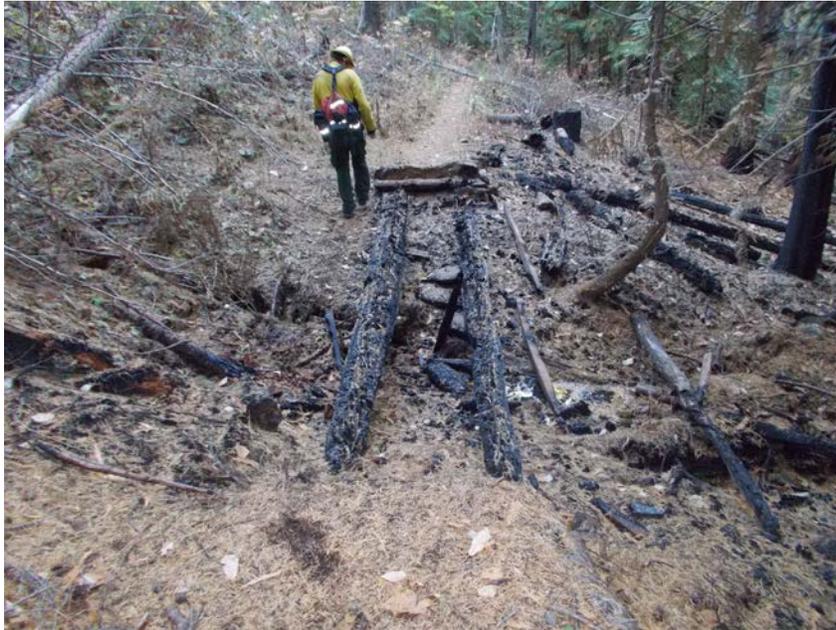
**Figure 2 - Burned Trail Bridge on Icy Springs Trail (IPNF)**

This treatment is designed to remove the Icy Springs Trail foot bridge from the creek to reduce the potential for hazardous material to be introduced into the water. The fire burned the Icy Springs Trail foot bridge. The burnt infrastructure (treated lumber) has now fallen into and remains in the channel. This system is an intermittent system that flows for a period of the year. Removal and proper dispose of the burned bridge material from creek will be necessary to keep hazardous material from entering into the water. Using a Force Account Trail Crew the burnt material will be extracted from the channel, hauled out, loaded onto a truck, and hauled to disposal site.

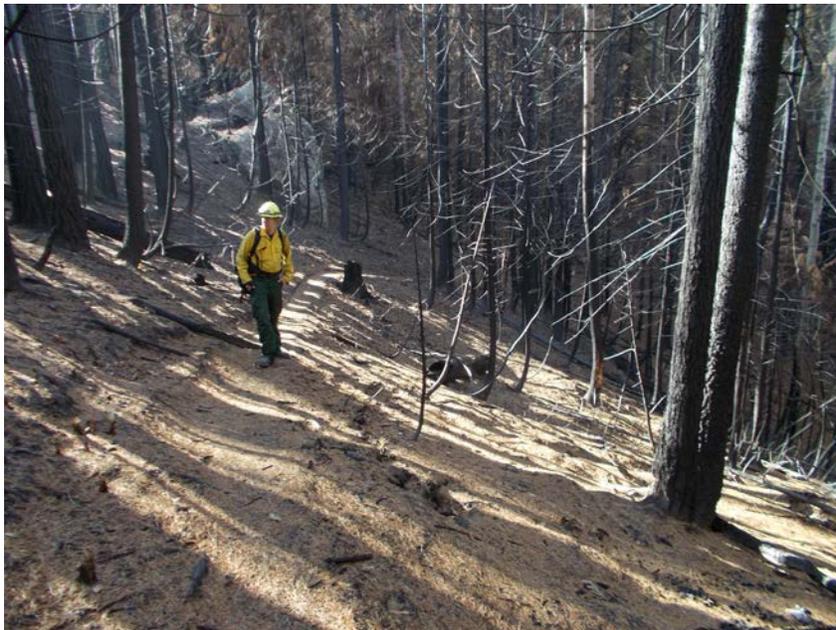
**Figure 3 - Typical Fire Intensity**

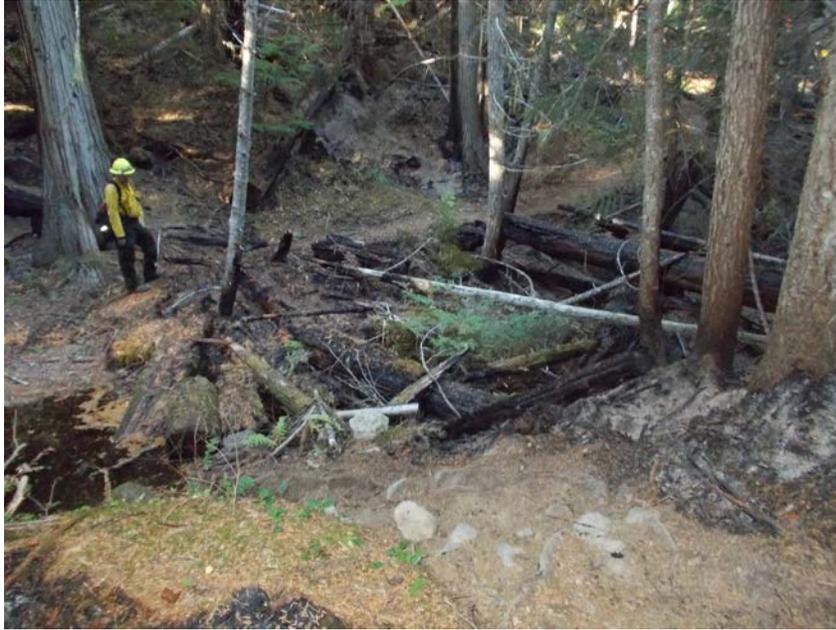
**Figure 4 - Water Crossing Dammed by Failing Fire Weakened Trees**

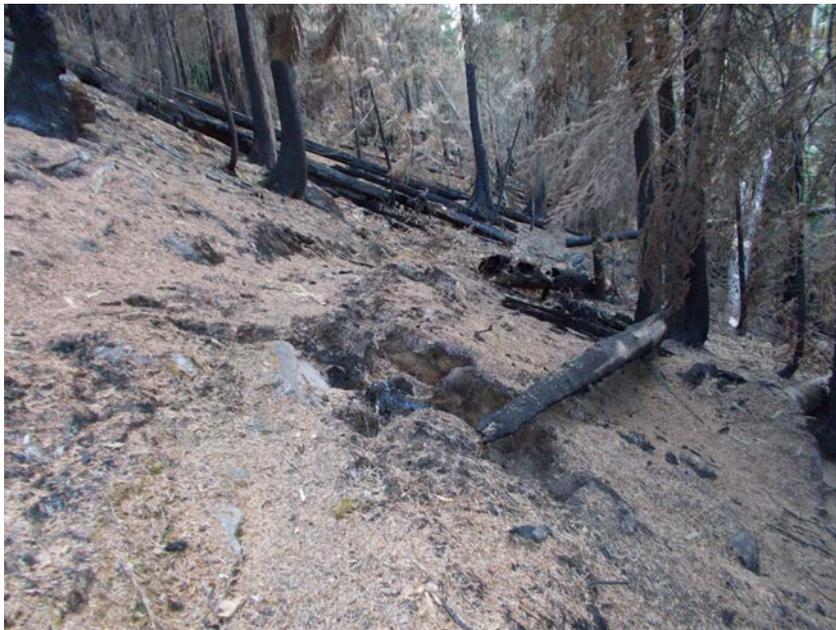
**Figure 5 - Trail Tread in need of Stabilization Work**

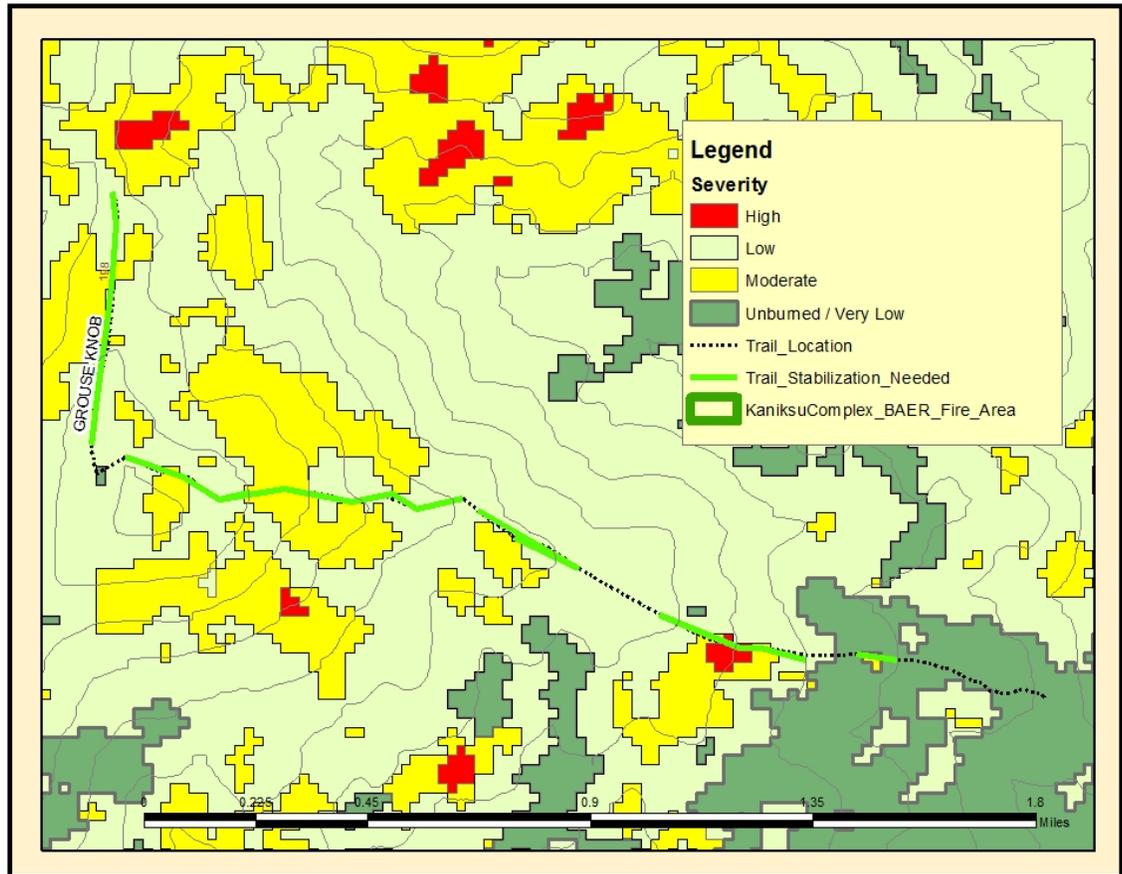
**Map 6 – Grouse Knob Trail (IPNF)**

**Grouse Knob Trail #198** – Grouse Knob is TC1 motorcycle trail located on the IPNF. This trail receives very little use and has not been maintained in at least 10 years. The trail tread was very difficult to find and in historic monitoring reports the trail was said to have been heavily impacted by logging operations in the area. Although this trail is primarily located within high to moderate burn severity, the low development level and lack of maintenance lead us to recommend this trail to be low in priority for stabilization efforts.

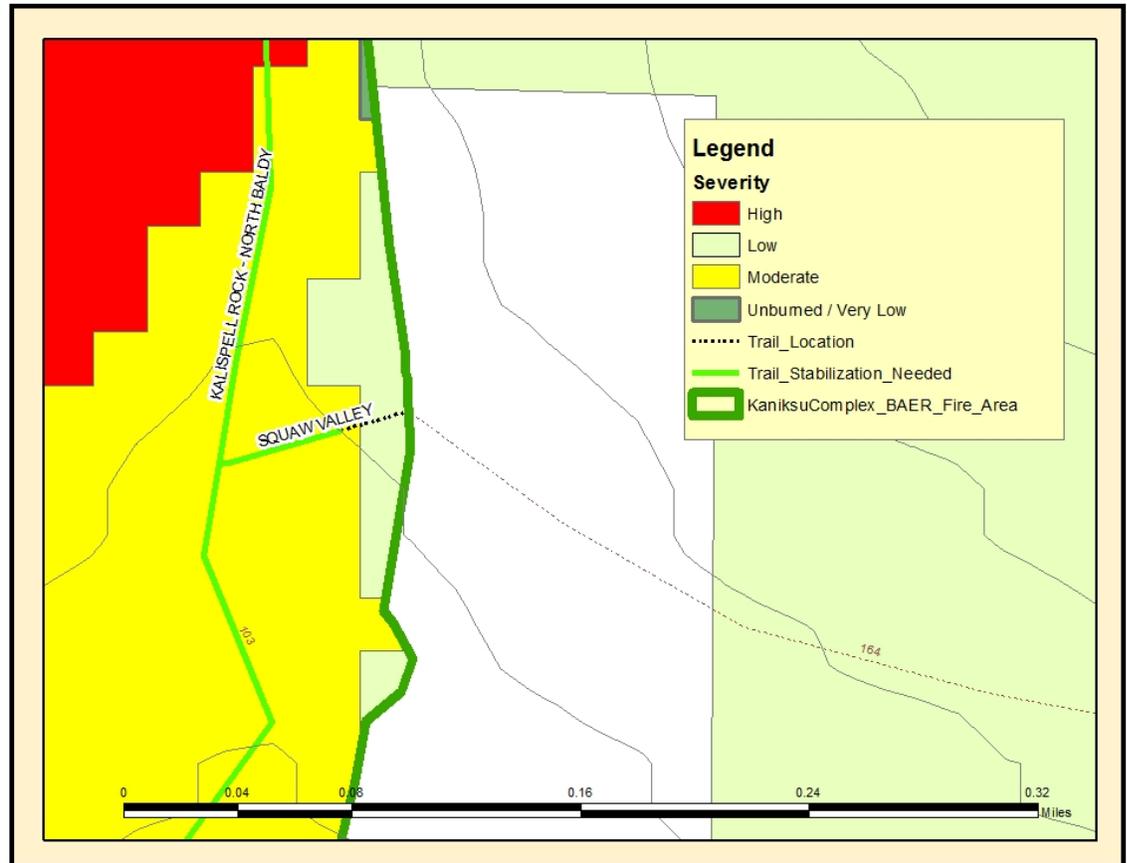
**Map 7 – Squaw Valley Trail (IPNF)**

**Squaw Valley Trail #164** – The section of tread located within the burned area is very short. This trail was largely used as fire-line during suppression activities and has largely been rehabilitated by the division. They did a great job!!!

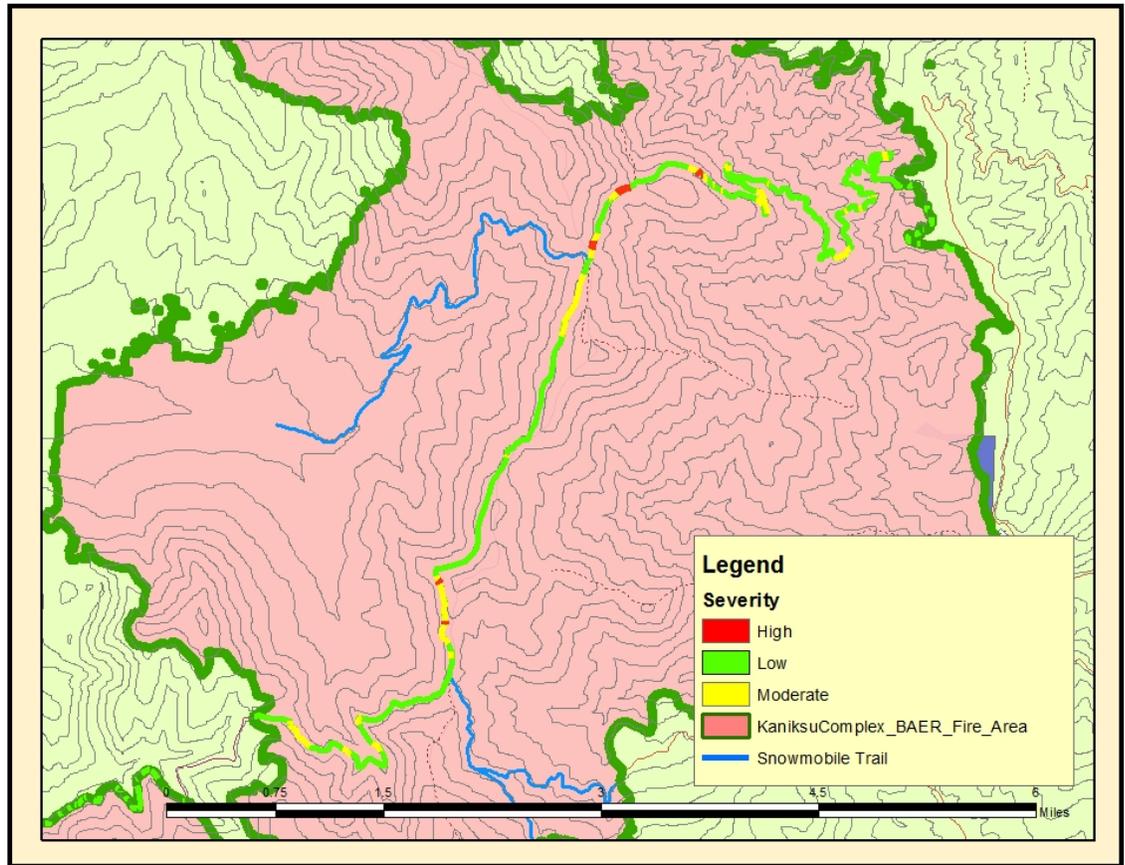
**Map 7 – Burn Severity on Potential Snowmobile Route within the Tower Fire**

An additional alternative would be to maintain a single route through the burned area. A potential route could be maintained starting a Kings Lake Sno-Park traveling the 5030 and 5080 to the Pelke warming hut then on to 312 and 219 to Hill Resort. Approximately .25 of a mile of this route would occur within high burn severity. Approximately 2.43 miles would also occur within moderate burn severity. The risks to human health and safety could be reduced by completing hazard tree removal along burned section (high to moderate) of open snowmobile trails. Increased avalanche forecasting in burned areas would also help.
