SLIDE FIRE BAER SEVERITY ASSESSMENT

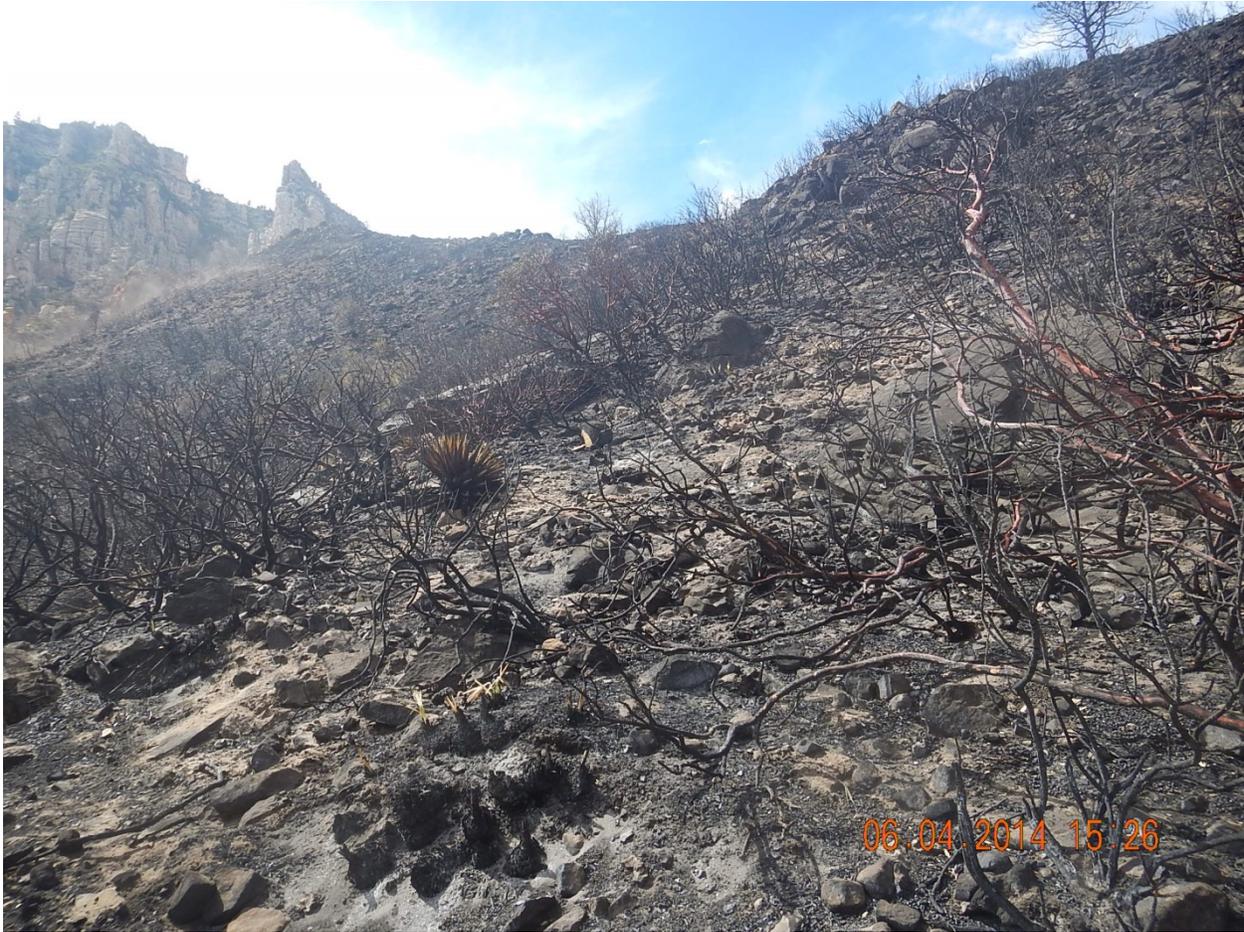
6/4/2014 - The Slide Fire removed vegetation in many areas, including steep canyons. Rock fall has always been a risk in these areas. Roots, from trees and shrubs burned in the fire, no longer holding rocks, subject the canyons to increased potential for dry ravel and rock fall. This progressive accumulation of sediment without vegetation to slow it down creates an increased impact throughout Oak Creek Canyon.

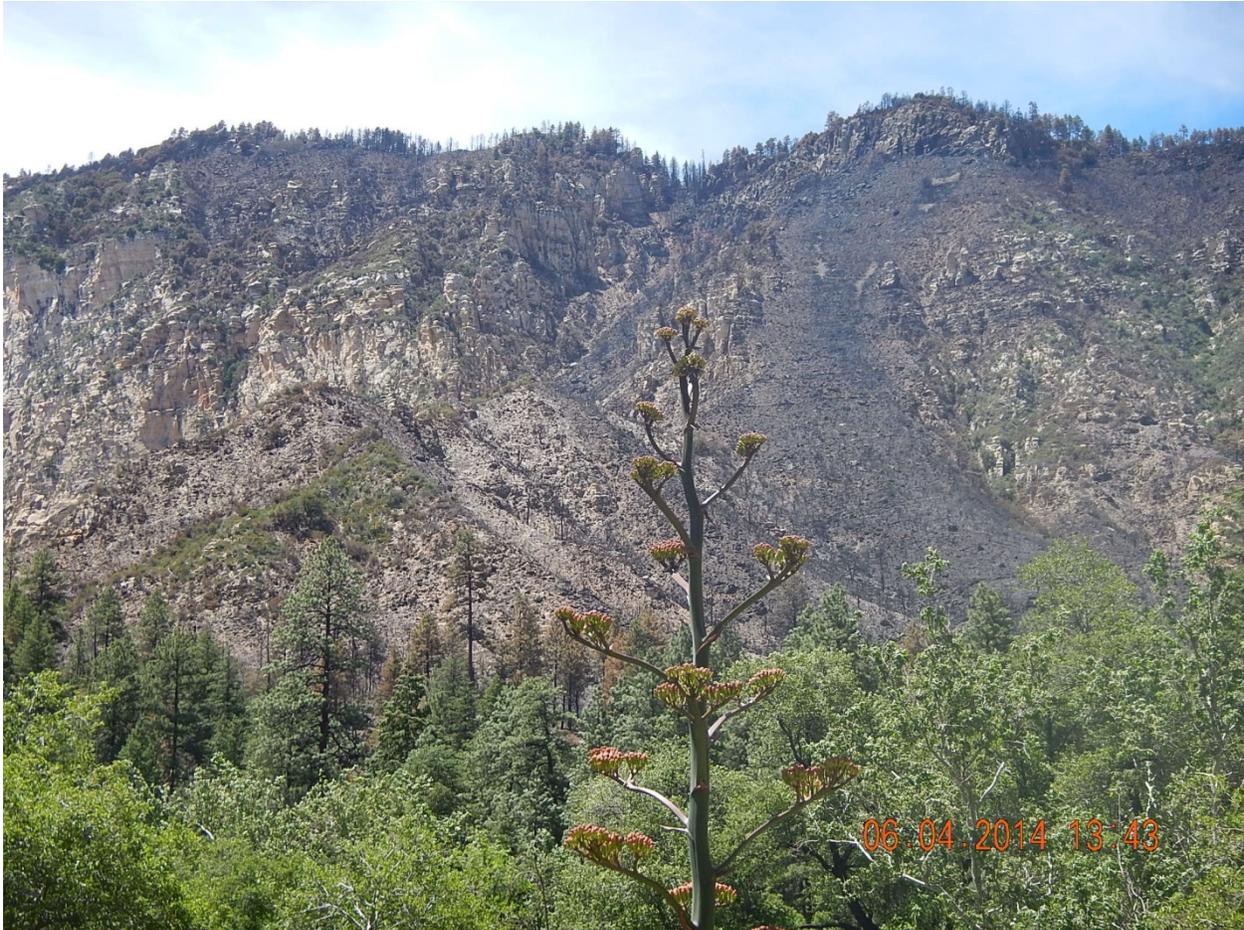
6/4/2014 - The Slide Fire removed vegetation in many areas, including steep canyons. Rock fall has always been a risk in these areas. Roots, from trees and shrubs burned in the fire, no longer holding rocks, subject the canyons to increased potential for dry ravel and rock fall. This progressive accumulation of sediment without vegetation to slow it down creates an increased impact throughout Oak Creek Canyon. A BAER team crew heard rock fall already occurring during one field assessment day this week.

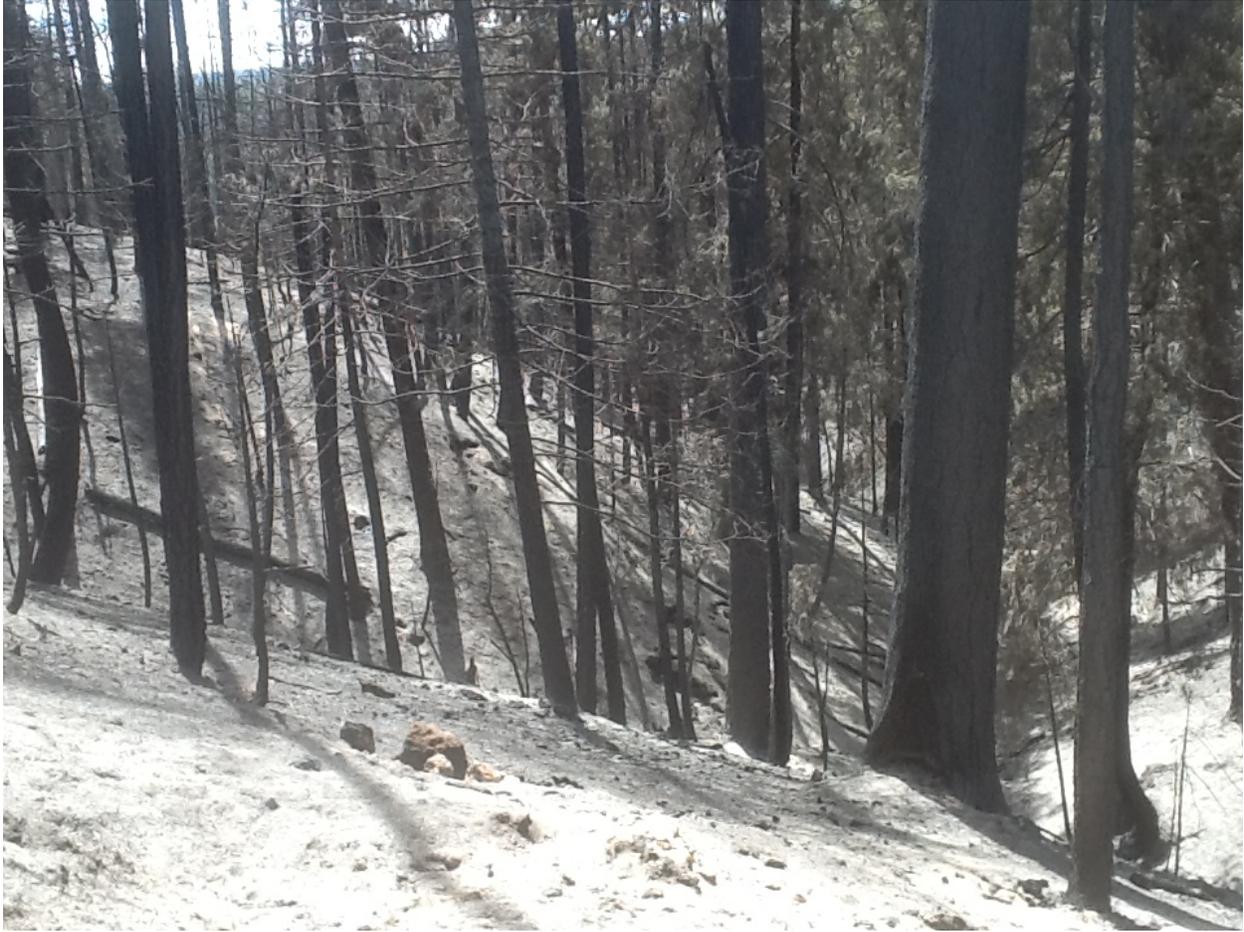
6/4/2014 – A thick layer of powdery gray or white ash covering the ground is an indicator of high soil burn severity. Ash and debris can be swept into rivers and streams by summer rain storms, potentially impacting downstream water sources.

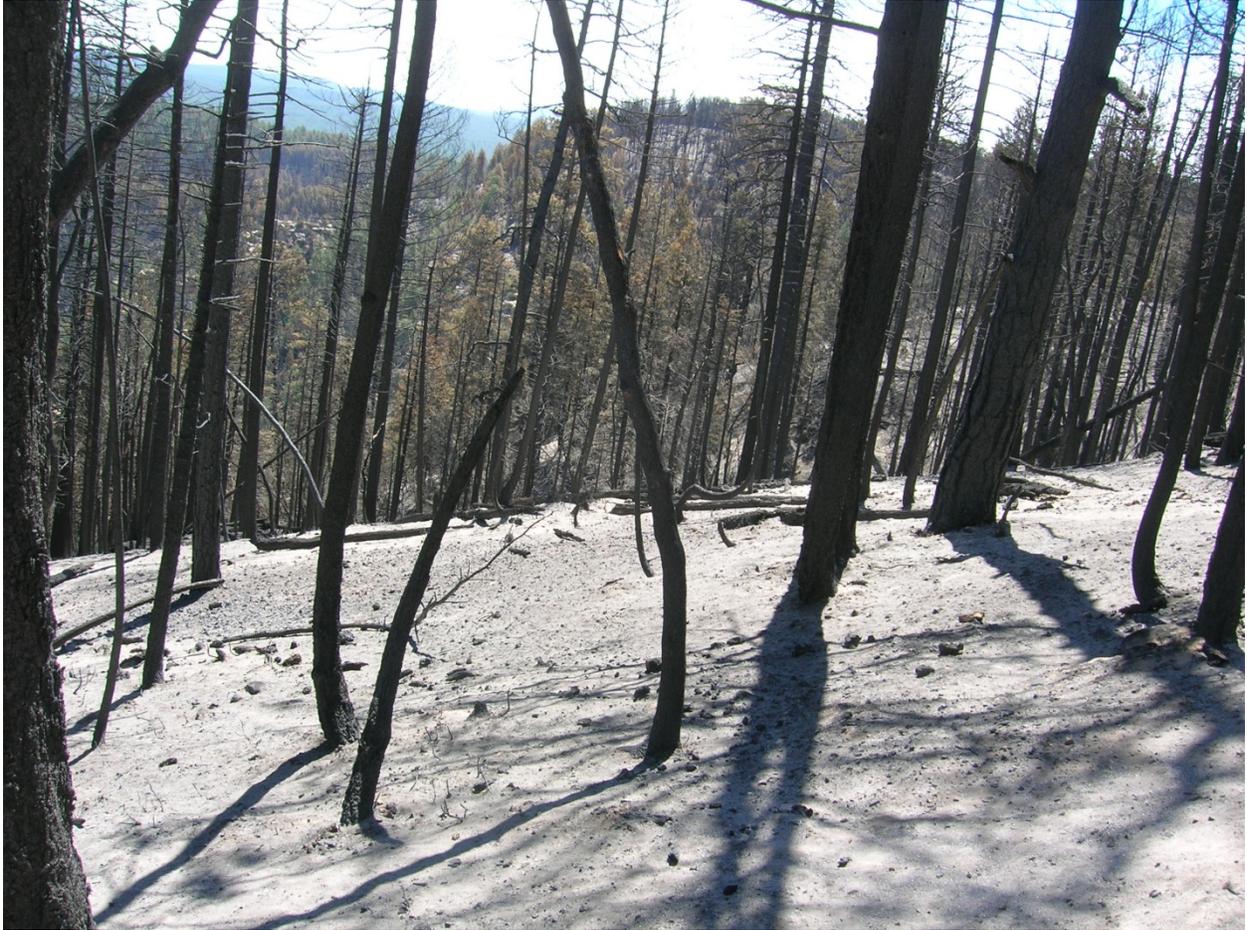
6/3/2014 – A thick layer of powdery gray or white ash covering the ground is an indicator of high soil burn severity. Ash and debris can be swept into rivers and streams by summer rain storms, potentially impacting downstream water sources.

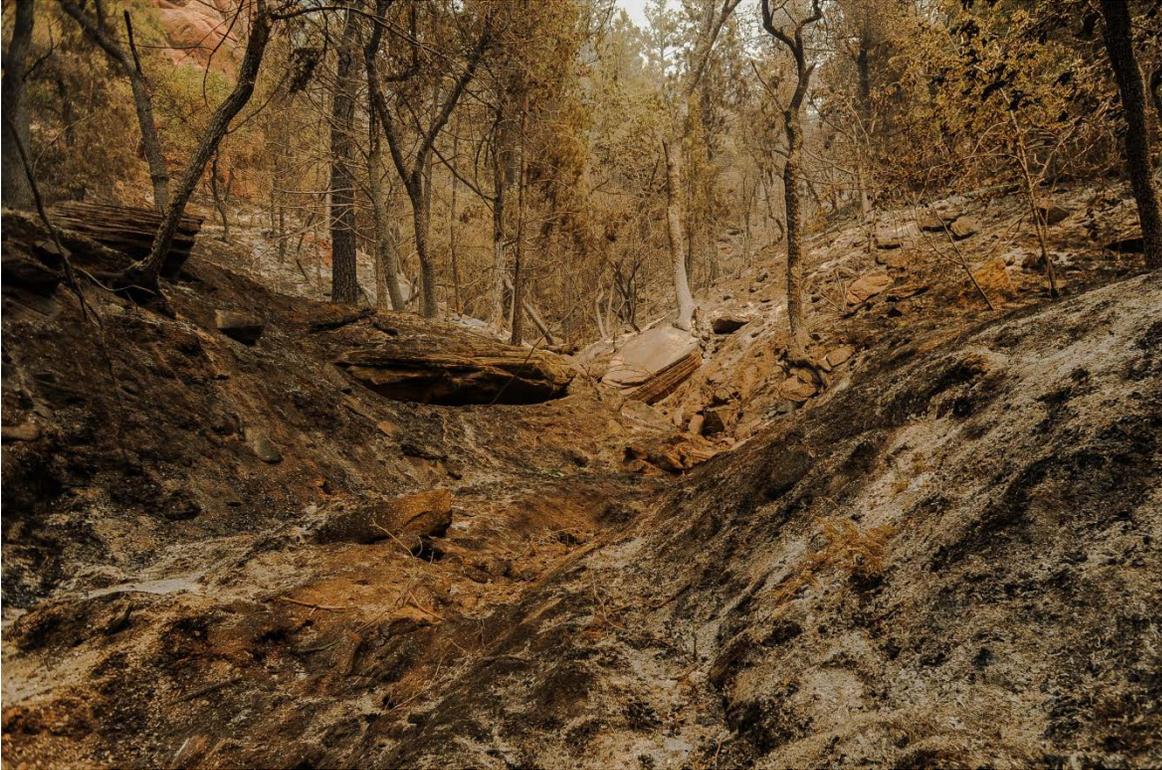
In the aftermath of the Slide Fire, a Public Information Officer with the Type 1 Incident Management Team photographed a series of photos in the West Fork of Oak Creek. This photo, north of the footbridge, illustrated the potential for ash and potential rock fall that may occur following a thunderstorm.

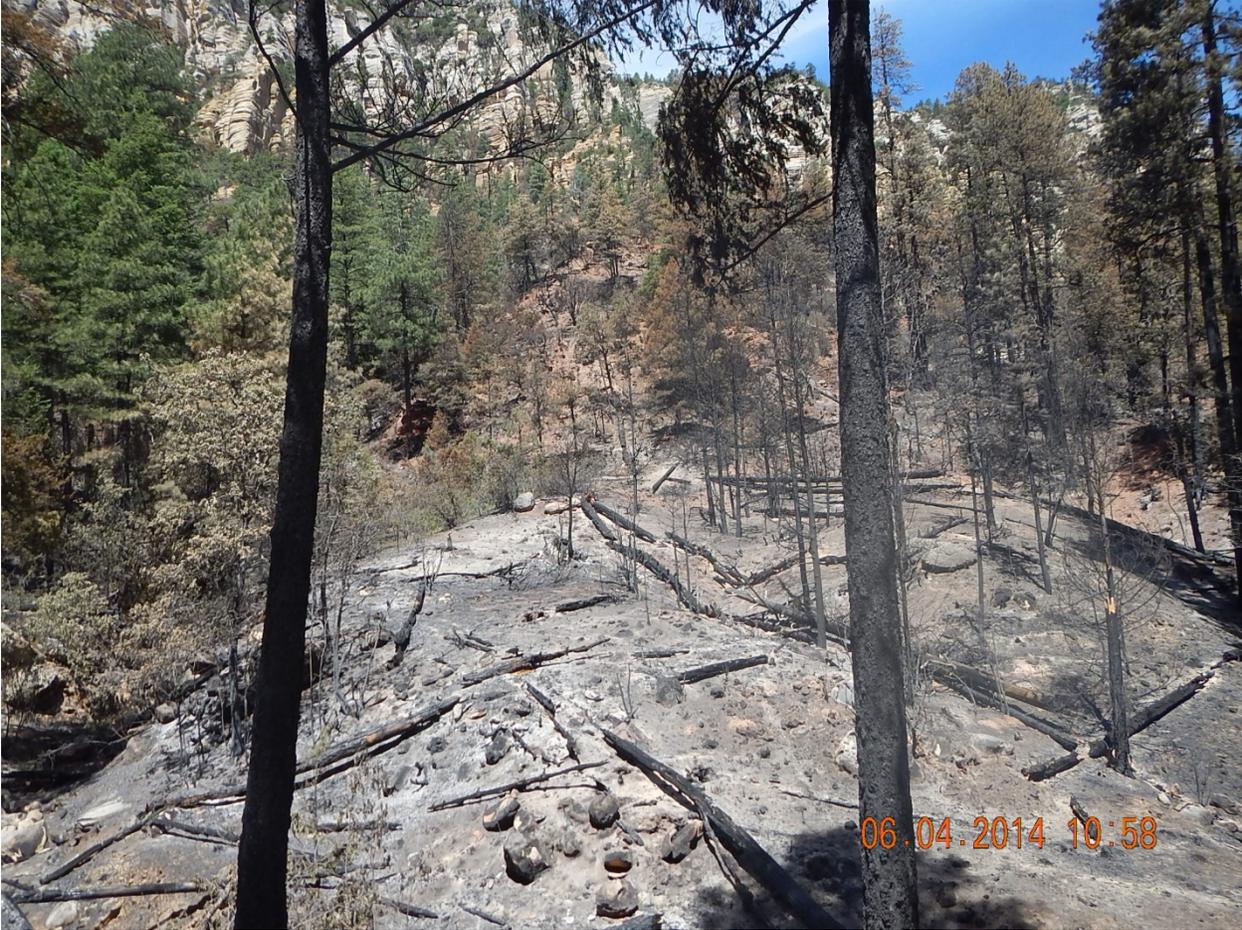
6/4/2014 – This photo, taken in Oak Creek Canyon, shows potential for debris and ash flow that may have downstream impacts following a thunderstorm.

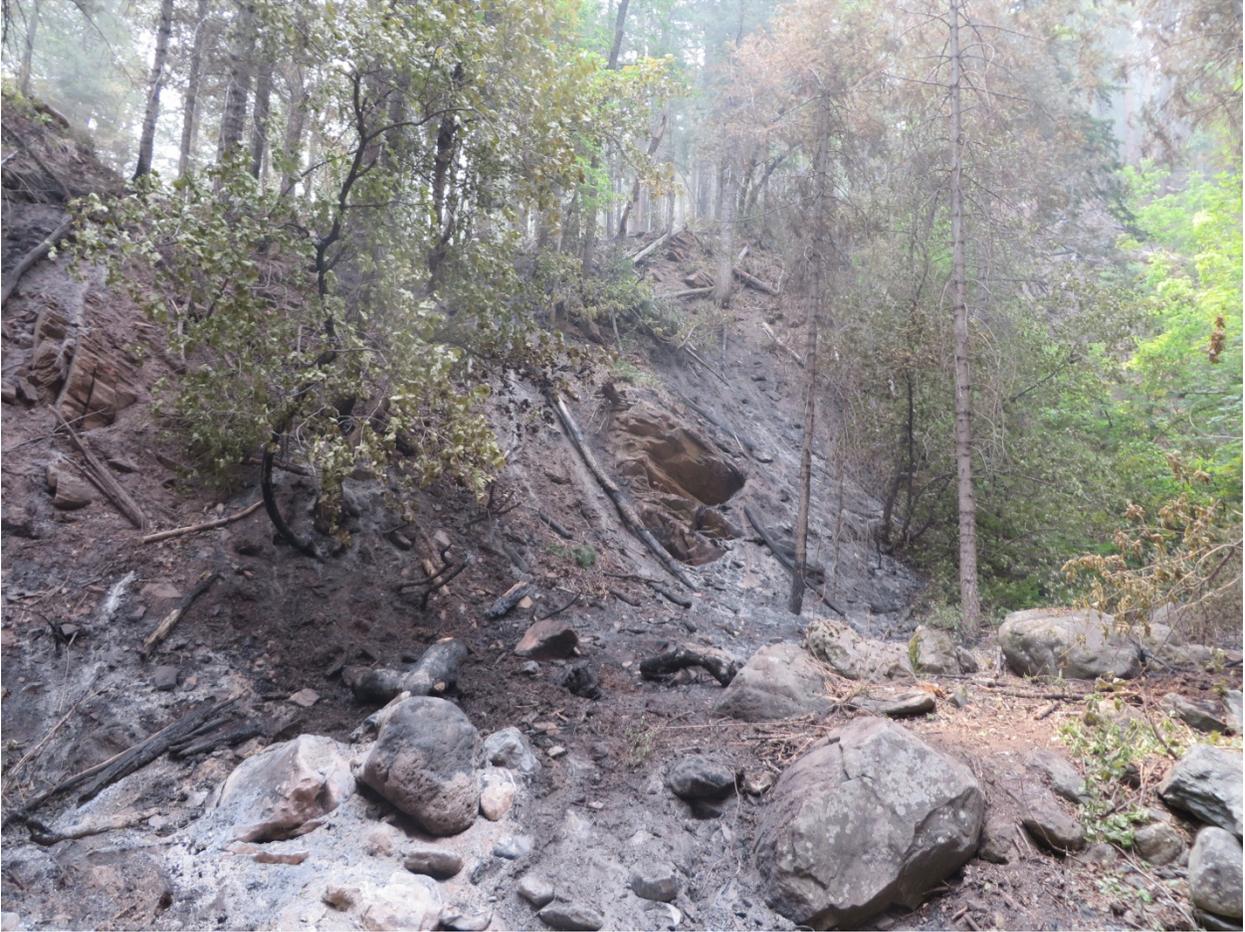
6/3/2014 – This photo, taken in Sterling Canyon, shows potential for debris and ash flow that may have downstream impacts following a thunderstorm.

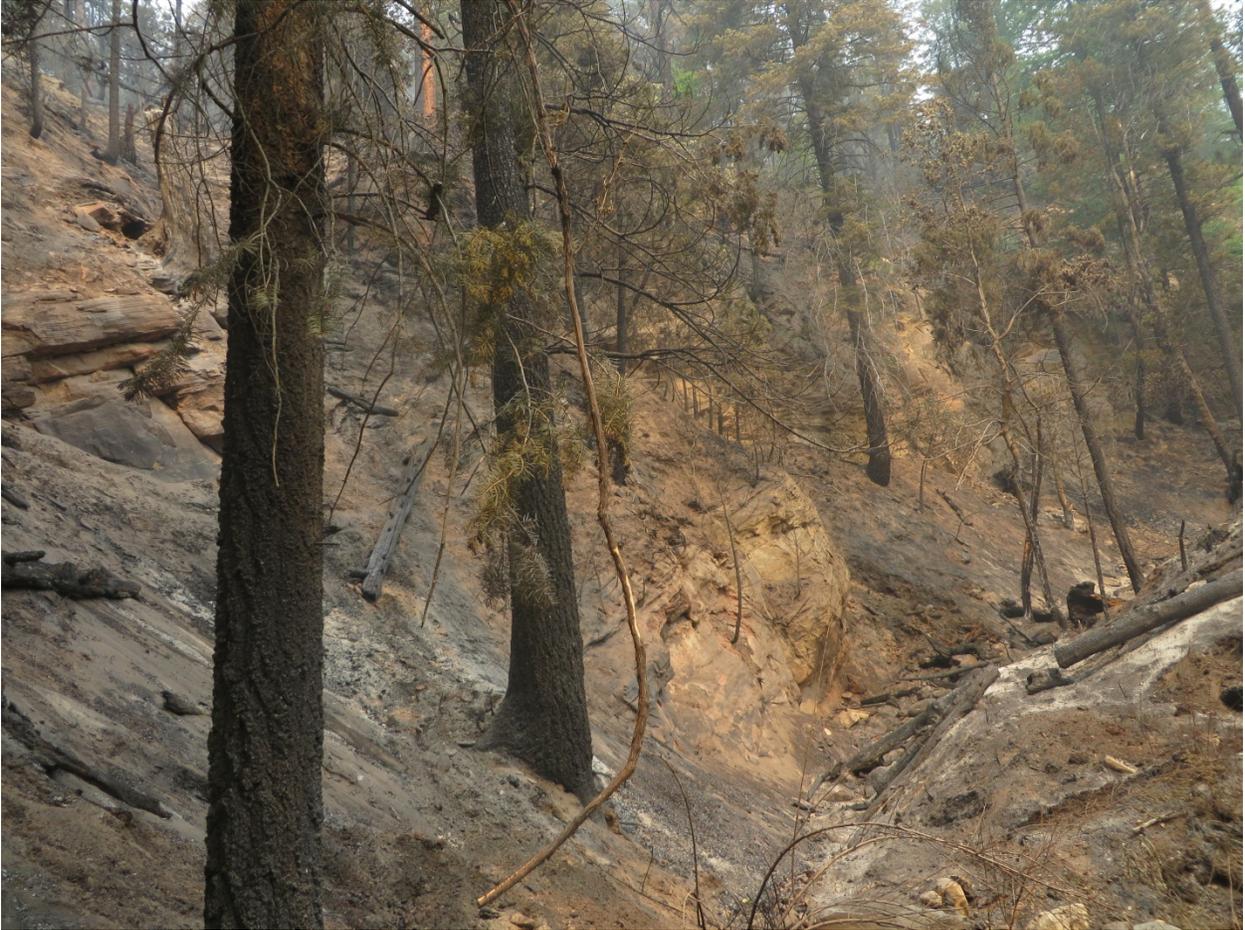
6/3/2014 – This photo, taken in Sterling Canyon, shows potential for debris and ash flow that may have downstream impacts following a thunderstorm.
