Burned Area Emergency Response (BAER) Assessment  
FINAL Specialist Report – GEOLOGIC HAZARDS

South Complex, Shasta-Trinity N.F.  
September 15, 2015

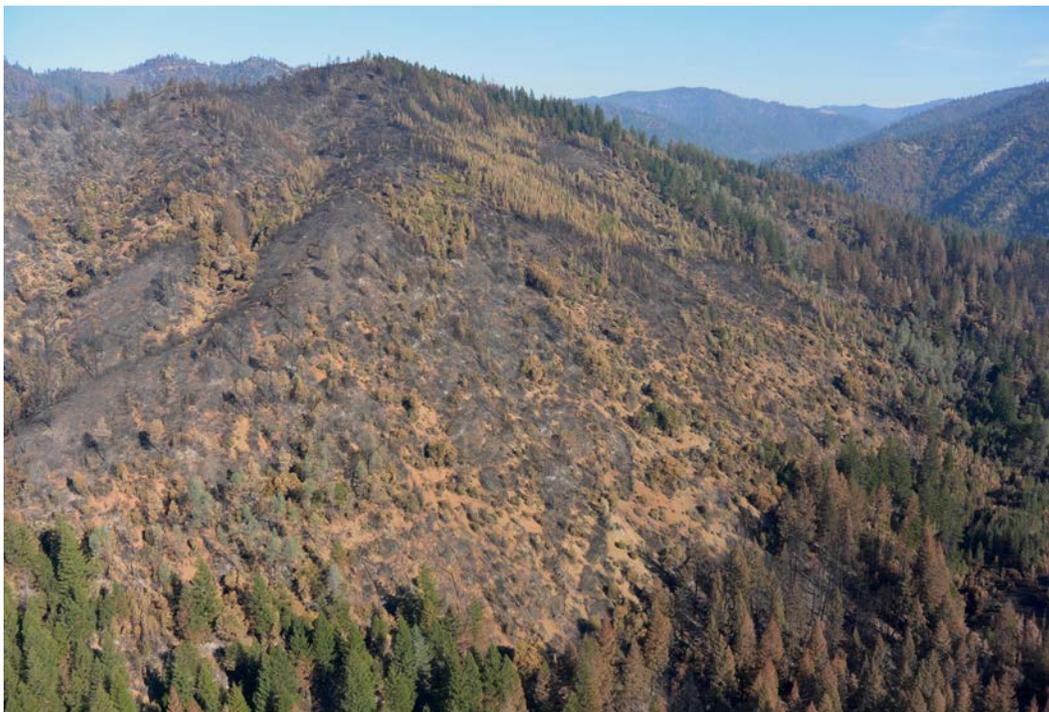
Slope instability features such as recent pre-fire debris slides, rock-falls, channels and gullies frequent the steep inner gorge slopes, while fluvial erosion processes have shaped the gentler valleys and ridges. Areas of active mass wasting are typically void of vegetation (see photo 1). Some areas show a great deal of slope dissection and slope instability, while other areas are amazingly smooth, un-dissected and devoid of instability features. Some channels were choked with sediment that will mobilize during flood events and add significant bulk to flowing water. Other channels, especially on steep hillsides, were relatively devoid of pre-fire sediment, but now are subject to filling with post-fire colluvial debris and rolling rock.

**Photo 1:** Active mass wasting – Rays Peak, Pattison fire

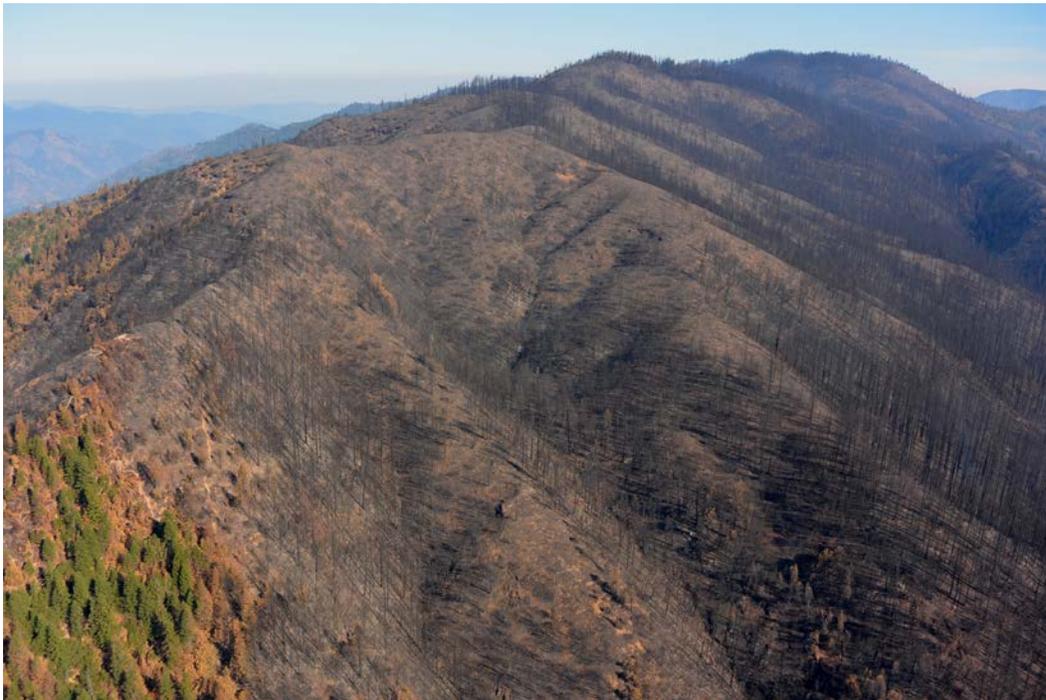
The Castle fire area includes two major watersheds: The Eltapom Creek and the South Fork Trinity River. The few sub-watersheds that flow directly into the South Fork Trinity River and are part of the South Fork Trinity River watershed can be divided into two major areas. The north-west corner of the fire, which includes sub-watersheds/creeks that all flow from Underwood mountain west directly into the South Fork Trinity River and the Young Gulch sub-watershed/creek that flows directly into the South Fork Trinity River and drains the whole south-west corner of the fire. Out of these two areas, the sub-watersheds/creeks to the north-west burned for the most case with a very low-unburn soil burn severity. In contrast, the Young Gulch watershed experienced a whole range of burn severity from very low-unburn to high soil burn severity. Out of the whole South fire Complex, the watershed that exhibits the highest concentrations of moderate-high soil burn severity is the Eltapom Creek watershed (see photo 2).

As mentioned above, the Eltapom watershed exhibits the highest concentration of moderate to high soil burn severity in the fire area. A major sub-watershed in the Eltapom watershed is the Buckhorn watershed and its tributates. In an event of a 10-year storm, segments of the Buckhorn and its tributates are predicted to produce debris flows ranging from less than 1K to 100K cubic meters with a probability ranging from 0-20% all the way up to 60-80% depending by the

**Photo 2:** Moderate-High soil burn severity at the headwaters of the Buckhorn Creek, sub-watershed of the Eltapom watershed

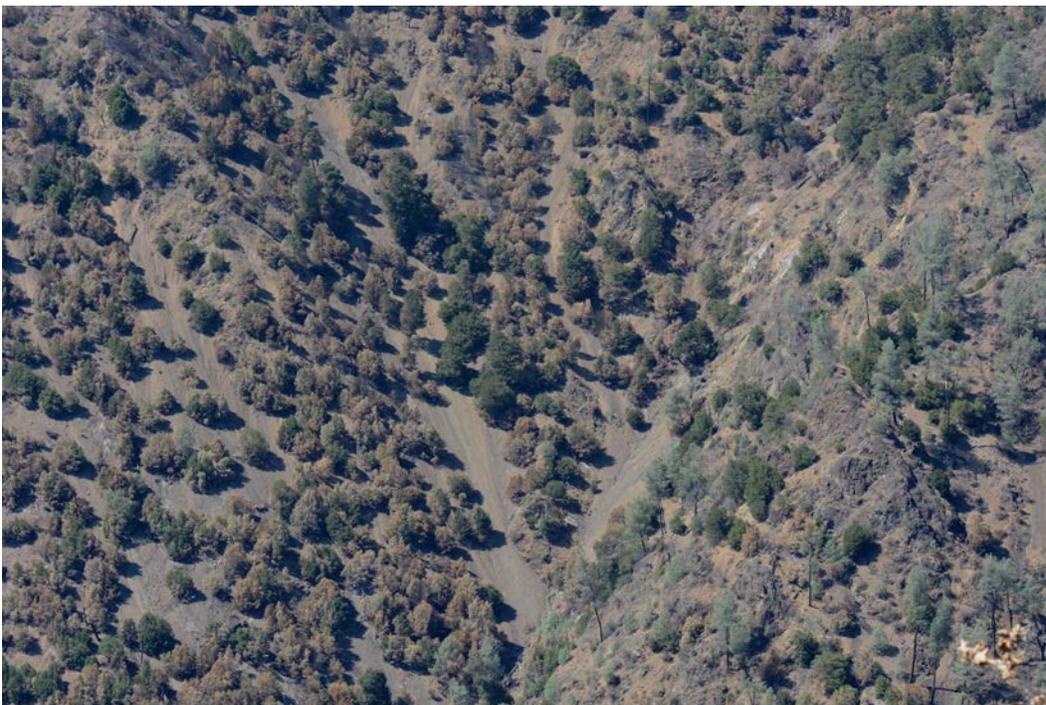
Through ground surveys, flight recons and study of geomorphic maps evidence of past mass wasting was observed throughout much of the South Complex burnt area. From on-the-ground observations it is clear that some of the headwaters of the Eltapom creek, the Buckhorn creek and others are loaded with unsorted, unconsolidated materials available to be transported.

**Photo 3:** Steep mountainside ephemeral channels loaded with unconsolidated materials available to be transported, Eltapom Creek

With an unstable lithology that is weak and prone to landslides, many dormant and active landslides, slopes that are in some cases over 75% steep and upper slopes/channels that are loaded with unconsolidated materials available to be transported (see photo 3) the Eltapom watershed under these new (burn) conditions is expected to activate some dormant debris slides, initiate some new debris slides and potentially produce some debris flows. Beyond some level 1 & 2 FS roads that might experience some excessive rock falls, dry ravel and erosion, other concerns/Values At Risk (VAR) in this area include: negative effects on water quality and fish habitat, soil productivity and threat to ingress - egress of private properties. Along segments of FS roads (4N24, 4N09, 4N04) that might experience some excessive rock-fall and erosion, it is recommended to keep the basins at the creek crossings as clear as possible and have storm patrols after every major rain storm. It is also recommended to install rises on some of the culverts crossing these roads, as well as installation of rolling dips to channel plugged culverts off the roadway.

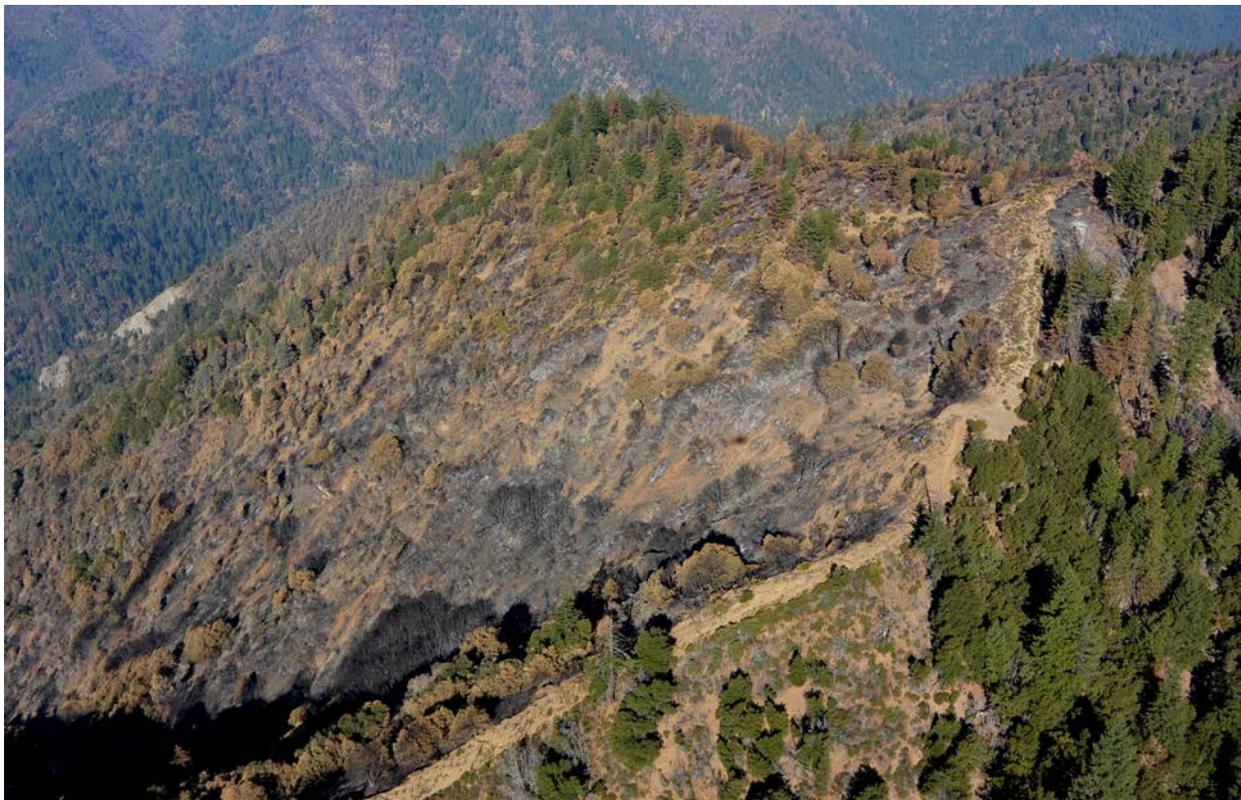
The Pattison fire burnt area includes two major watersheds: The Corral Creek watershed to the north and east of the fire and the Olsen Creek-Hayfork Creek watershed to the south-west of the fire. In general, the majority of the Pattison Fire had low and very low/unburned soil burn severity. Some very small patchy areas (around Rays Peak, Gates Mountain and Pattison Peak) exhibit moderate to high soil burn severity (see photo 4), mostly in the Olsen Creek-Hayfork Creek watershed.

**Photo 4:** Mass wasting and patchy moderate burn severity near Pattison Peak – Pattison fire

In both major watersheds that constitute the Pattison Fire very few Values At Risk (VAR's) were identified. The few VAR's that were identified for this fire include: a few level 1 & 2 FS roads that might experience some excessive rock fall, dry ravel and erosion and two trails that might be prone to some erosion. Along these few of FS roads, it is recommended to keep the basins at the creek crossings as clear as possible and have storm patrols after every major rain storm. It is also recommended to install rises on some of the culverts crossing these roads, as well as installation of rolling dips to channel plugged culverts off the roadway.

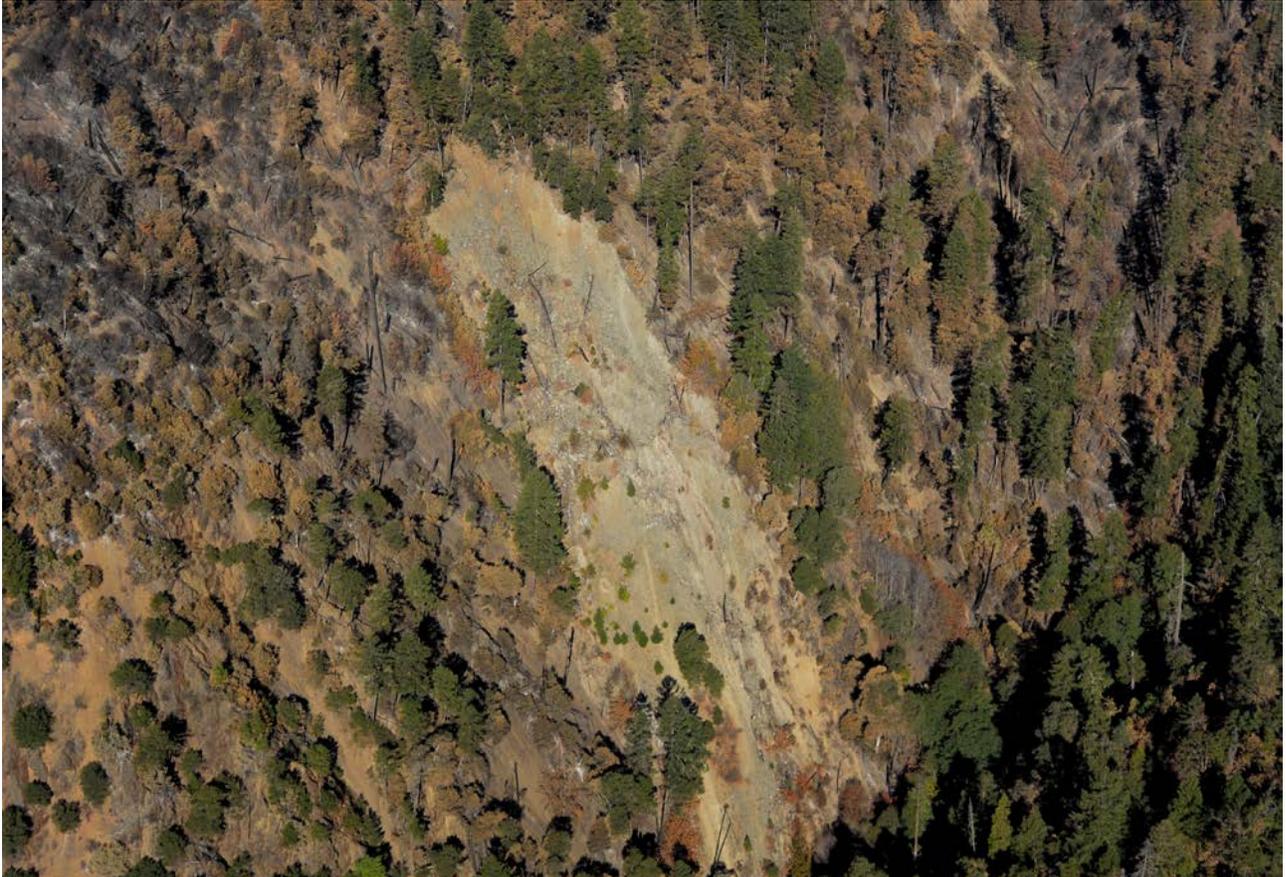
Through ground surveys, flight recons and study of geomorphic maps it is evident that that mass wasting takes place throughout much of the Pattison Fire burnt area. For the most case, this mass wasting includes inner gorge debris basins, dormant landslides and a few active landslides (see photo 5).

**Photo 5:** Active landslide, lower Corral Creek, Pattison Fire
