Trails Assessment - Rough Fire North Zone BAER
Sierra National Forest
September, 2015
By: Casey C. Shannon, BAER Hydrologist
Inyo National Forest

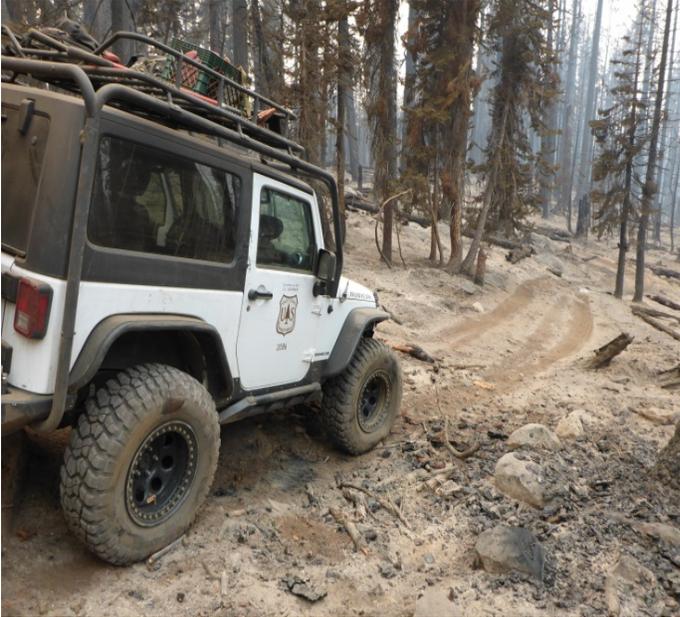
Photo 1: Spanish Mountain OHV Trail in moderate burn severity and steep slopes. Lack of adequate drainage features on this section of trail will likely cause increase soil erosion and loss of trail post-fire.

Prior to the first damaging rain events and within the first year following the fire, storm proofing is recommended to minimize erosion of the trail tread. Storm proofing treatments, implemented with hand-tools, would include out-sloping, de-berming, water-bars, armored crossings at ephemeral drainages, and other suitable treatments outlined in the BAER Treatments Catalog to protect the trails from accelerated post fire flows and soil erosion. Rodgers Ridge, Cliff Camp, Bear Wallow, Statham, Kings River NRT hiking trails and Spanish OHV trail would be treated. Repairs are recommended for at least 4 miles of hiking trails and 2 miles of OHV trail (total of approximately 6 miles) within high and moderate soil burn severity where high watershed responses are anticipated. Trail stream crossings need to be cleared of obstructions (loose floatable woody debris, rocks, etc.) to allow for channel capacity and flow bypass and to reduce lateral erosion to the trail entries and reduce potential for on-trail diversion of flow.

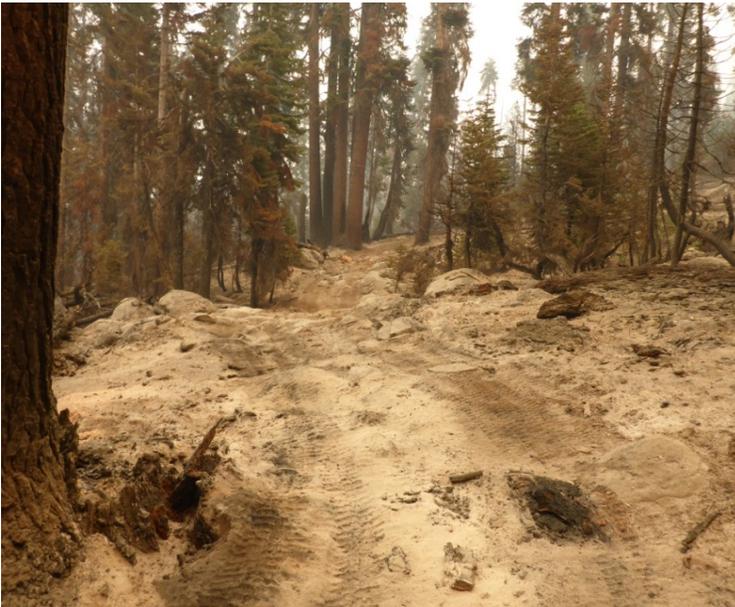
Photo 2: Steep section of the Spanish Mountain OHV Trail. Moderate to high burn slopes are located over a large area above this section of trail that will bring increased runoff to the trail. Other trails surveyed on fire have similar conditions. Additional drainage features are needed to reduce erosion. Rough Fire NZ BAER Trails Assessment, Sierra National Forest September, 2015
C. Shannon, BAER Hydrologist

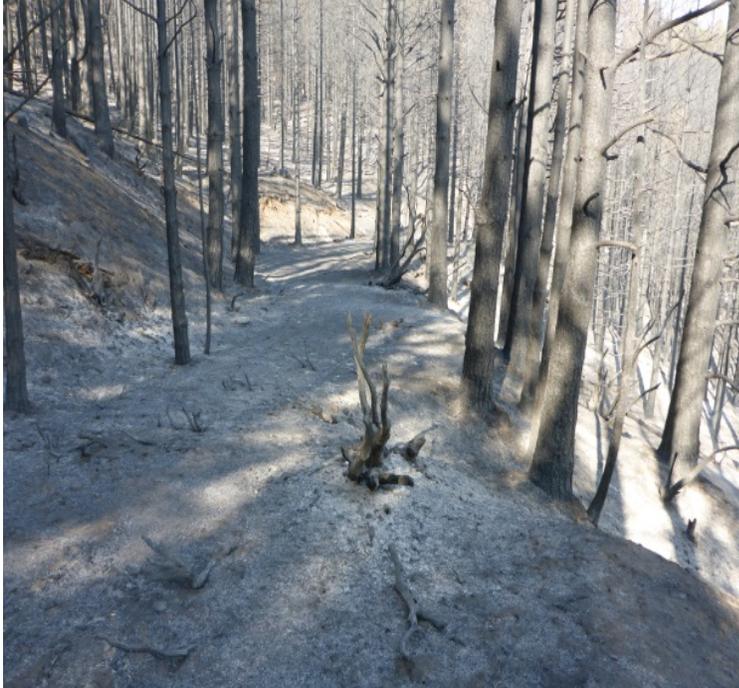
Photo 3: Abandoned logging trail off Rodgers Ridge. An example of one of the several abandoned logging trails/skid trails now exposed by removal of vegetation by the fire that are connected to Forest Roads and Trails in the fire area. Without vegetation present to hide the trails, the potential for OHV's to trespass on the trails is high.

Increased unauthorized access to the Rough Fire burned area is expected to occur due to removal of vegetation. Unauthorized access is a threat to the burned watersheds. Erosion, spread of invasive species, damage to cultural sites, destruction of rare plant and native plant communities, disturbance to wildlife, destruction of wildlife habitat, and risks to public safety can result from unauthorized access. The BAER Assessment team has identified areas off the Spanish OHV trail and 11S025A for example, within the burned area for barriers to prevent unauthorized off highway vehicle access: Old, previously closed skid trails and routes that were grown over are now exposed. These areas offer easy unauthorized OHV access to burned areas and thus are recommended for blocking and signage to protect vegetative recovery. Blocking will consist of installation of native on site materials, Funding for crews to construct the barriers and signage is requested. This will also require limited heritage clearance for the ground disturbance.

Through past experience, the BAER Team determined that signage, and barriers, installed to discourage soil disturbance and assist in allowing natural vegetative recovery, are not effective without enforcement patrol. Therefore, additional funding is requested to monitor effectiveness these barriers. Funding is also requested for District FPO's to patrol within and adjacent to the burned area to enforce the physical barriers and deter unauthorized access, on National Forest System lands.

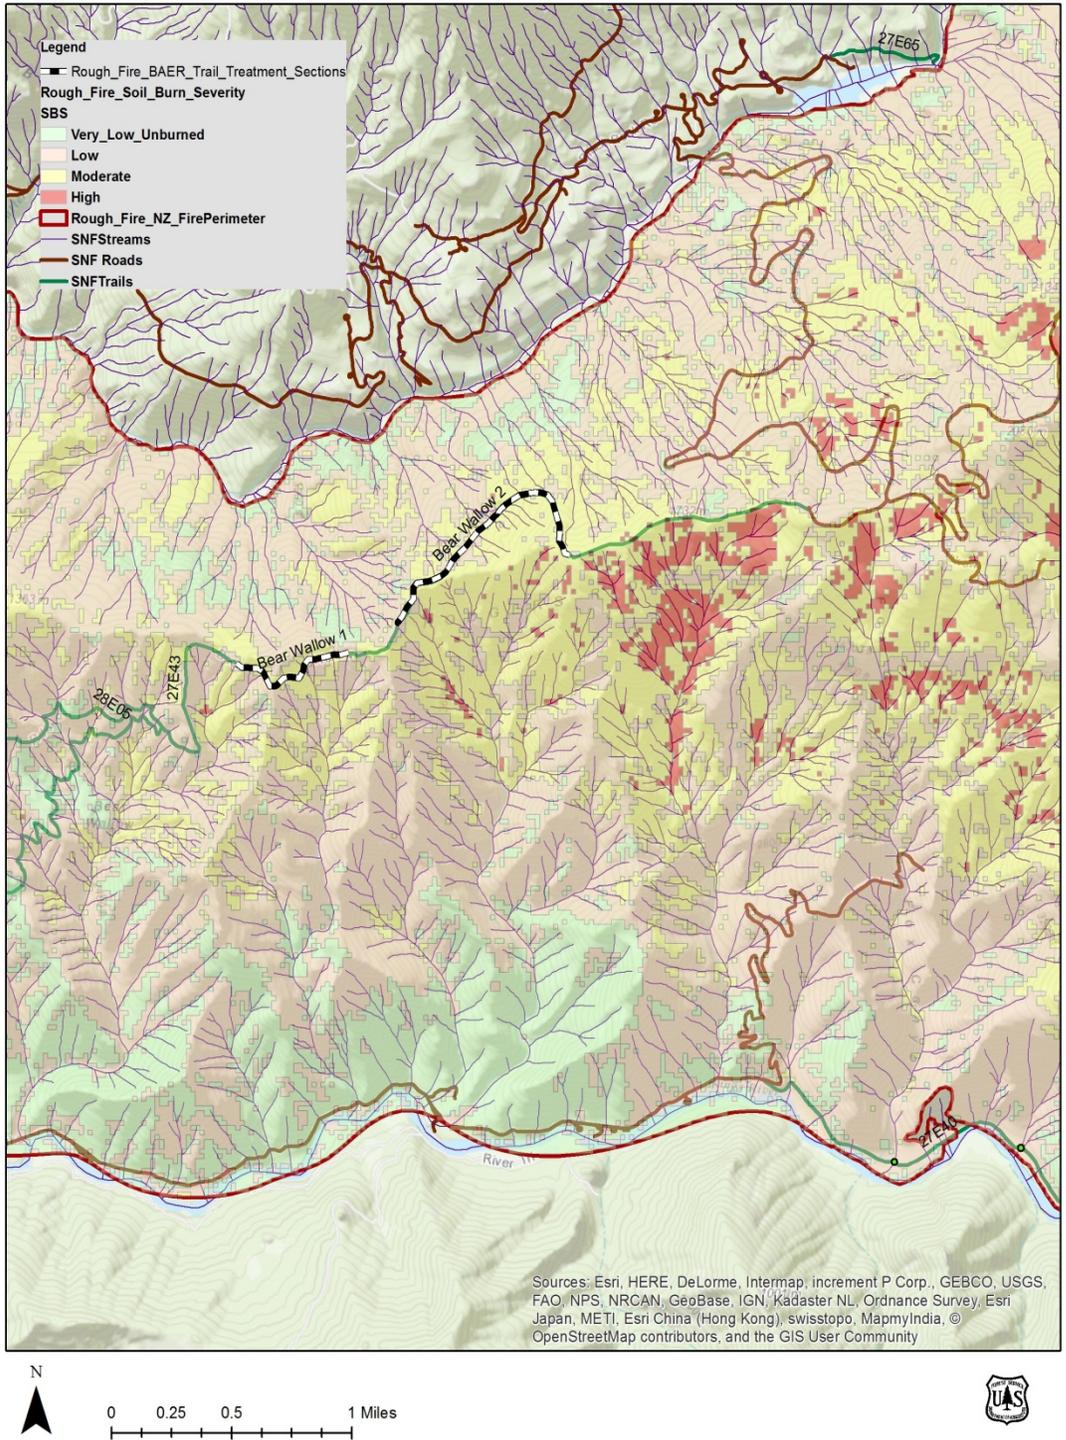
Rough Fire North Zone BAER Sierra NF - Bear Wallow Trail Treatment

Map 1: Location of Bear Wallow Trail treatment sections on Roberts Ridge.

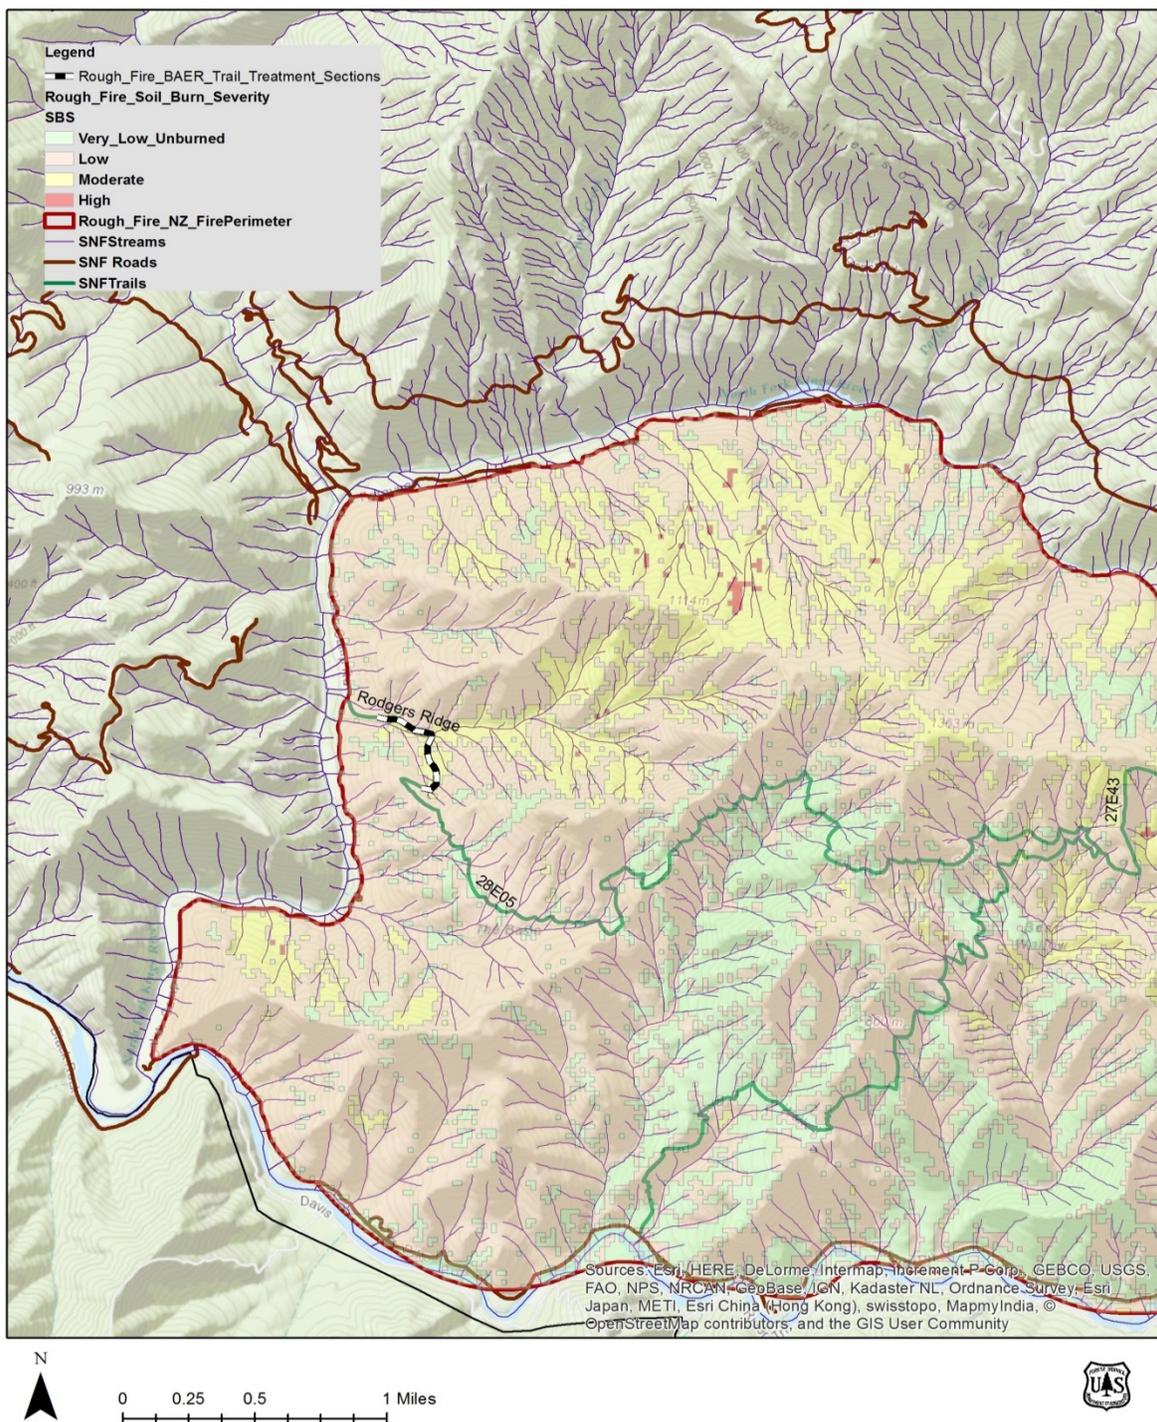
Rough Fire North Zone BAER Sierra NF - Rodgers Ridge Trail Treatment

Map 2: Location of Roberts Ridge Trail treatment section, near North Fork Kings River trailhead.

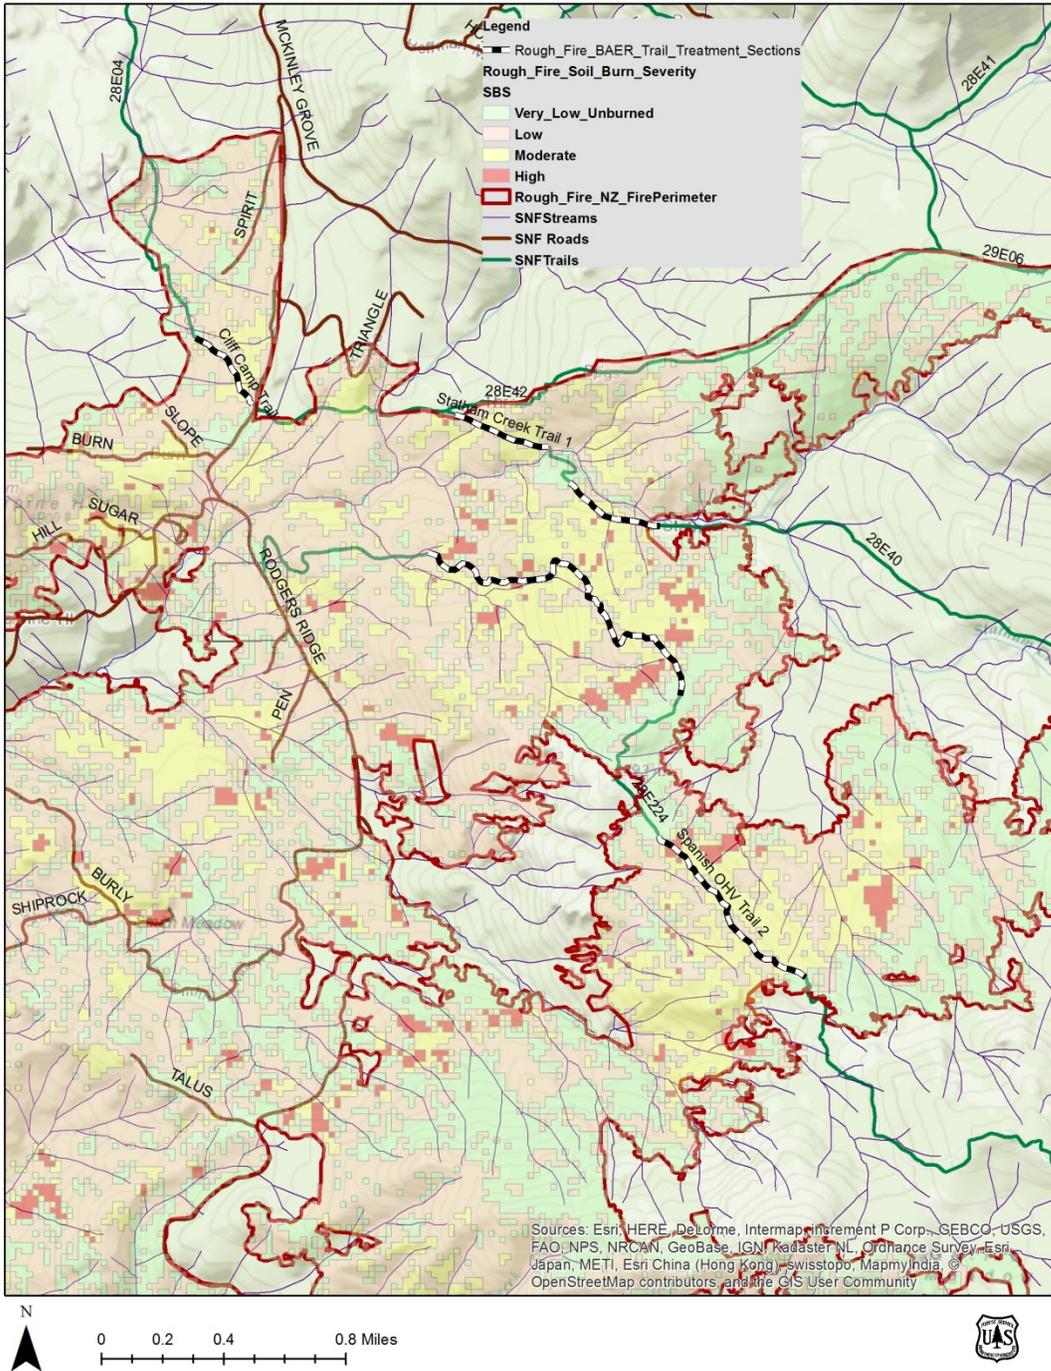
Rough Fire North Zone BAER Sierra NF- Spanish Mountain Area Trail Treatments

Map 3: Location of Spanish Mountain trails treatment sections, including Spanish Mountain OHV, Cliff Camp and Statham Creek trails.

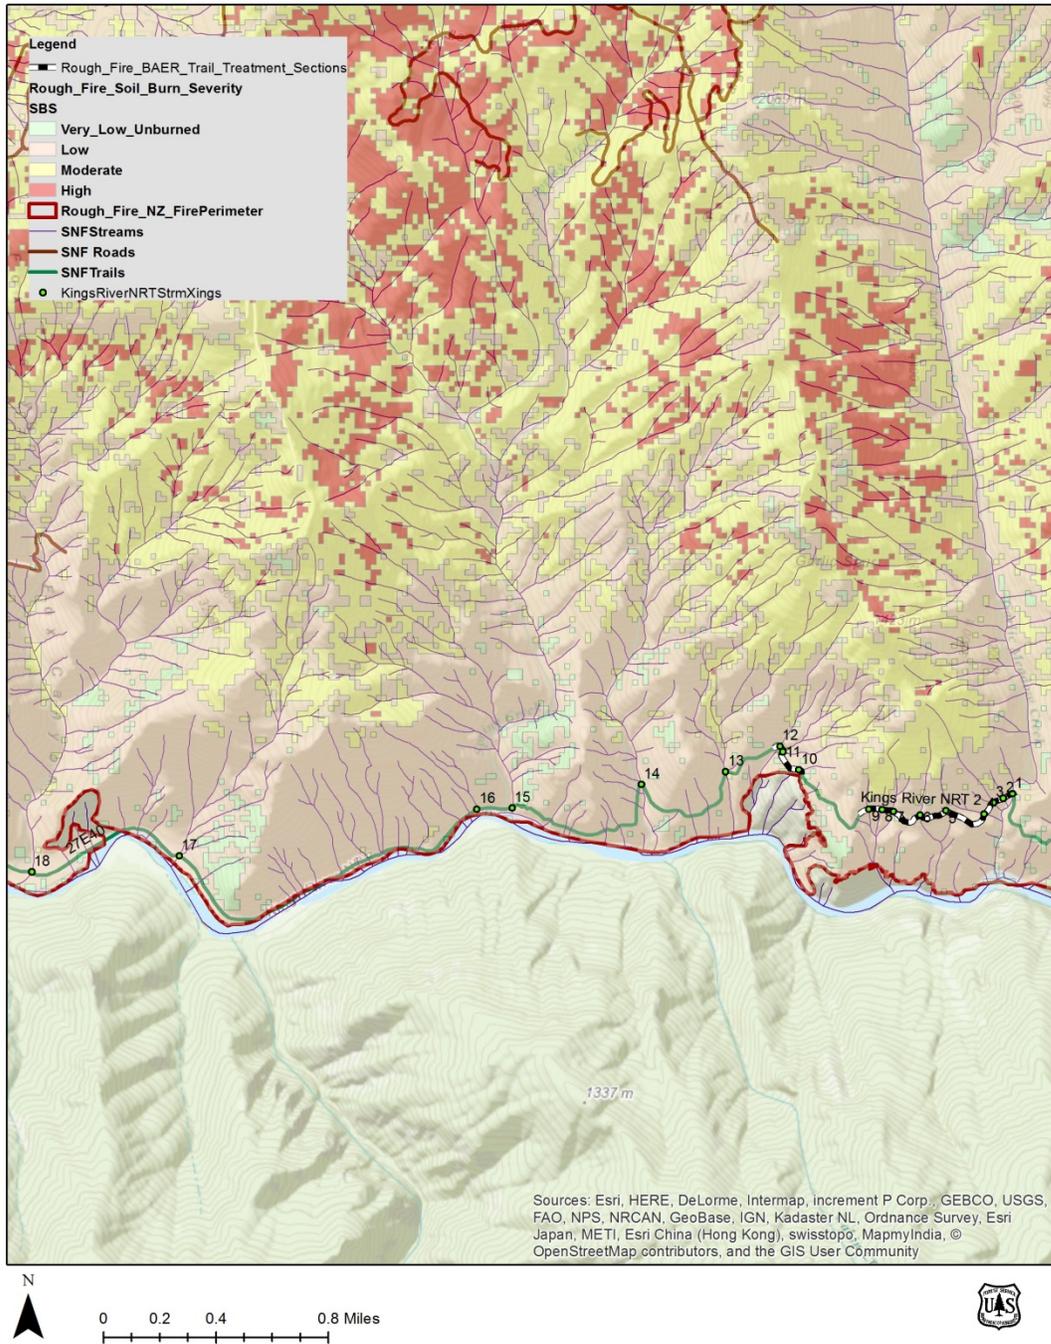
Rough Fire North Zone BAER Sierra NF- Kings River National Recreation Trail Treatment

Map 4: Location of stream crossing sites and trail treatment sections on the Kings River NRT.
