BAER Assessment Soils Report – Nickowitz Fire

Six Rivers National Forest (R5-SRF)

October 2015

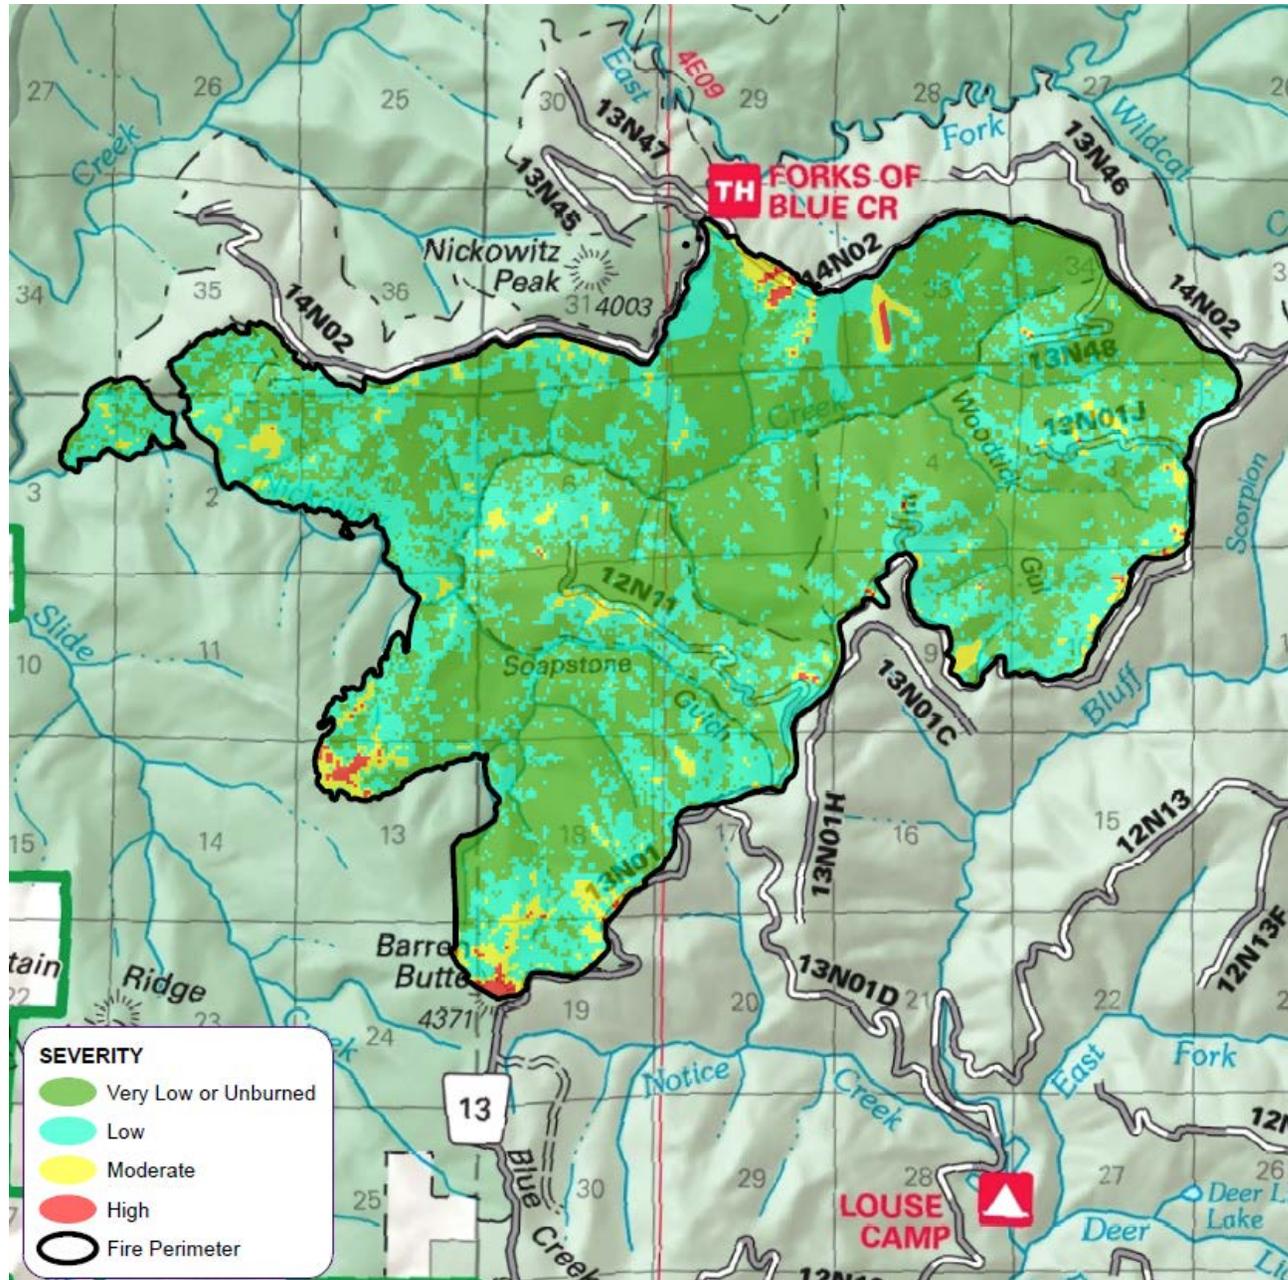
APPENDIX – SOIL BURN SEVERITY MAP

Soil burn severity was assessed based on field surveys and Burned Area Reflectance Classification (BARC) imagery. SBS is summarized in Table 1.

An estimated 85% of the Nickowitz fire area sustained low SBS and about 10% remained unburned, occurring in small un-mappable patches as a mosaic. The remaining 5% had moderate SBS in a few hand-mapped patches, and elsewhere under individual crowns of scattered trees. Given the preponderance of low SBS, there were no concerns to soil productivity, and few potential concerns to other VARs such as vernal pool plant community stability or cultural resources. Very few roads exist beyond the upland flats, except one road in the private portion of the fire which has a single culvert-crossing that appears well armored on both inlet and outlet.
