# Cameron Peak Fire Forest Service Burned Area Emergency Response Executive Summary

## Arapaho Roosevelt National Forest

### December 15, 2020

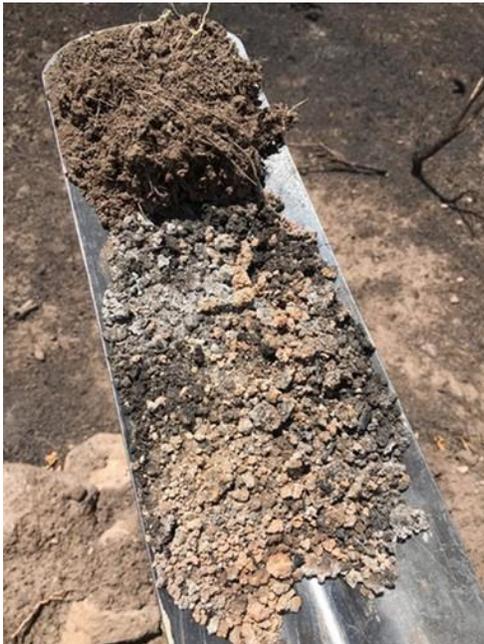
**Figure 1: Comparison of low soil burn severity with roots and structure (top of shovel) vs. high soil burn severity with no soil structure or roots to help bind soil (bottom of shovel)**

Areas of low and unburned SBS have minimal effects to soil properties, and therefore little to no post-fire effects. Moderate SBS indicates that some soil properties have been affected and the duff and litter layer that acts as a sponge to absorb precipitation has mostly been consumed. High SBS areas have significant alterations to soil properties such as complete consumption of litter and duff, loss of root viability and changes to soil structure that often drive substantial watershed response including increased erosion and runoff following precipitation events.

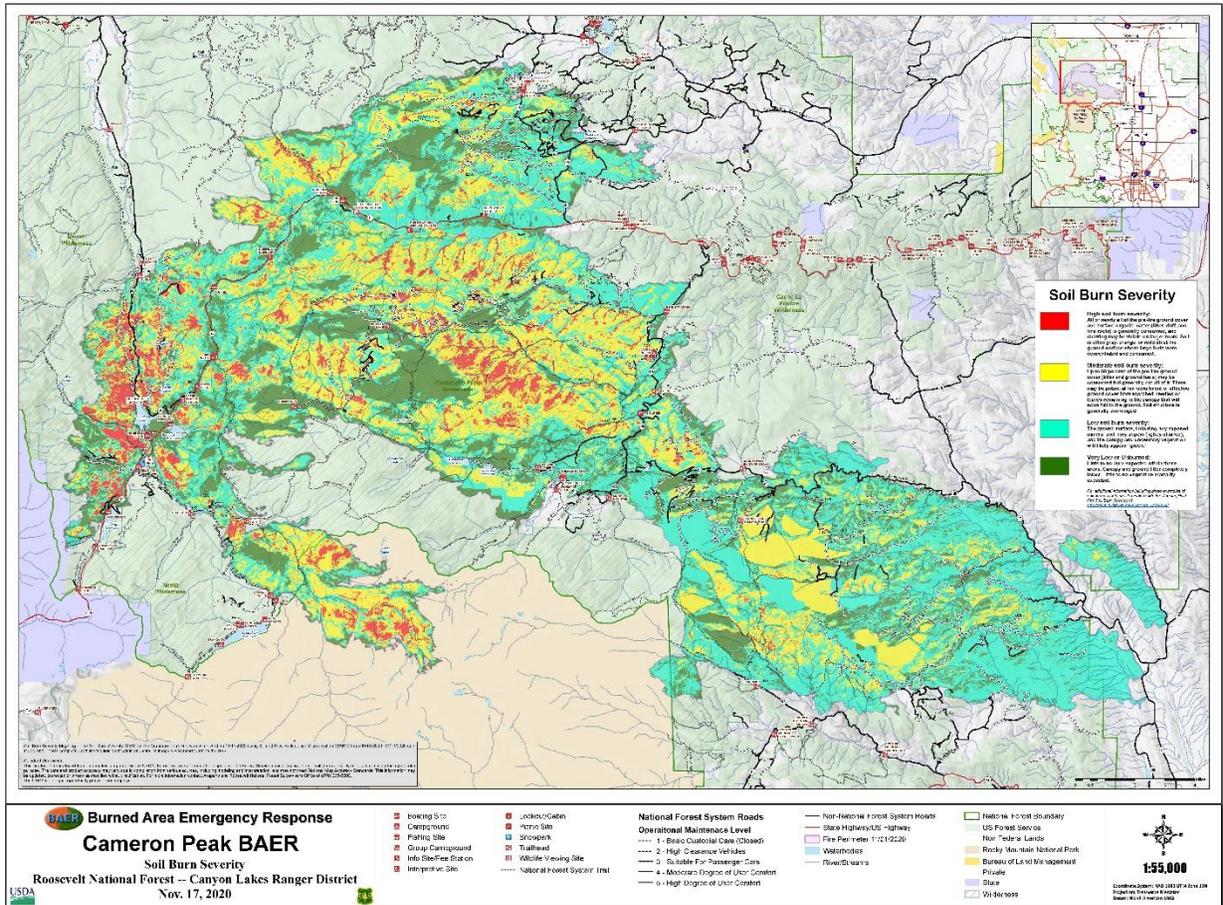
Figure 2. Cameron Peak Soil Burn Severity map

The U.S. Forest Service Geospatial and Technology and Applications Center provided the BAER team with an initial Burned Area Reflectance Classification (BARC) maps derived from satellite imagery that compares pre and post fire images. The team conducted field verification surveys to adjust the BARC to create the final SBS map (Figure 2).

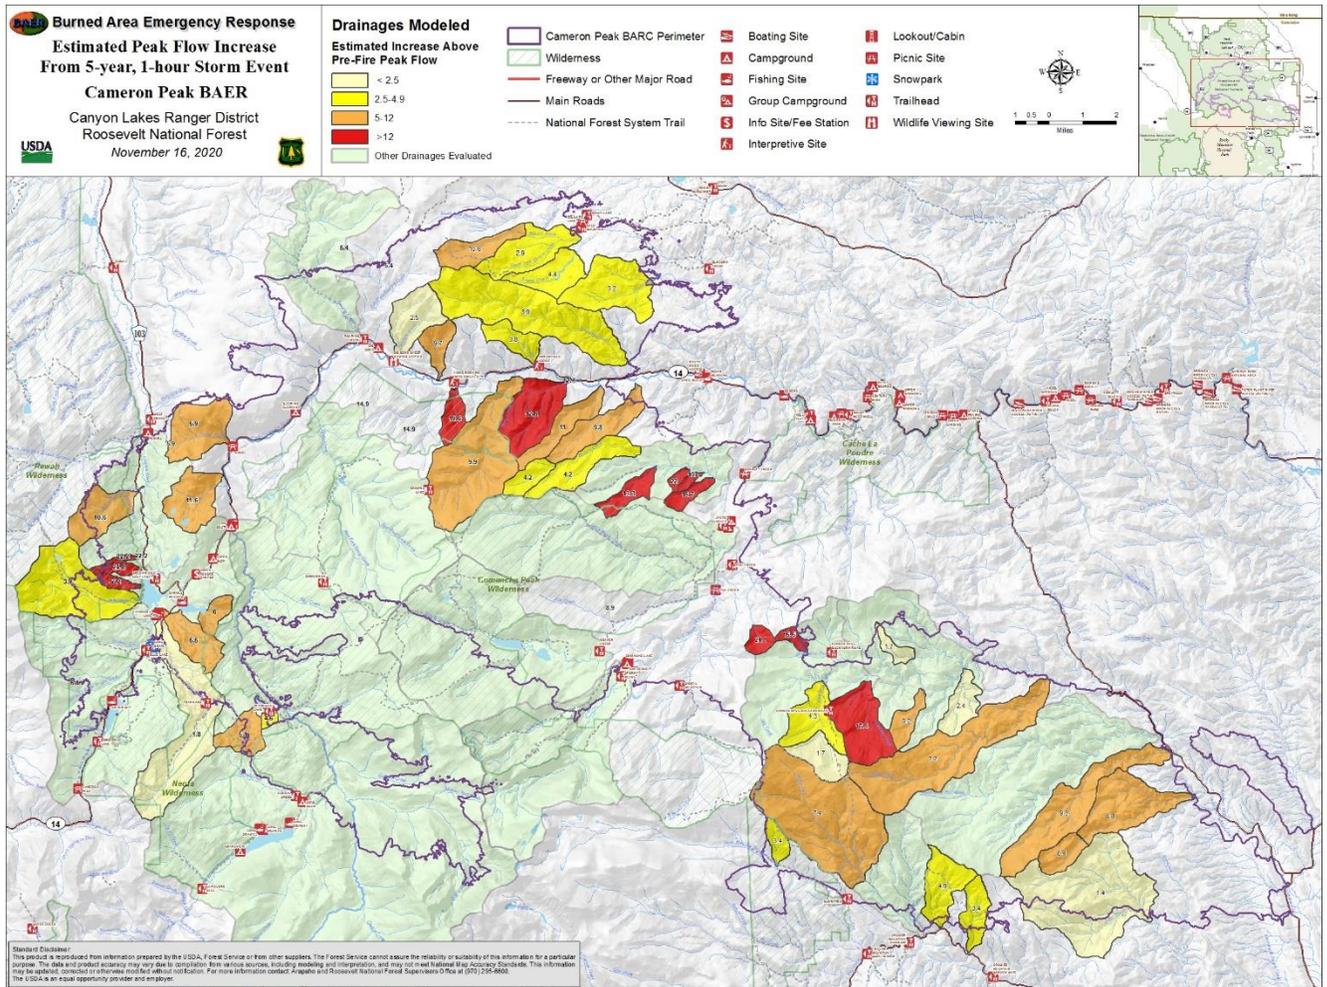
**Figure 3: Percent increase above pre-fire streamflow for the WEPPcloud-PEP modeled drainages.**

The WEPP *Post-fire Erosion Prediction* (PEP) distributed model was used to estimate increases in peak flows resulting from the fire for drainages under 6,000 acres. The 5-year-recurrence-interval, one-hour design storm was used in this analysis to represent a relatively common high-intensity rain event that may occur over the area. Modelling results are summarized in Table 5.
