TECHNICAL SPECIALIST'S REPORT – BURNED AREA EMERGENCY RESPONSE

Resource: Engineering
Fire Name: Hayden Pass **Month/Year:** 7/2016
Author: Aaron Lamp, Civil Engineer PSICC [alamp@fs.fed.us]

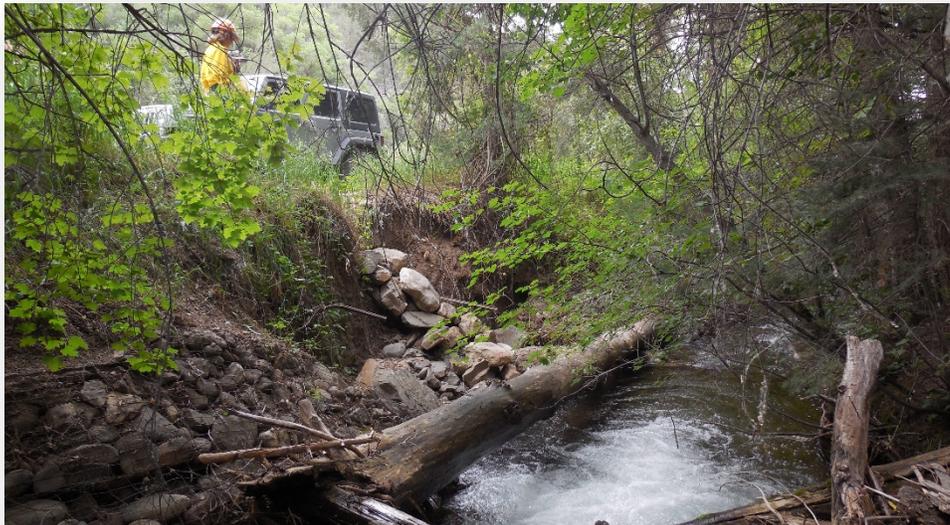
Figure 1: NFSR 6.2A [Coaldale CG]

- NFSR 6 [Hayden Creek]: No direct fire damage to the road, limited burned slopes above the road near the pass (high clearance segment), two AOPs observed at the Middle and North Prong of Hayden Creek (neither have burned area contributing to their watersheds).
 - Because of the high bench of the road, low burn impact on the adjacent slope and limited interaction with Hayden Creek, the threat is judged to be unlikely.
- NFSR 6.2A [Coaldale CG]: no direct damage, in close proximity to the South Prong of Hayden Creek (highly impacted watershed upstream.) Noted existing fill slope erosion and past attempts to armor with gabion baskets and riprap.
 - Due to close interaction with Hayden Creek and an already threatened fill slope, high rates of erosion and fill destabilization are expected with the projected flow increases and full or partial loss of the road is judged to be very likely.

- NFSR 6.2A [Coaldale CG]
- NFSR 6.3C [S. Prong Hayden Creek]
- NFSR 35 [Mosher Creek]
- NFSR 40 [Big Cottonwood]

- NFSR 6.2A [Coaldale CG]
- NFSR 40 [Big Cottonwood]

- NFSR 6.2A [Coaldale CG]
- NFSR 6.3C [S. Prong Hayden Creek]
- NFSR 40 [Big Cottonwood]

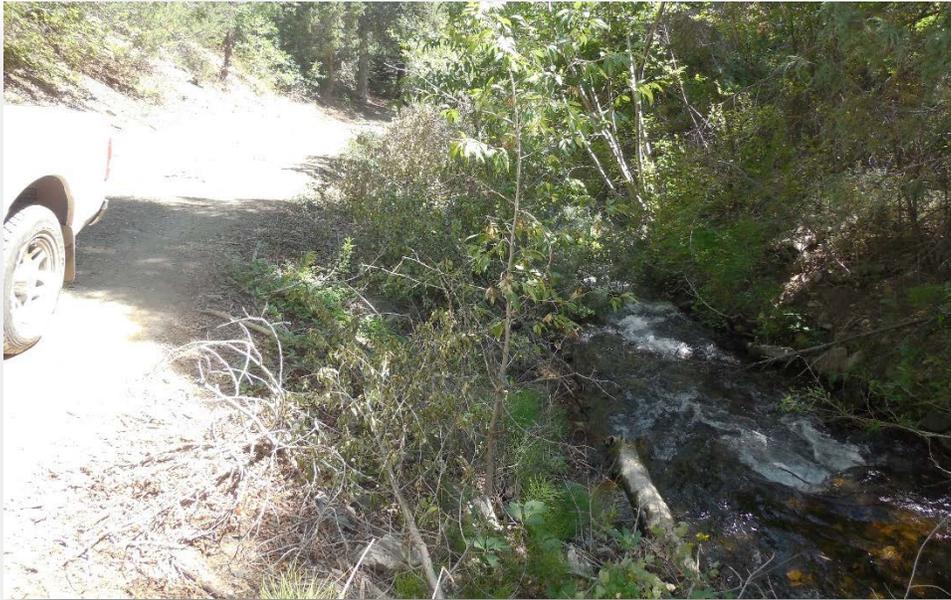
Figure 2: NFSR 40 [Big Cottonwood]

- NFSR 40 [Big Cottonwood]: No direct damage to the road but portions are in close proximity to Big Cottonwood Creek which drains the above highly impacted watershed. Poor drainage features in the road are inadequate to direct flows back to the creek and existing bank erosion compromises the road at several locations due to position in floodplain. Homes were observed adjacent to creek with several private bridges spanning Big Cottonwood Creek.

- The road is expected to be at risk to increased flows, sediment and debris due to up-gradient burned area. Minimal shoulder and elevation difference exists in several areas adjacent to the creek. During storm flows, water is very likely to enter the prism and high rates of erosion are expected in the fill slopes of the road.

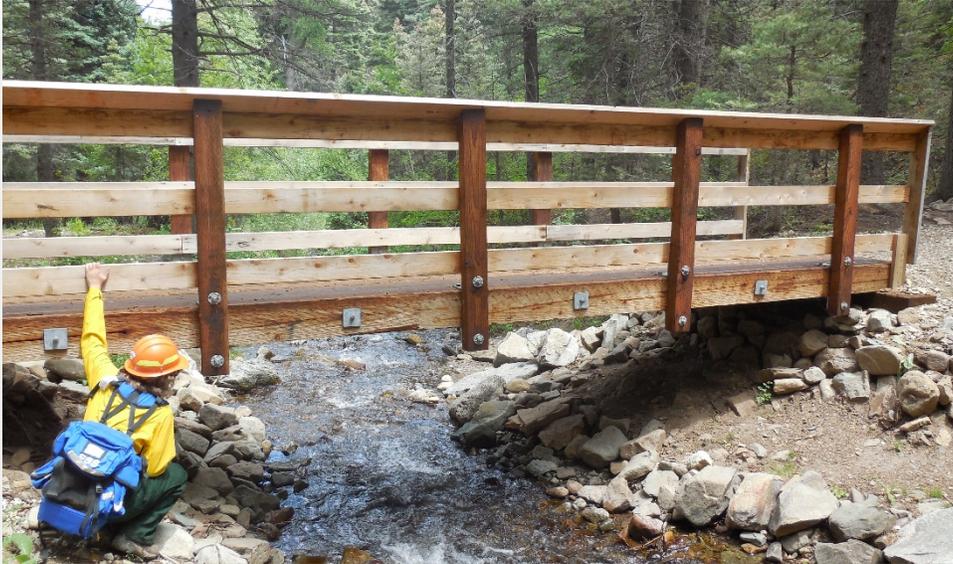
Figure 3: Trail Bridge on the Rainbow Trail above NFSR 6.3C

- Trail Bridge on the Rainbow Trail above NFSR 6.3C [S. Prong Hayden Creek]: 25' Glu-laminated timber bridge spanning the South Prong of Hayden Creek on rock gabion abutments. 4.0' freeboard.
 - The freeboard is inadequate to pass projected flows and expected debris due to substantial burned area upstream and low slope in the cross section. Damage to or failure of superstructure is likely.

- Coaldale Campground
- Trail Bridge on the Rainbow Trail above NFSR 6.3C [S. Prong Hayden Creek]
- Trail Bridge on the Rainbow Trail at trailhead on NFSR 40 [Big Cottonwood]

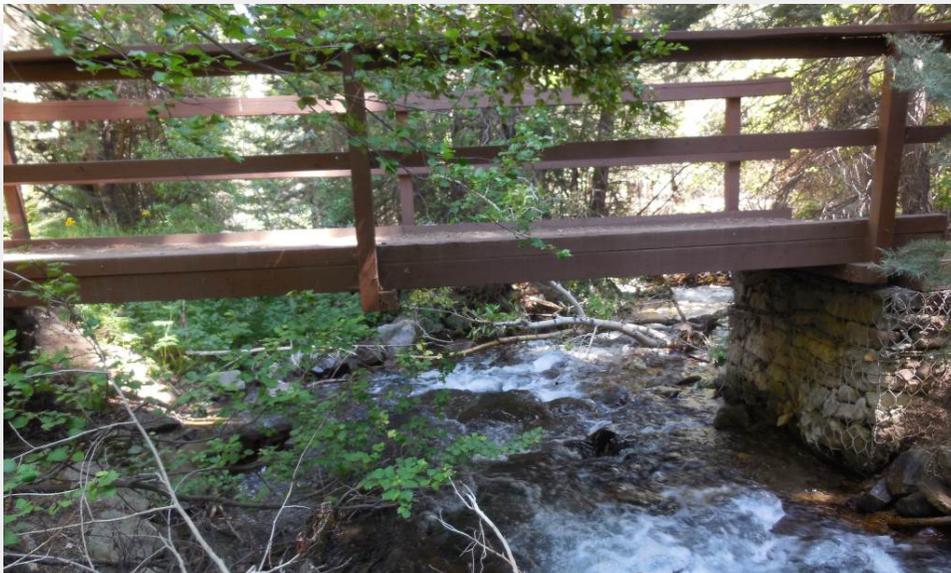
Figure 4: Trail Bridge on the Rainbow Trail at trailhead on NFSR 40

- Trail Bridge on the Rainbow Trail at trailhead on NFSR 40 [Big Cottonwood]: 20' timber bridge spanning Big Cottonwood Creek. Rock gabion abutments with some damage. Stream currently flowing in and around one abutment. 4.0' freeboard.
 - The upstream watershed (including Wolf Creek) is highly impacted by the burn and increased flows are expected. Gabion condition and the constricted channel make abutment failure (and subsequent bridge loss) very likely due to snagged debris and flow impact on the stacked rock.

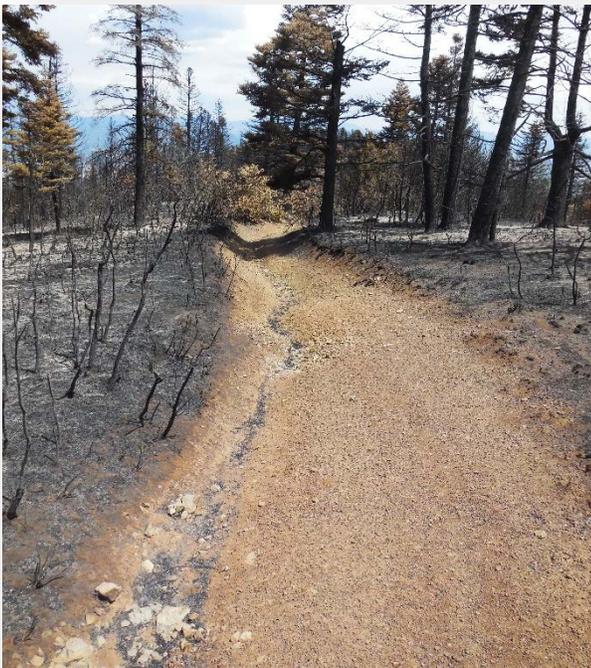
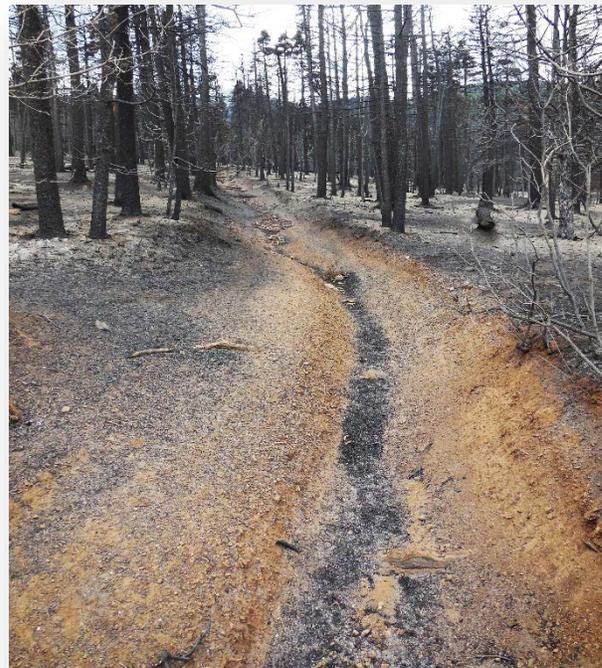
Figure 5: Unauthorized roads in Little Cottonwood Drainage

- Unauthorized 2-track roads in the Little Cottonwood drainage were observed accessing the Rainbow Trail from private lands. Roughly 2 miles are along ridge tops and will have little impact in post burn conditions but another 4 miles travel in floodplains or directly up slopes. Lack of drainage features paired with poor alignment has entrenched these roads under existing flow conditions.
 - These roads and trails are in a highly impacted watershed and are expected to be exposed to greatly increased flows. Water and debris will be caught by these incised "channels" and instigate excessive erosion and sedimentation along adjacent slopes and down the watershed. Water quality, soil productivity, slope integrity and hydrological function are very likely to be negatively affected.

- Trails and 2-tracks in Little Cottonwood Drainage (see Map)
