Hayden Pass Wildfire BAER

Resource Report

Fisheries Resources

San Isabel National Forest

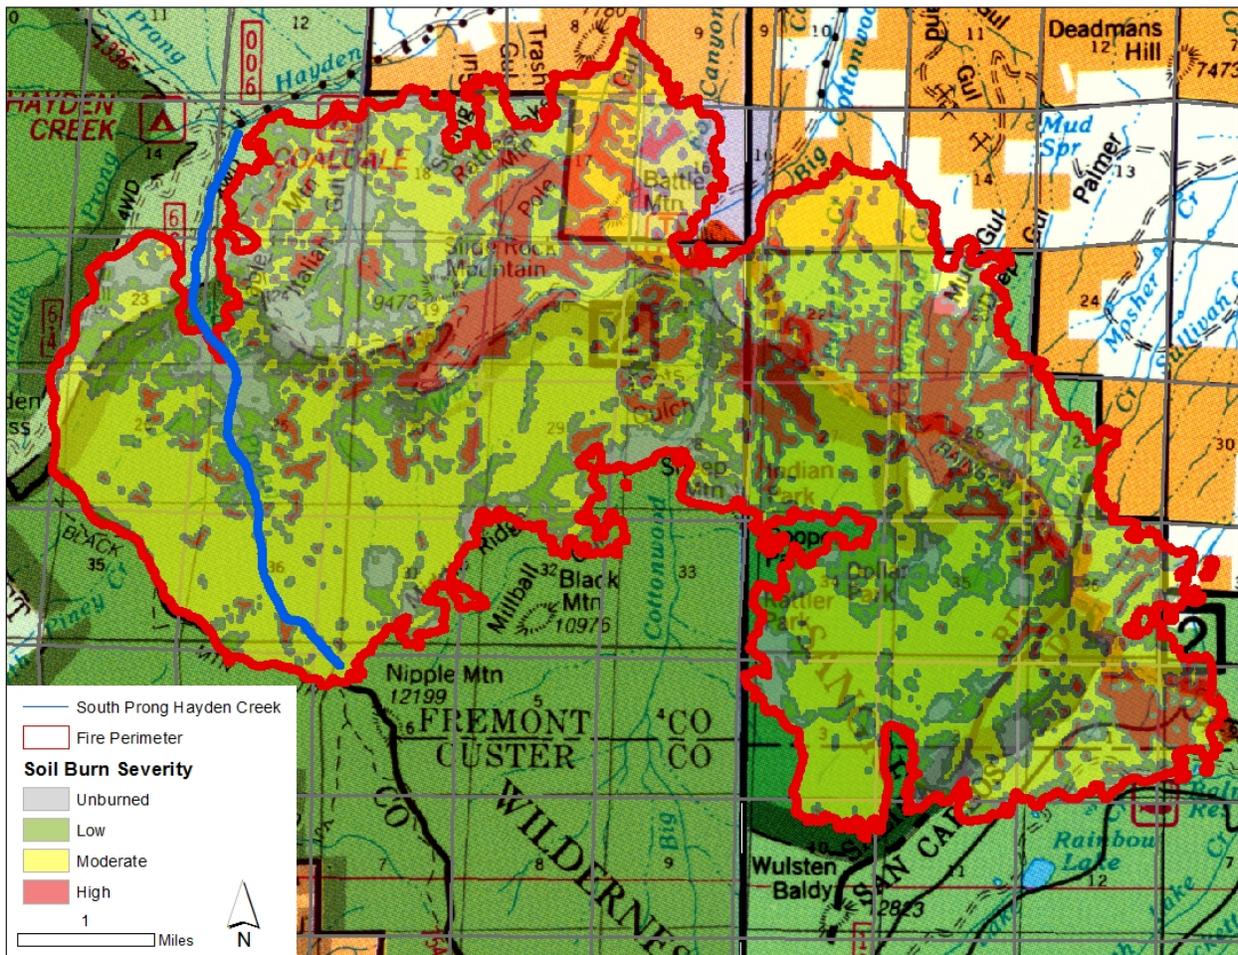
Figure 1. South Prong of Hayden Soil Burn Severity

The cutthroat trout, their habitats, and habitat improvements within the fire perimeter have largely been unaffected by the fire itself. The South Prong of Hayden Creek is 4.34 miles from the headwater to the confluence with Hayden Creek. 2.43 miles of adjacent land were unburned, .74 miles are of low soil burn severity, .80 miles of moderate and .37 miles of high as shown in Figure 1. The highest quality habitat exists for the first mile upstream of the confluence and slowly reduces in quality as you move upstream. A majority of occupied habitat and surrounding

riparian vegetation has not burned but some uplands and a majority of the headwater is burned. The habitat and cutthroat are at risk to future losses, disturbances, and habitat degradation from post-fire watershed events. These impacts include potential for localized extirpations due to ash flows; reduced water quality and changes in water chemistry due to ash delivery and changes in water temperature from loss of canopy shading; and scouring of riparian/aquatic vegetation and changes in streambed/pool habitat due to debris flows and sediment delivery. Because of the fish barrier, fish that swim downstream to escape debris flows will not be able to return to their native habitat and will be lost to the population.

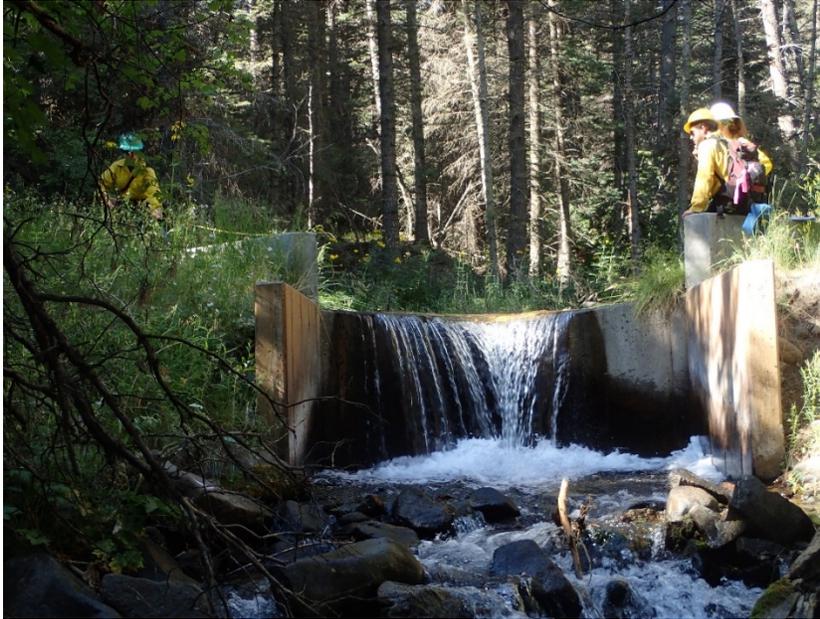
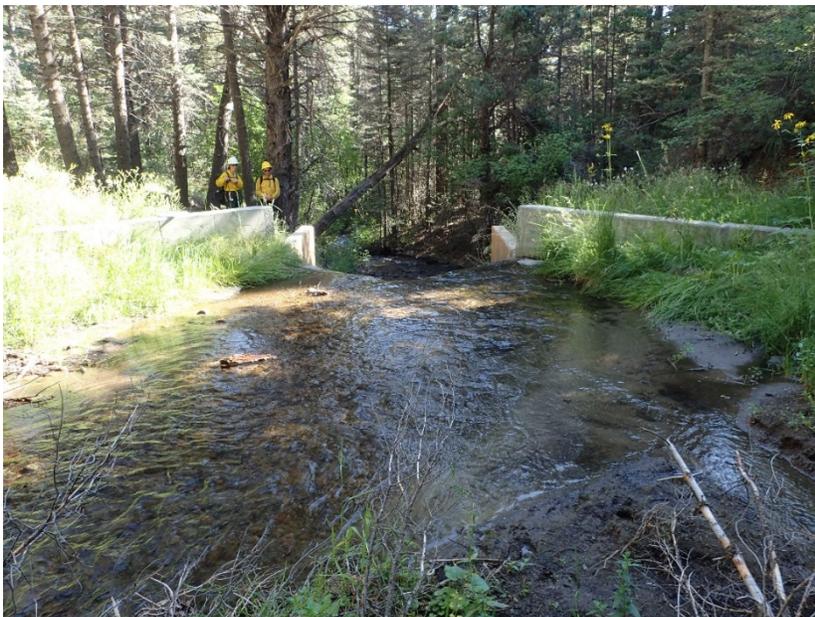
In 2005-2006 habitat in the South Prong of Hayden was enhanced by building a manmade barrier to exclude downstream brown trout from migrating into cutthroat habitat, installing structures to increase sediment transport, creation of deeper pool habitats, and converting a road that was within the WIZ to a single track multiple use trail. This population was once in danger of extinction and when last surveyed in 2014 at least five age classes were present and numerous fry were collected. A self-sustained, robust population resided in the habitat improved reach easily meeting population stability criteria.

Fish Barrier on South Prong of Hayden Creek just above confluence with Hayden Creek

Exclusion of nonnative trout, through the maintenance of the barrier, will continue to be important to protect the cutthroat population. The BAER team assessed the potential for damage to, or loss of, the barrier. It is likely that this barrier may be damaged or destroyed and require

repair to prevent invasion of non-native species. The negative interaction between native cutthroat trout and nonnative trout, through predation and competition, and hybridization has been well documented. It is important that this barrier be monitored and if damaged or destroyed be repaired or replaced immediately.

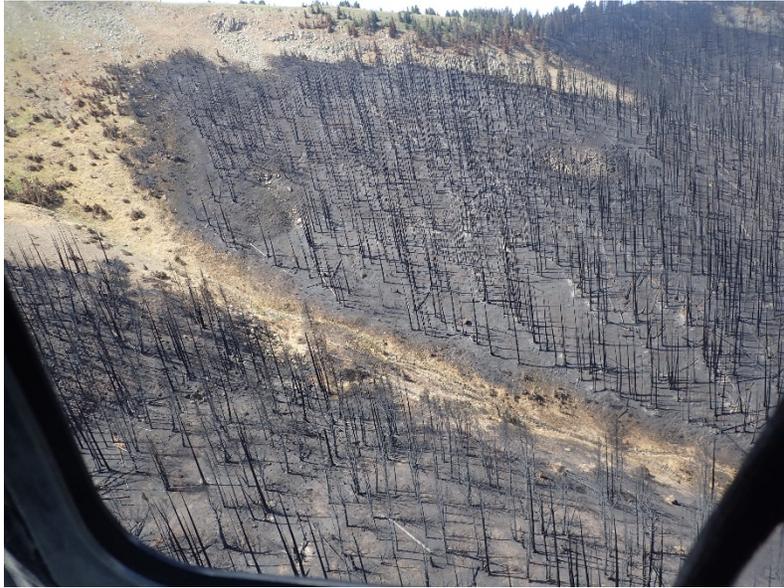
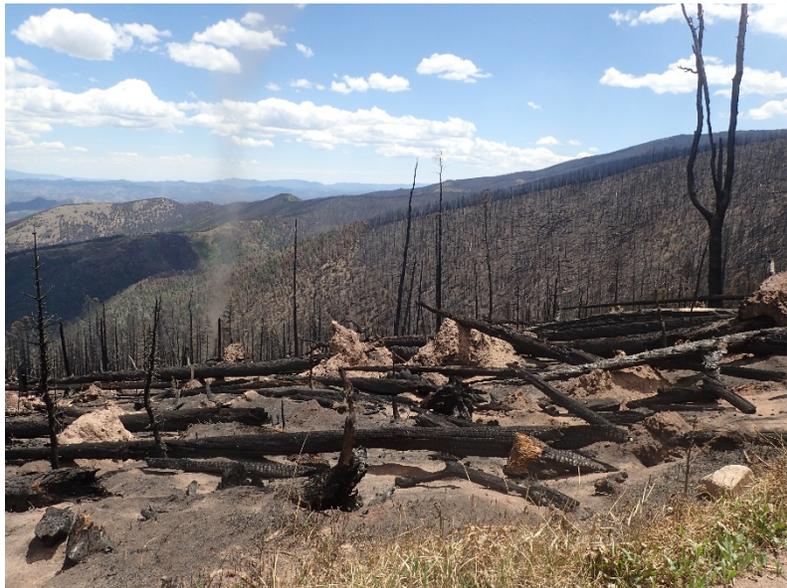
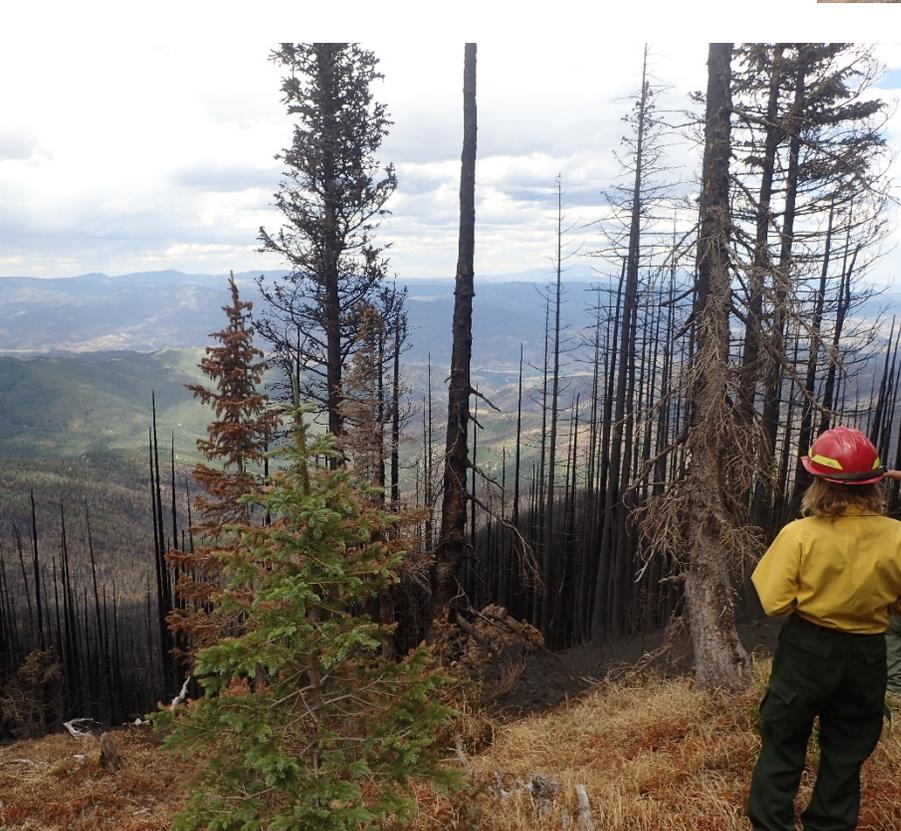
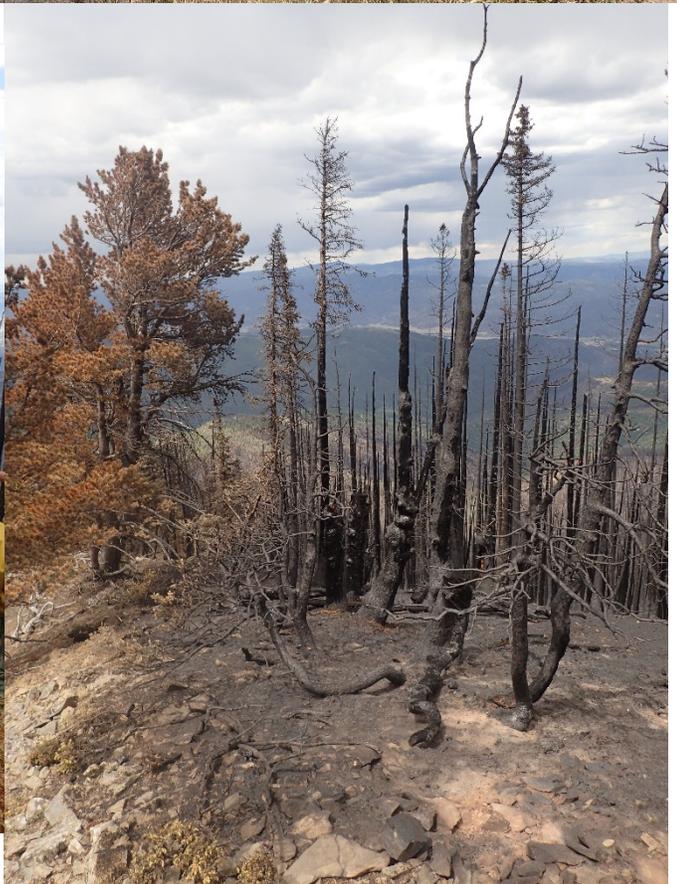
South Prong of Hayden Headwaters
