Stickpin Fire BAER
Resource Report
Colville National Forest
Hydrology

Prepared by
John Rihs, Hydrologist, Apache-Sitgreaves NF's
With
Mike McConnell, Hydrologist, Gifford Pinchot NF
Bill Goodman, Hydrologist, Freemont-Winema NF's

September 27, 2015

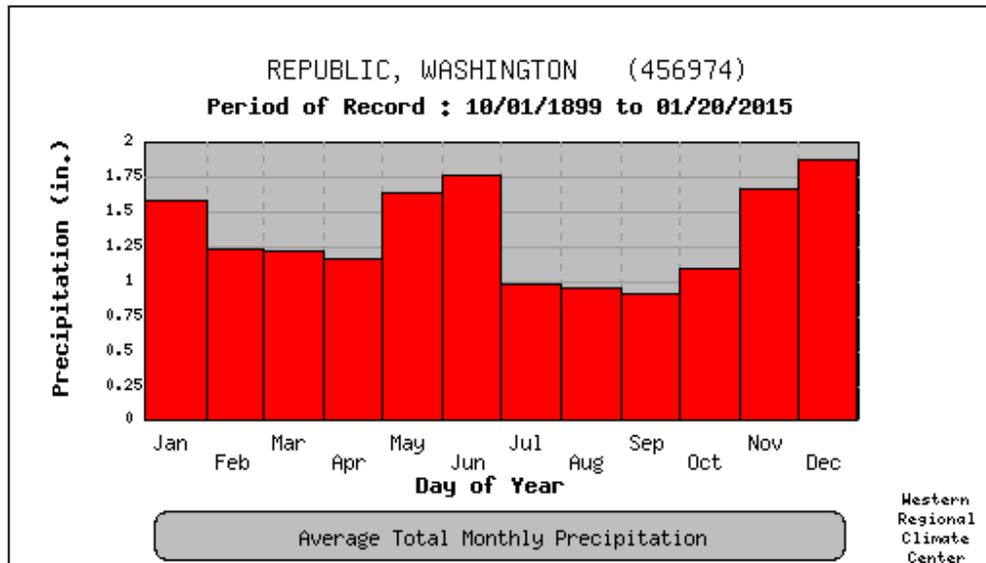
The nearest long-term precipitation record is located in Republic, Washington (2,500 ft. elevation) located approximately 6 miles to the NNE of the North Star Fire. Rainfall season for the town of Republic, Washington typically occurs from January to June with precipitation amount between 1 and 2 inches. Summer season from July to September receive less rainfall precipitation with less than 1 inch before picking up again in October with December being the wettest month. The area receives an average rainfall of 30 inches per year, and snowfall with almost 50 inches a year. Period of record for the town of Republic from the Western Regional Climate Center is 115 years (Figure 1).

Figure 1. Average monthly precipitation for Republic, Washington (Western Regional Climate Center).

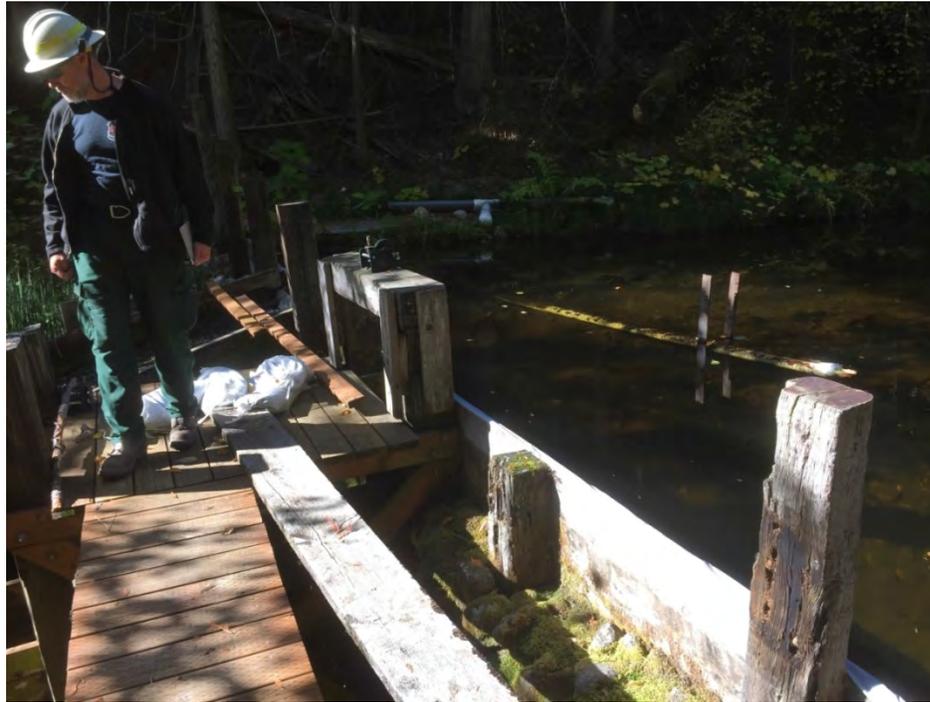
The intake facility, located on the National Forest, is a mix of modern and historic structures. Historic structures include a Douglas-fir log with dimensional lumber, 12 inch wooden pipeline, and rock features supporting a weir gate and spillway.

days of water for the community should the facilities need to be shut down. Additionally, the historic intake structures is accessed by a foot trail, making cleaning of sediments captured by the weir system can only be done by hand.

The intake structure is at higher risk during normal storm events as they will have higher flows and sediment transport from burned areas in the upper drainage. For the 25-year storm event, a 150% increase in flow is estimated.

Figure 2: Historic weir intake structure for the Orient, WA, water municipal water system.

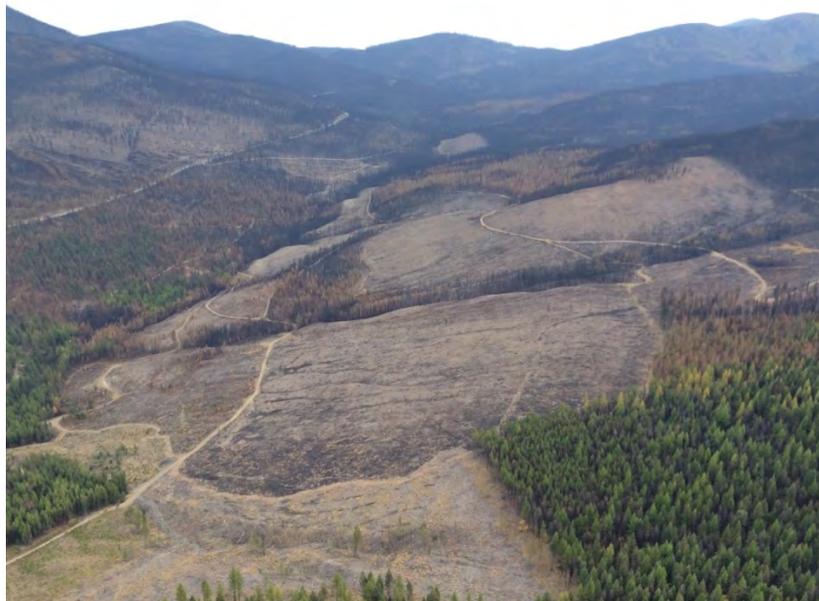
Figure 3. Photo looking upstream in West Deer Creek. Private land in the fire perimeter.

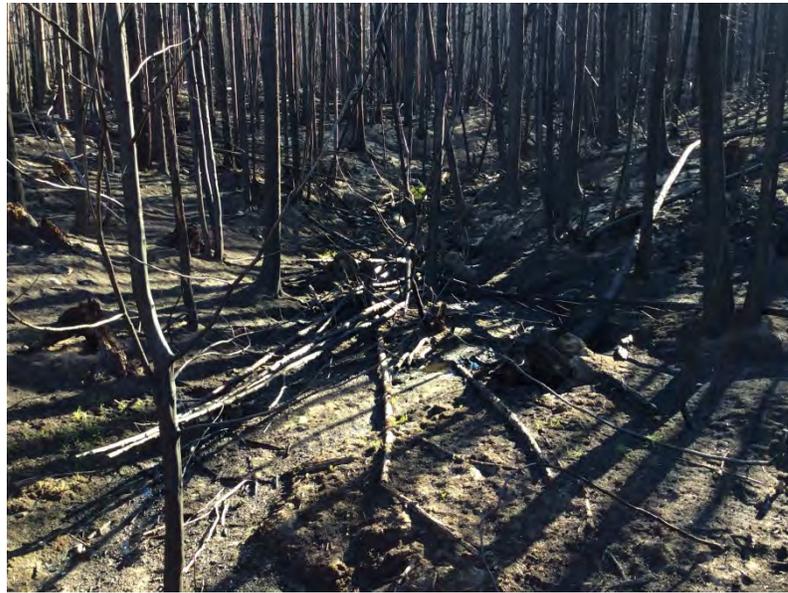
Figure 4. Upland stream channel.

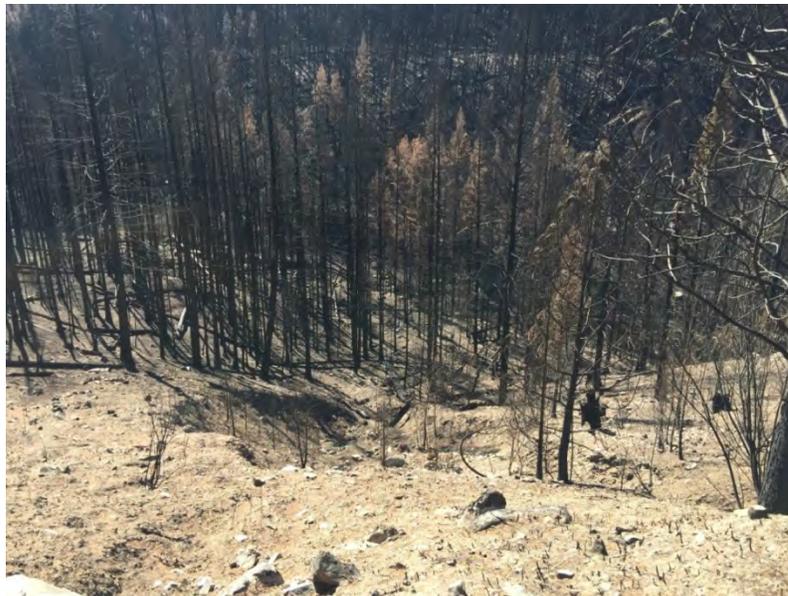
Figure 5. Pre-fire erosion feature on private land above Long Alec Creek.

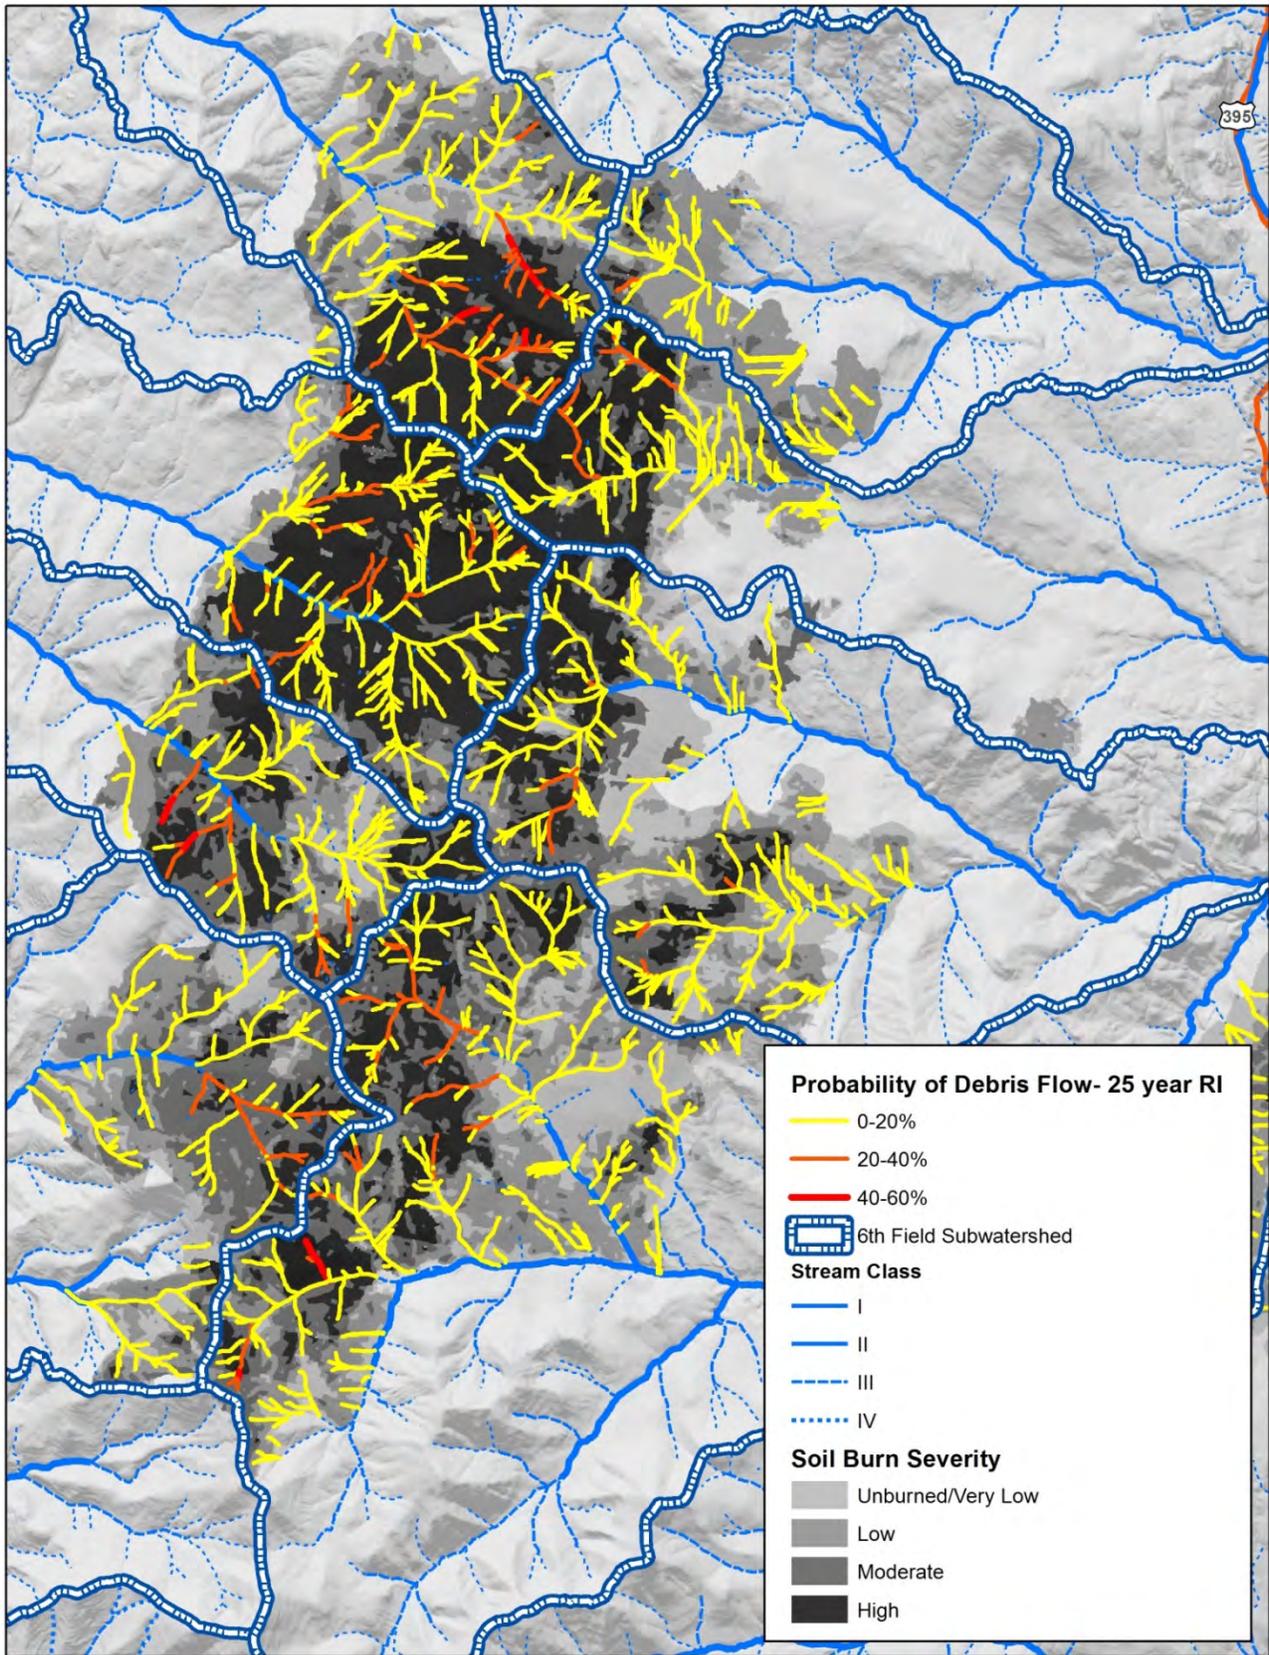
USGS Debris Flow Model

Another key data set used for the assessment was prepared specifically for the BAER assessment by the U.S. Geologic Survey (USGS). It depicts spatially the probability of debris flows in small catchments and stream reaches in the fire given a storm of a specified recurrence interval. The model was developed by the USGS as a tool to help analyze the risk of post-fire debris flows. It was originally developed to assess the potential for debris flows after fires in southern California and the Rockies. Though not tested or calibrated for physiographic ecoregions in Washington, the model was applied to the Stickpin fire to see if it could be useful for identifying slopes and streams that may be prone to debris flows, and therefore the values potentially at risk. It was found that the data in the model applied to the Stickpin fire were generally useful for identifying potential impacts to resources and infrastructure. It may however, have underestimated the probability of risk because inherently, the stability of the decomposed volcanic ash mixed with granitics in the area is already comparatively low. None the less, the data has been useful in a relative sense because it identifies those areas or reaches where the density of highest probability is greatest. The debris flow model shows the highest concentration of debris flow probability in the upper Long Ranch subwatershed in the area of proposed treatments. The model was reviewed by local Hydrologist expert Bill Swartz who verified modeled problem areas. Overall the model was very helpful in designating priority treatment areas.
