# COLVILLE NATIONAL FOREST BURNED AREA EMERGENCY RESPONSE [BAER] PLAN

## STICKPIN FIRE RECREATION RESOURCE ASSESSMENT

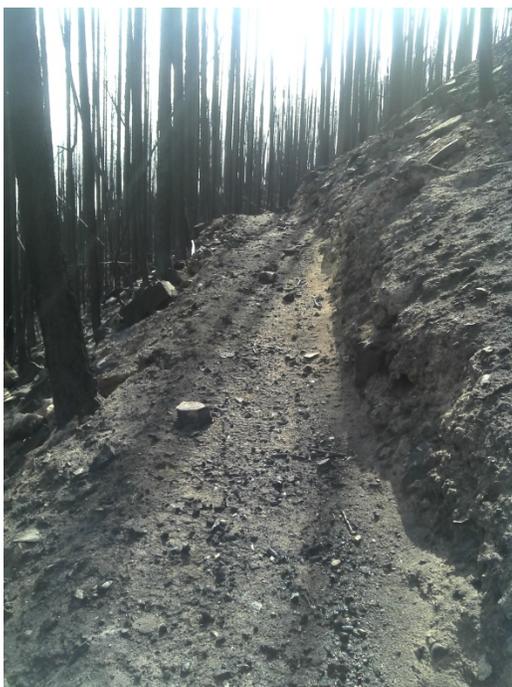
Trail within the Stickpin Fire (nearly half) experienced mostly high burn severity conditions. Trails have damaged tread where roots and stump holes burned and collapsed the walking surface. Many fallen fire-killed trees and much debris that has rolled into the tread have impeded trail access, throughout the fire area.

Example of a trail segment that is at high risk of erosion unless measures are taken to improve drainage.

Description: Clean existing trail drainage structures (water bars and check dams), and remove slough and berm from tread on trails that are within High and Moderate burn severity areas to ensure optimum functionality. Work should be performed prior to snowfall in order to be functional for spring snowmelt or a seasonal rain-on-snow event could prove catastrophic.

Description: Install drainage structures along portions of trails to protect water quality and minimize damage to trails. Rock water bars and armored stream crossings are the preferred structures. Work should be performed prior to snowfall in order to be functional for spring melt or a seasonal rain-on-snow event that could prove catastrophic.

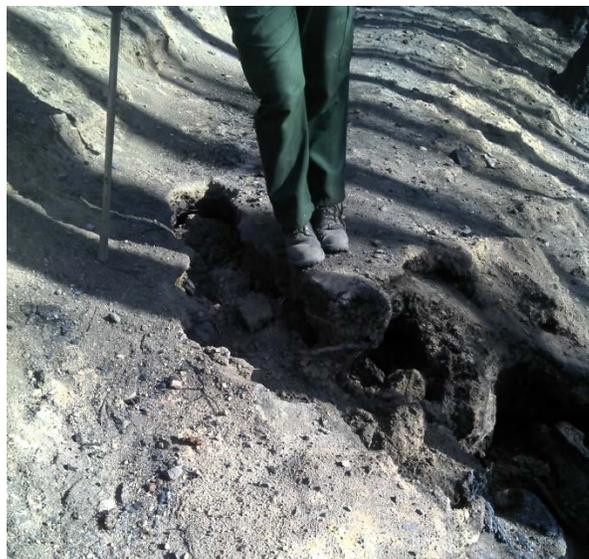
Stump  
Hole on  
trail.
