COLVILLE NATIONAL FOREST BURNED AREA EMERGENCY RESPONSE [BAER] PLAN

NORTHSTAR RECREATION RESOURCE ASSESSMENT

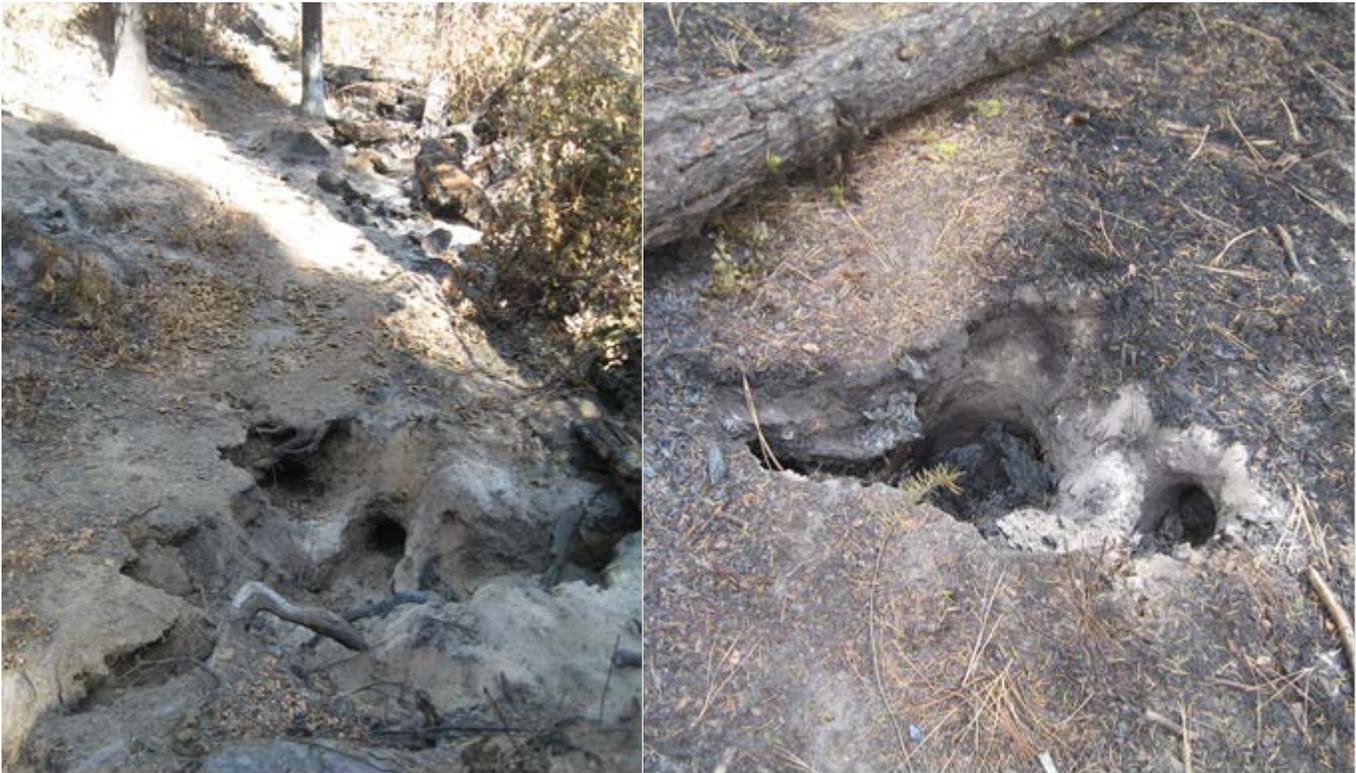
Trails within the Northstar Fire experienced moderate to high burn severity conditions. Trails have damaged tread where roots and stump holes burned and collapsed the walking surface. Many fallen fire-killed trees and much debris that has rolled into the tread have impeded trail access, especially in the high severity burned areas.

Danger from falling snags will be high and will persist for many years. There will also be increased risk to hikers from debris flows in cases of large precipitation events on trails.

- **Clean Existing Trail Drainage Structures**

Description: Clean existing trail drainage structures on 6 miles of trails that are within High and Moderate burn severity areas to ensure optimum functionality.

- **Trail Erosion Control Facility Installation**

Description: Install drainage structures along portions of trails to protect water quality and minimize damage to trails. Work must be performed prior to snowfall in order to be functional for spring melt or a seasonal rain-on-snow event that could prove catastrophic.

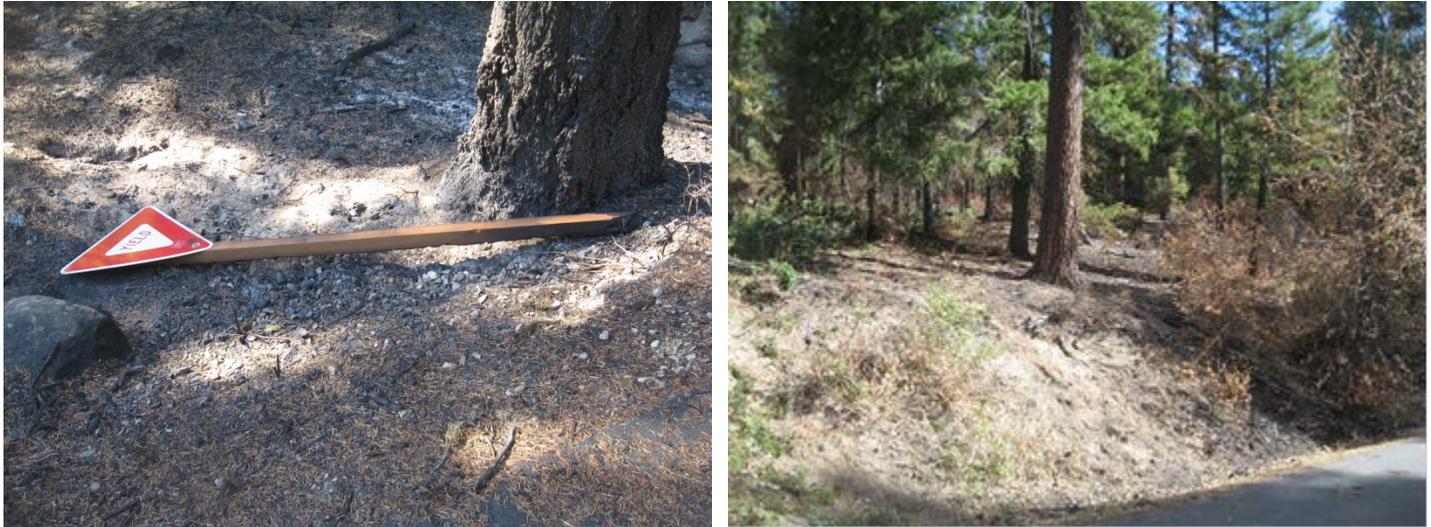
Swan Lake Campground experienced mostly low intensity ground fire with isolated single tree torching, resulting in increased number of hazard trees that have potential targets within the campground. However, active fire was observed during field assessments, but it is assumed that observed small pockets of fire were

contained and stayed at the relatively low intensity level. There are several burned stump holes and stumps remaining on the ground within the boundary of the camping area, which will pose a hazard to berry pickers. Wooden structures (wooden fences for preventing unwanted access) within the campground will need to be re-evaluated for safety and effectiveness.

At least one road sign was burned and fell over, and will need to be replaced to direct traffic in order to prevent vehicle collisions.

- **Campgrounds/Designated Dispersed Sites**

Description: Remove hazard trees that pose a threat to the safety of visitors or property. Close individual camp sites for 1-3 years in Swan Lake Campground (up to 6 sites potentially) until hazard trees can be removed.

Install closure devices to ensure individual sites are adequately protected. Purchase and install signs to inform public of closure(s) and hazards present. It is estimated that the cost of removing isolated hazard trees will be less costly than installing closure devices, signing, and monitoring for compliance.
