# COLVILLE NATIONAL FOREST BURNED AREA EMERGENCY RESPONSE [BAER] PLAN

## RENNER FIRE RECREATION RESOURCE ASSESSMENT

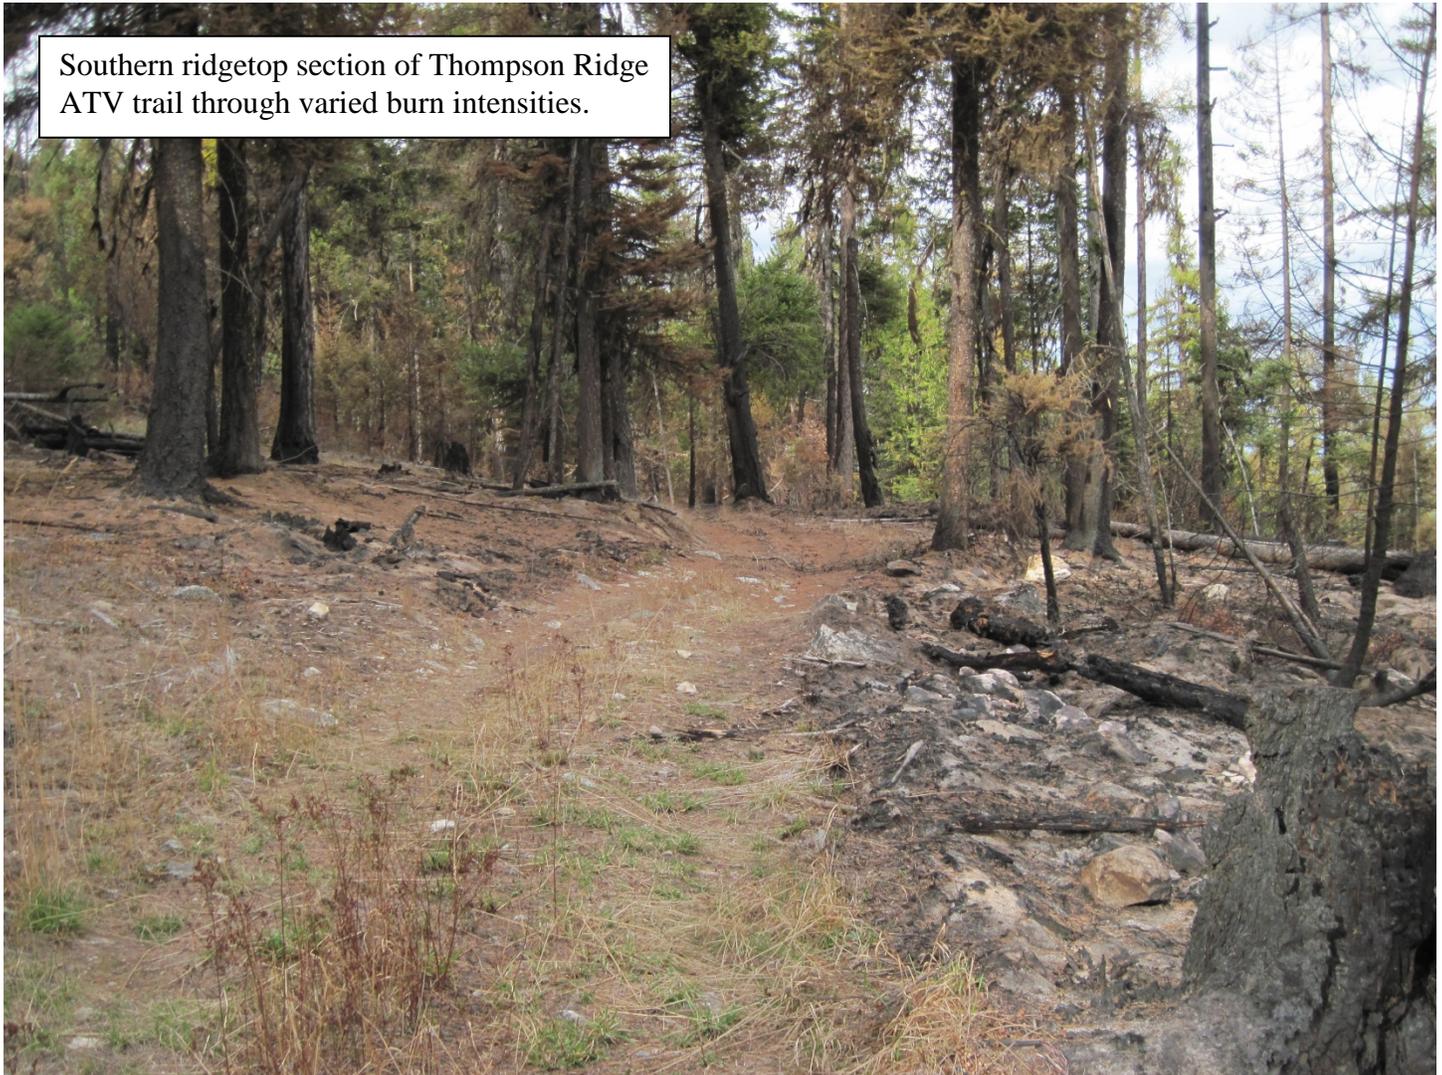
Thompson Ridge ATV Trail is the only formal trail within the fire area. It is mostly on a ridgetop as it travels north from Davis Lake, until it descends towards South Fork Boulder Creek. There is a steeper section approximately 2 miles long at the north end of the trail that burned in low, moderate, and high fire areas.

Description: Clean existing trail drainage structures and remove slough and berm from tread on northern 2 miles of the Thompson Ridge ATV trail. Work should be performed prior to snowfall in order to be functional for spring snowmelt or a seasonal rain-on-snow event could prove catastrophic.

Monitoring: Inspect trails after major precipitation events and after spring runoff to assess effectiveness of erosion control structures at diverting water from trail surface.

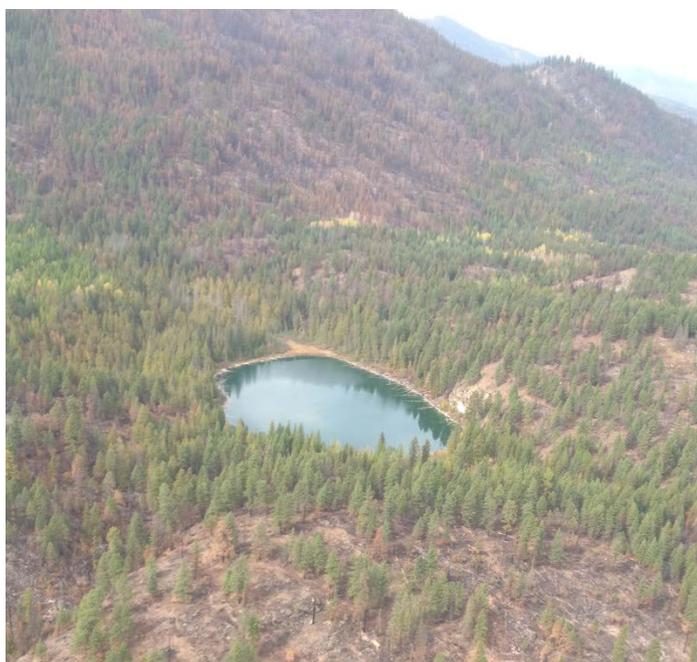
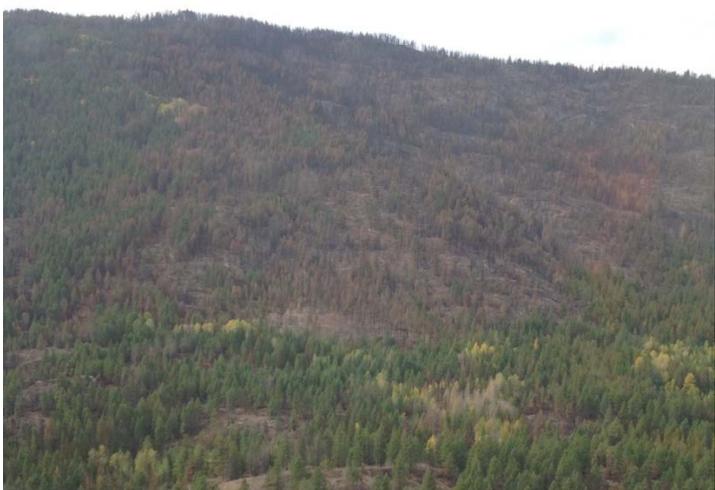
From an aerial observation Renner Lake appears to be unaffected by fire. However, there may be some amount of low intensity fire on the ground. No on-site inspection was made of Renner Lake due to time constraints. Even though this is not a developed campground, it has a known history of use and a thorough inspection of the site should be completed prior to allowing the public into the area to ensure hazards are mitigated.

Aerial view of Renner Lake and slope above lake

Description: Purchase and install signs at Renner Lake dispersed site and at both termini of the Thompson Ridge ATV Trail. The signs will warn of increased hazards due to post fire conditions, including falling snags, rolling debris, and flooding.
