Coronado National Forest

BAER ASSESSMENT

HORSESHOE 2 FIRE

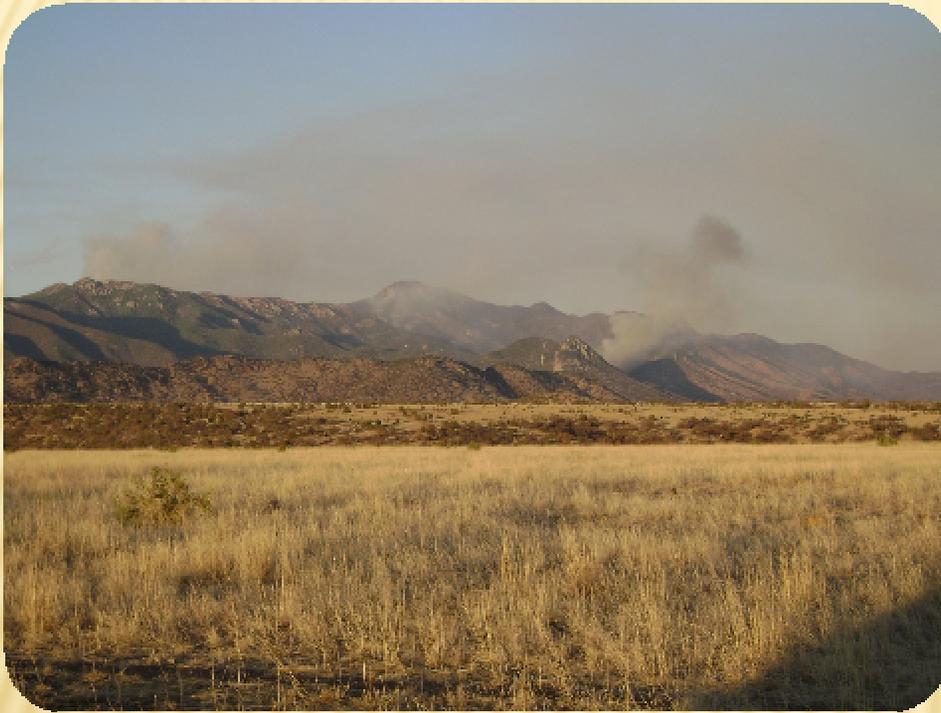
BAER PROCESS

- BARC Map
- Soil Burn Severity Map
- Establish Watershed Response
- Determine Threats to VAR
 - Human Life and Safety
 - Property
 - Natural Resources
 - Cultural Resources
- Propose Treatments
- Develop BAER Report
 - 7 Days After Containment
- Implementation

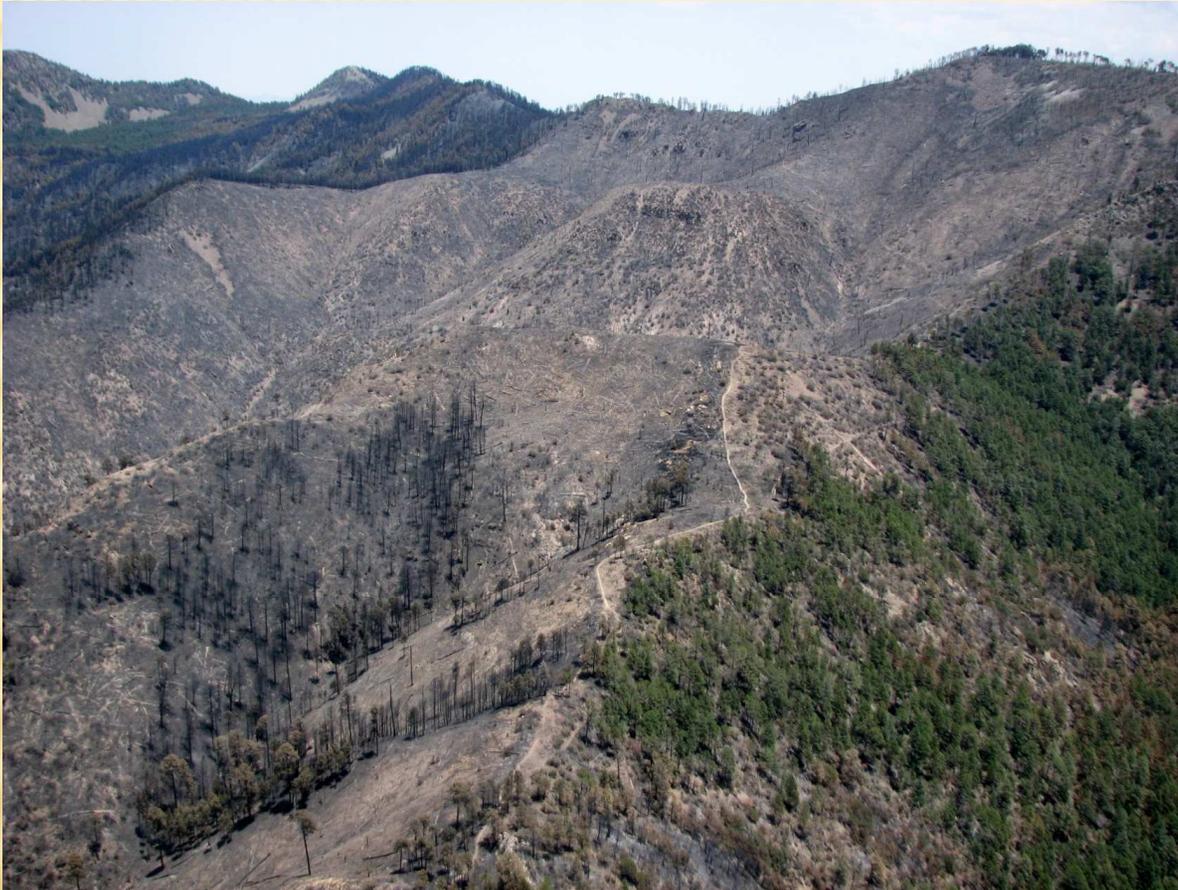
Soil Burn Severity	Acres	Percent
High	27,730	12%
Moderate	66,226	14.9%
Low	84,852	73.7 %
Unburned	44,093	11.3 %

Total Acres: 222,954
