USDA-FOREST SERVICE

**BURNED-AREA REPORT
(Reference FSH 2509.13)**

- A. Fire Name:** Nickowitz
- B. Fire Number:** CA-SRF-001470
- C. State:** CA
- D. County:** Humboldt and Del Norte
- E. Region:** 5 – Pacific Southwest
- F. Forest:** 10- Six Rivers
- G. District:** Orleans
- H. Fire Incident Job Code:** P5J0S5/0510
- I. Date Fire Started:** July 31, 2015
- J. Date Fire Contained:** October 27, 2015
- K. Suppression Cost:** \$13.5 million to date
- L. Fire Suppression Damages Repaired with Suppression Funds:**
1. Fireline waterbarred (miles): ongoing
 2. Fireline seeded (miles): 0
 3. Other (identify): Hand line repaired:
- M. Watershed Name and Number:** Bluff Creek (180102090804), East Fork Blue Creek (180102090901), Lower Blue Creek (180102090905), and Middle Blue Creek (180102090904)
- N. Total Acres Burned:** 7,750 ac
 NFS Acres(X) Other Federal () State () Private ()

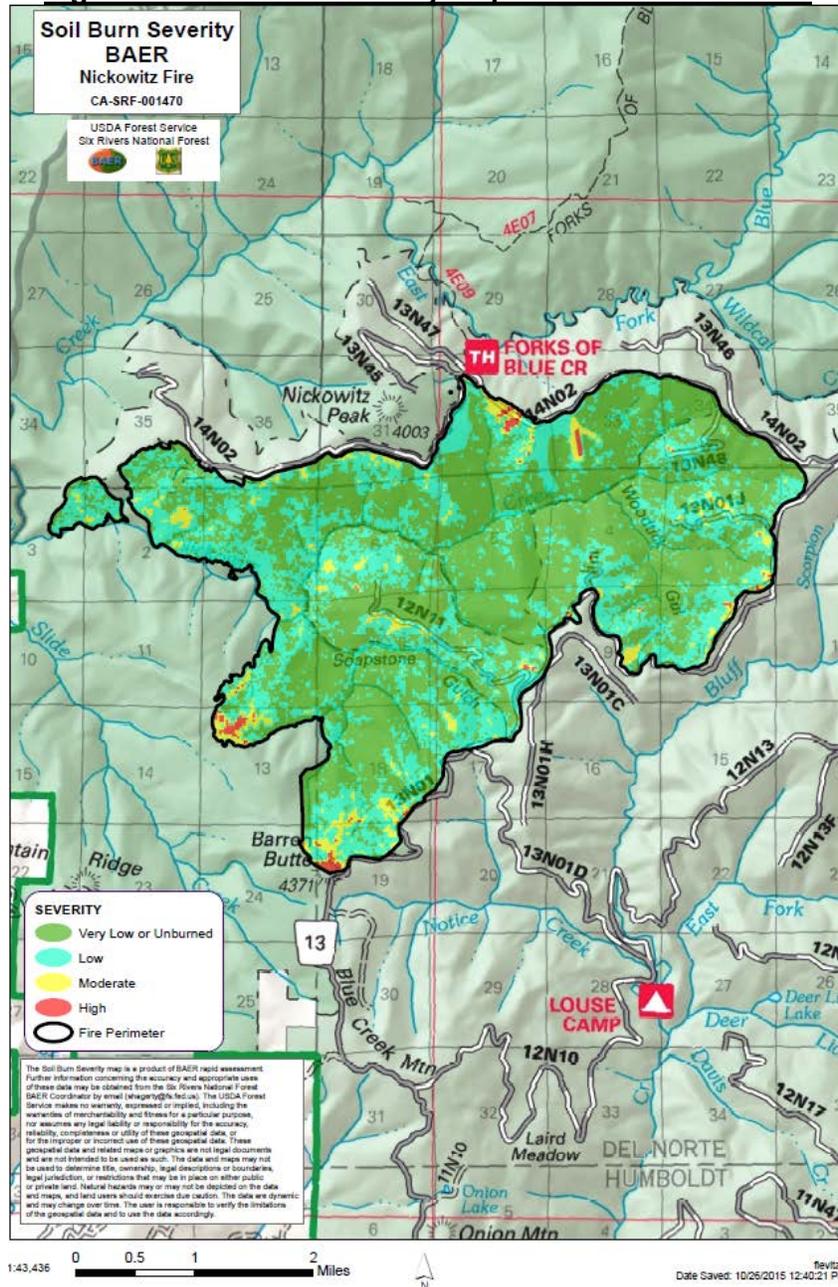
Figure 1 – Soil Burn Severity Map for the Nickowitz Fire

A. Burn Severity (acres): 4,464 (58% very low and unburned); 2,845 (37% low) 384 (4% moderate) 55 (1% high)

Background: The Nickowitz Fire was ignited by lightning on July 31, 2015, has burned roughly 7,750 acres within the Blue and Bluff Creek watersheds on the Six Rivers National Forest. The observed fire intensity and soil burn severity (SBS) is consistent with fire behavior documented in the Incident Management Team (IMT) close-out narratives. Predominantly low SBS exists across the areas where fires burned with a steady downhill backing spread, with limited spotting and occasional single tree torching. In these areas fuel consumption was limited to surface litter and smaller diameter vegetation (1 and 10 hour fuels).
